Site History Review
Fiskville Training College,
4549 Geelong-Ballan Rd, Fiskville, VIC

Ref no: 212163.1

Prepared for Ashurst

March 2014

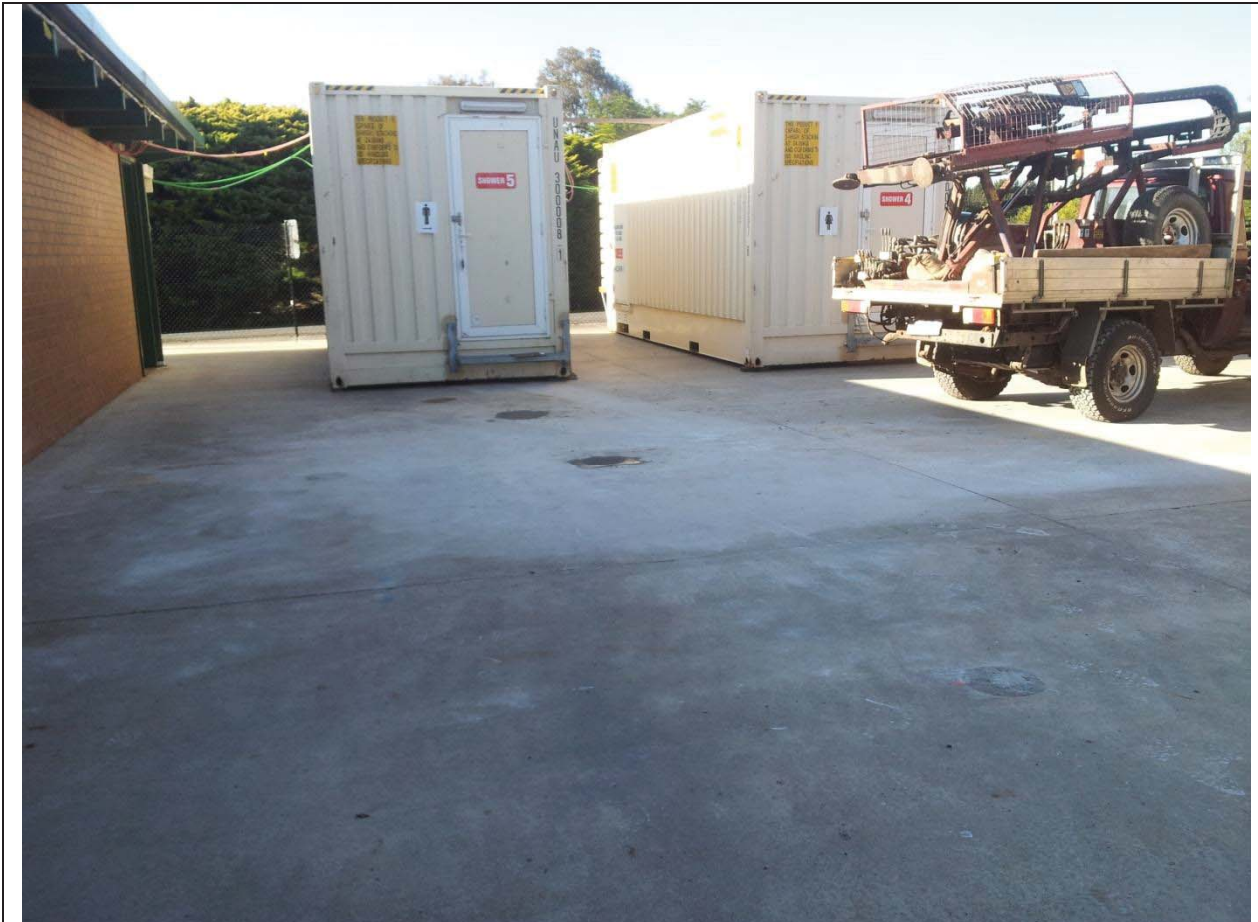
PLATE 1 Underground Storage Tank Area 2 (Feature 8b) looking north

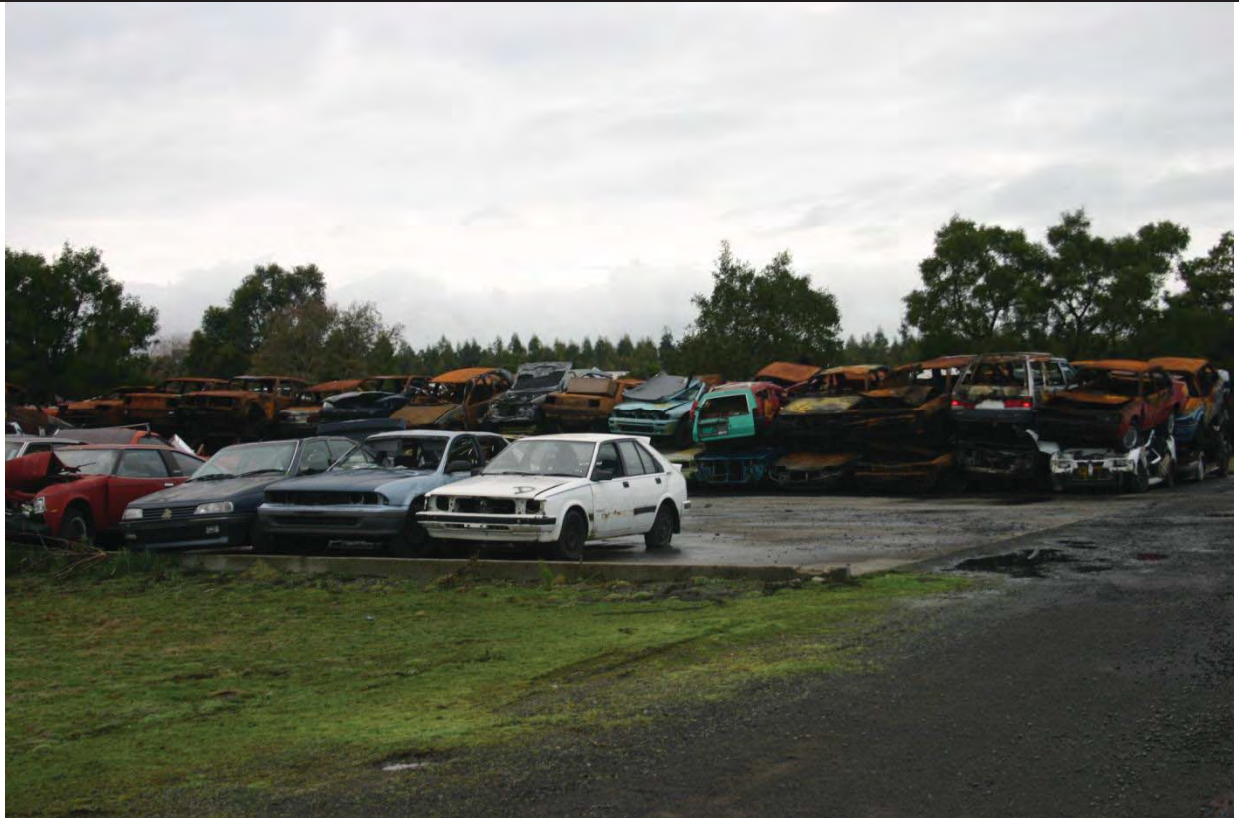
PLATE 2 Car Storage (Feature 51) looking west

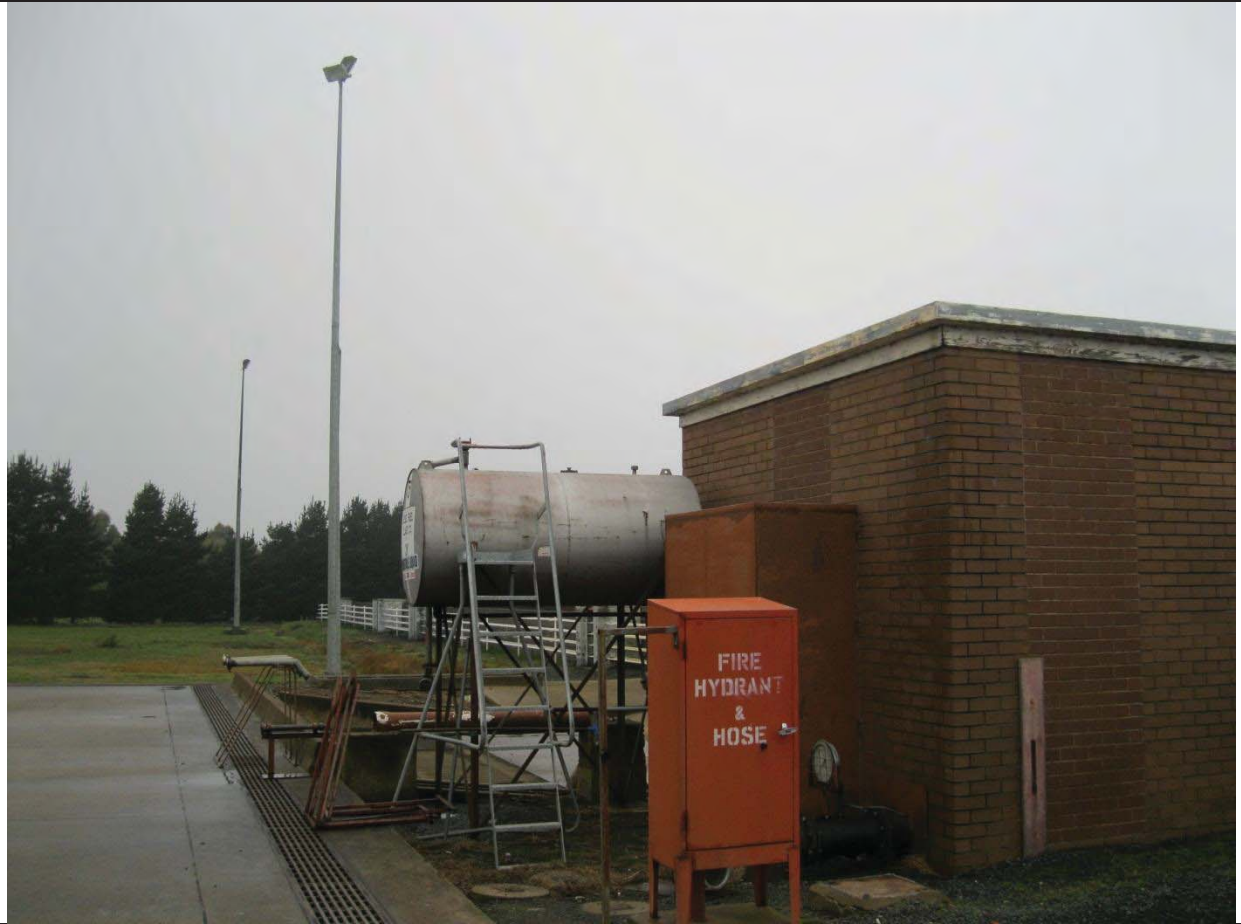
PLATE 3 Aboveground Storage Tank Area 2 (Feature 23b) looking east

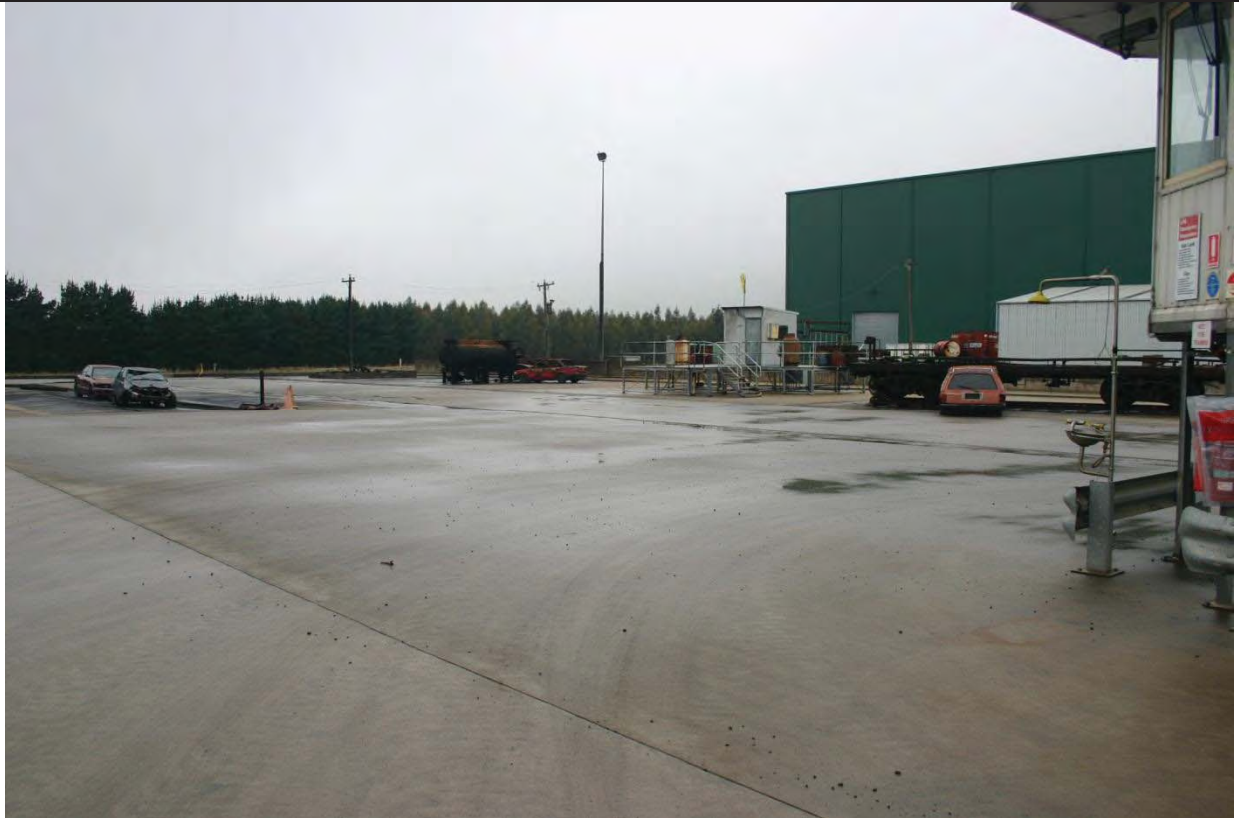
PLATE 4 Flammable Liquid PAD (Feature 27) looking south-east

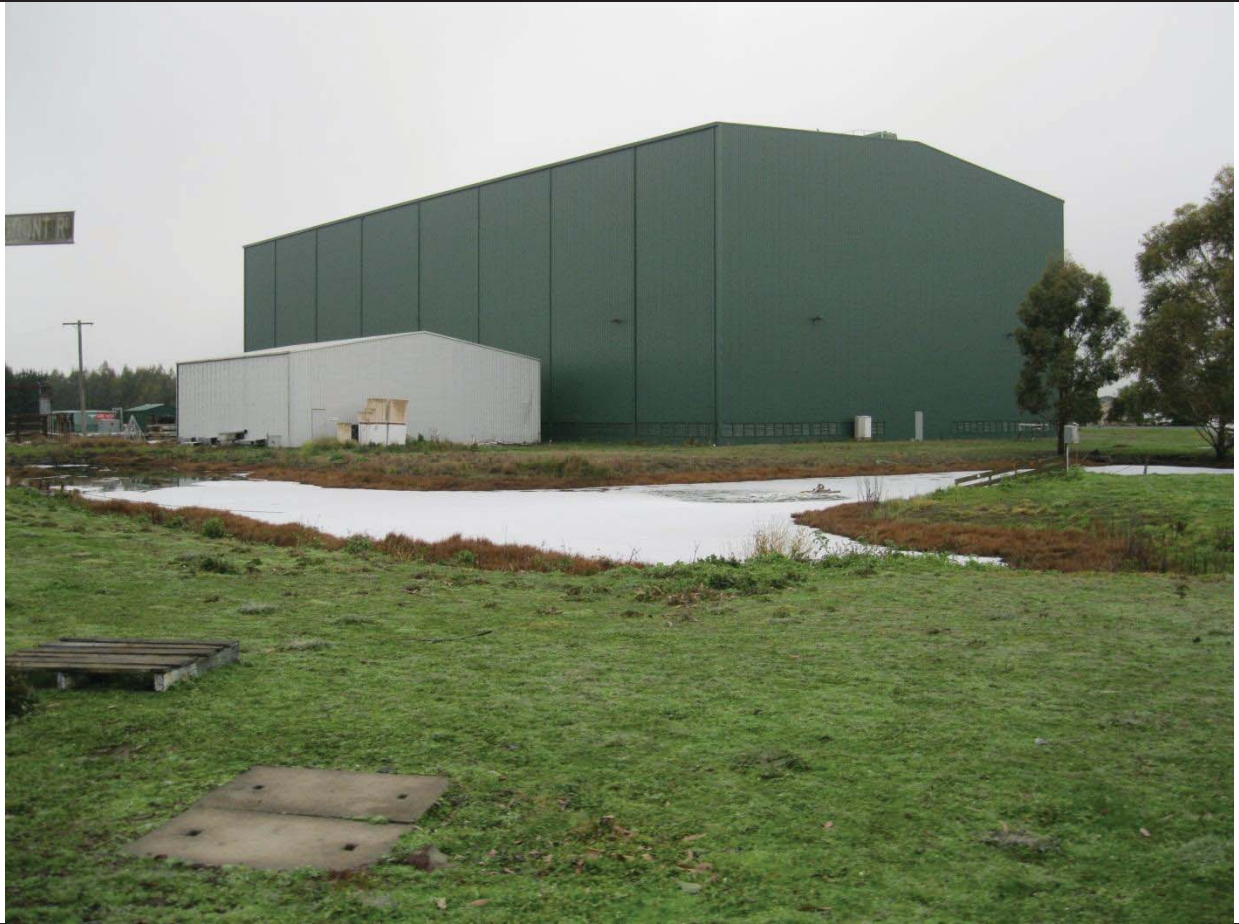
PLATE 5 Dam 1 and VUT building (Feature 31) looking south-east

4. It is recommended in relation to the VUT facility that they should discontinue any effluent discharge to CFA property (including Dam 1) and be required to plan for management of their liquid effluent independently of CFA in the future.

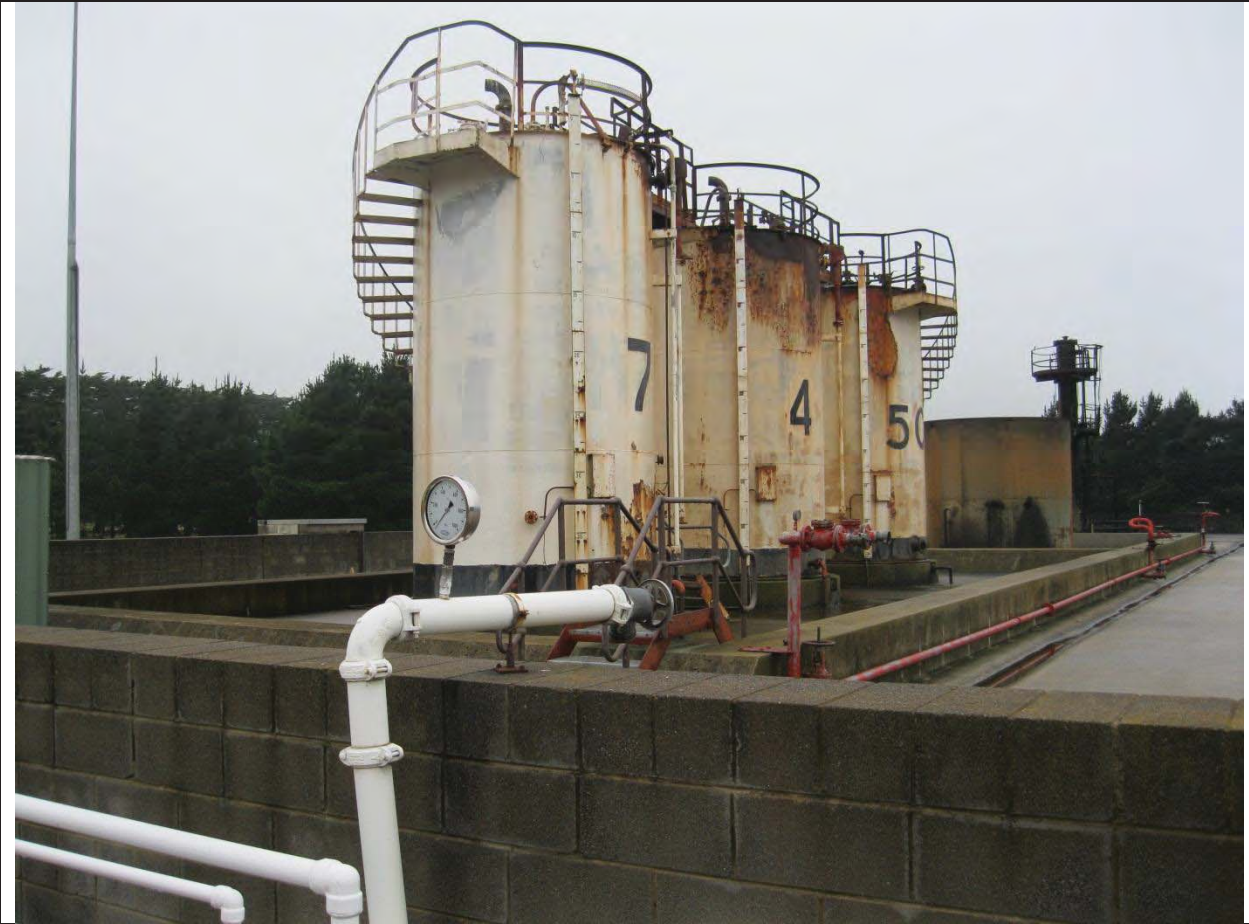
PLATE 6 Above ground Water Storage Tanks 1 (Feature 57a) looking north-east

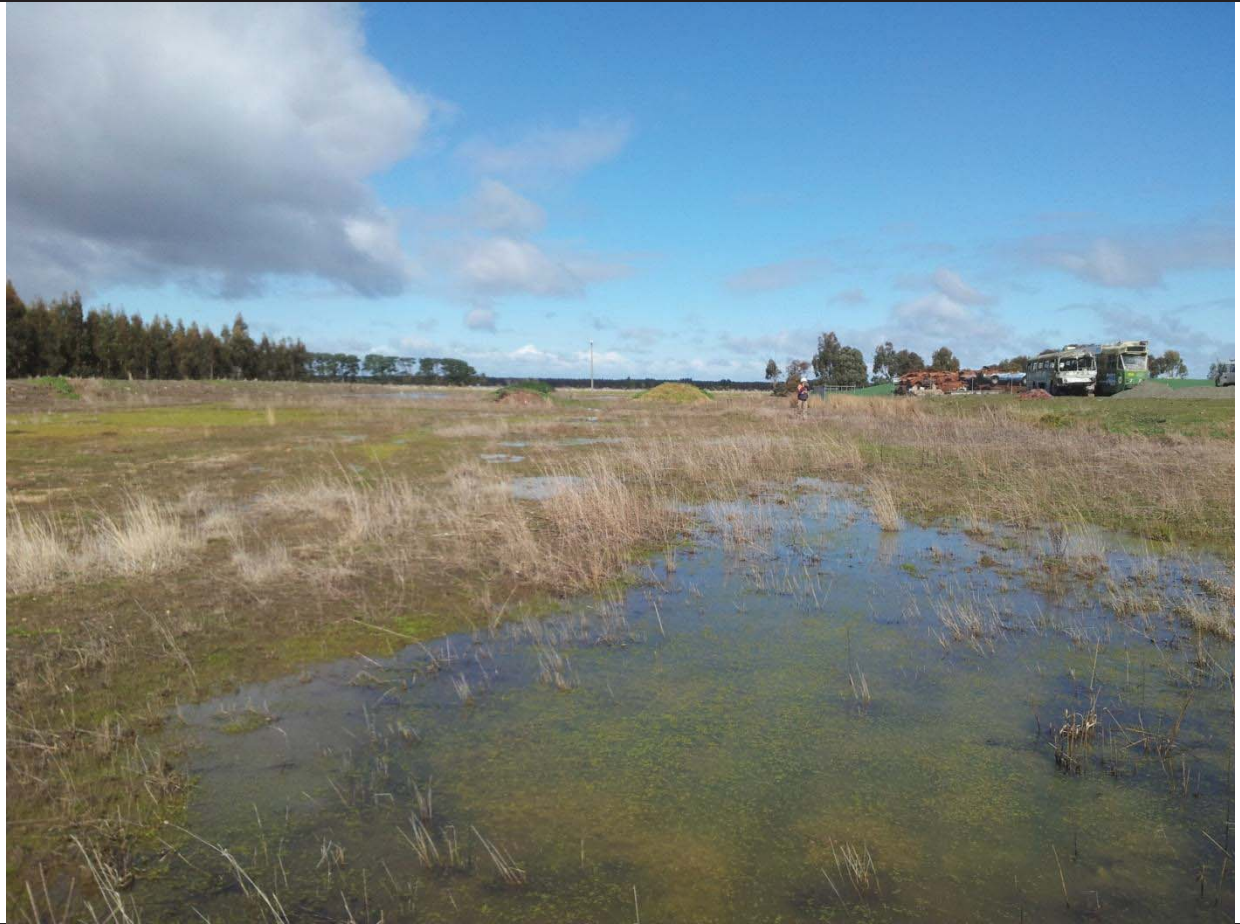
PLATE 7 Soil Composting Area (Feature 44) looking south

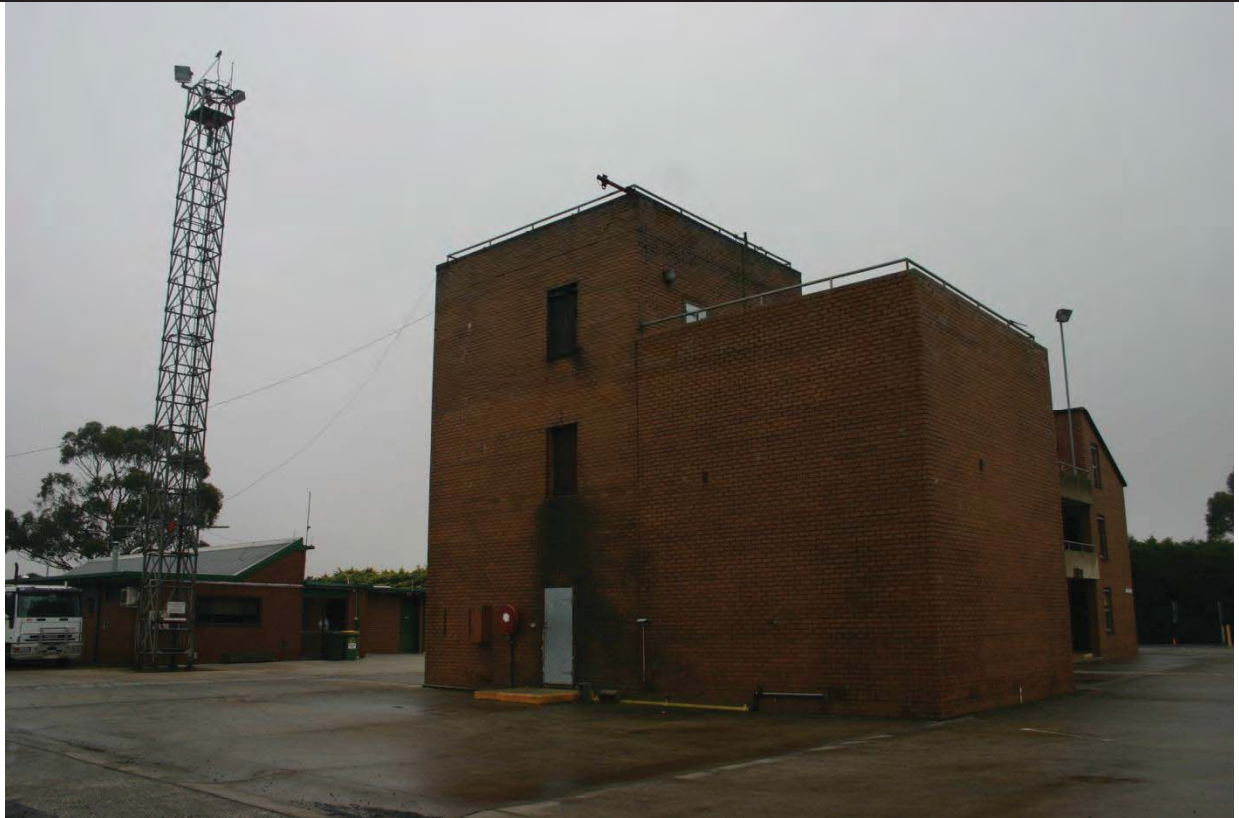
PLATE 8 Fire Attack Building (Feature 24) looking north-west

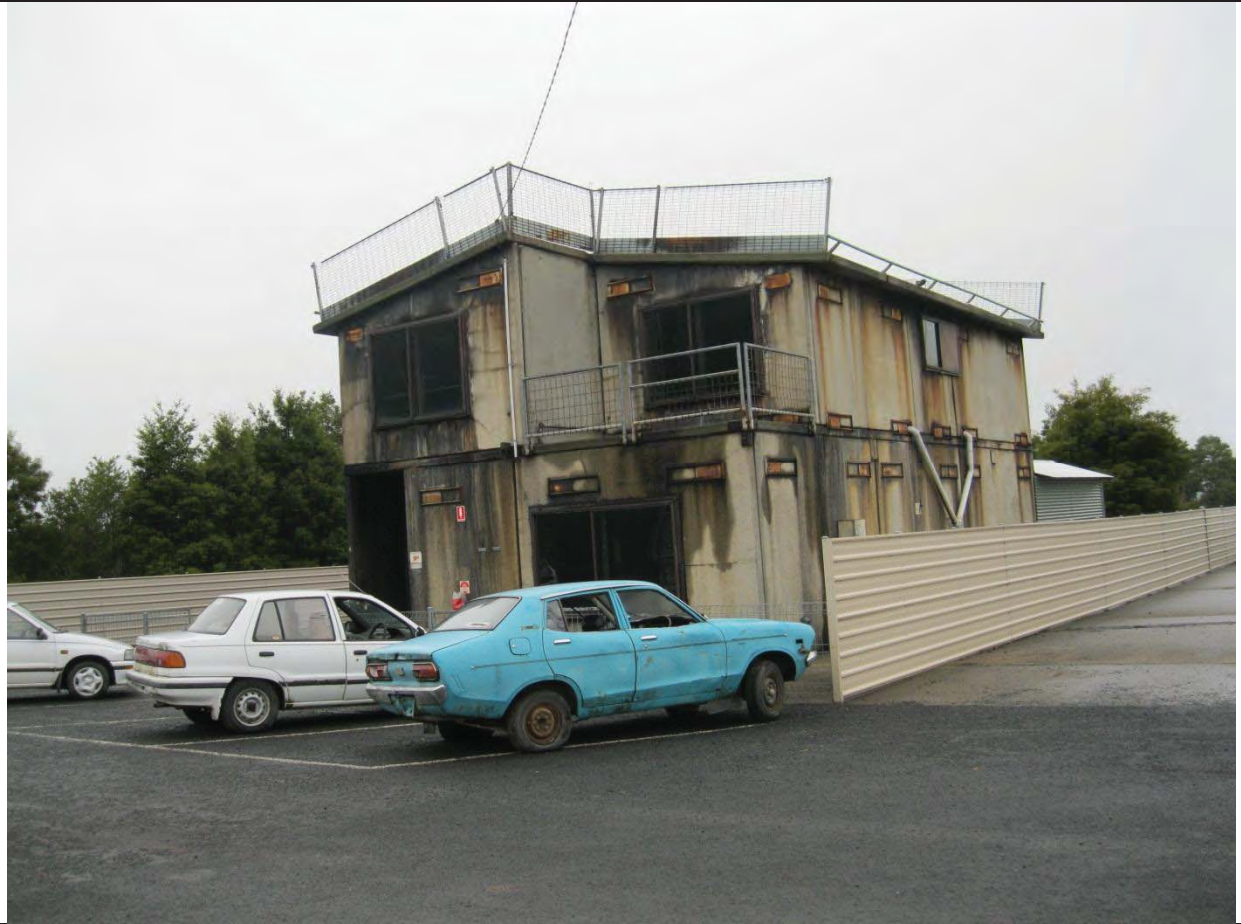
PLATE 9 Structural Fire Attack Building (Feature 33b) looking south-west

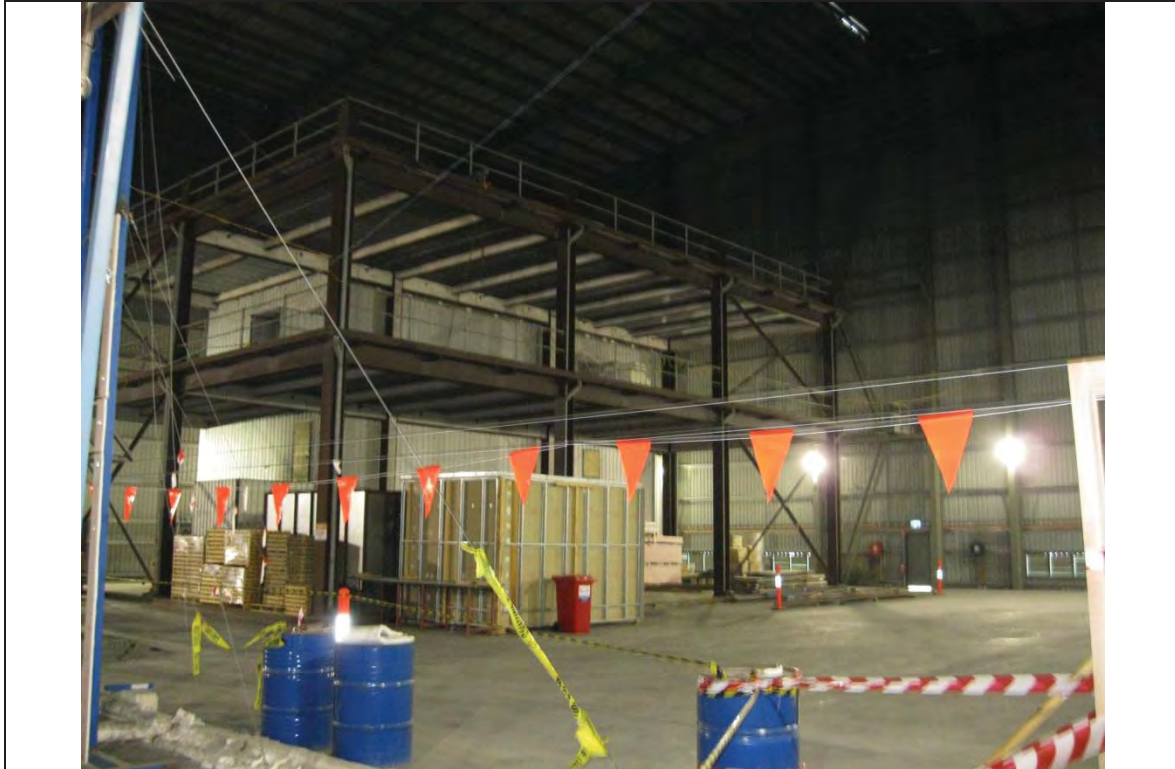
PLATE 3 ISO Rooms and 2 level building – Drums containing water

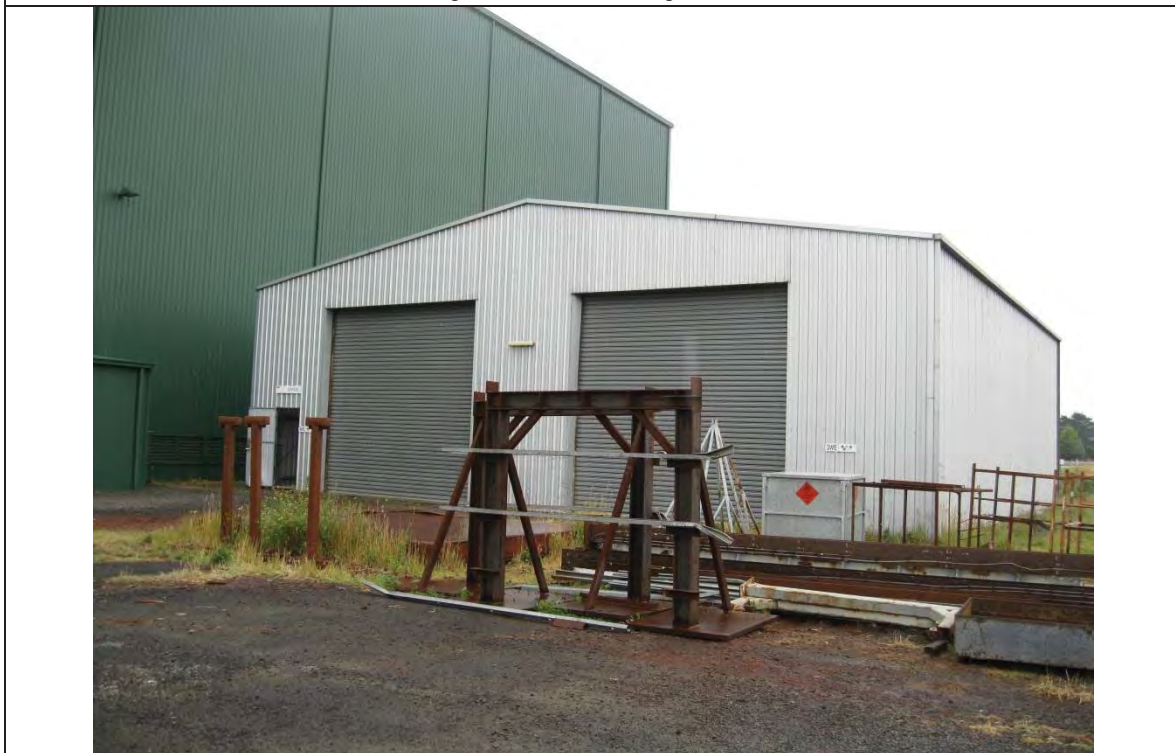
PLATE 4 Storage Shed & Flammable Goods Store

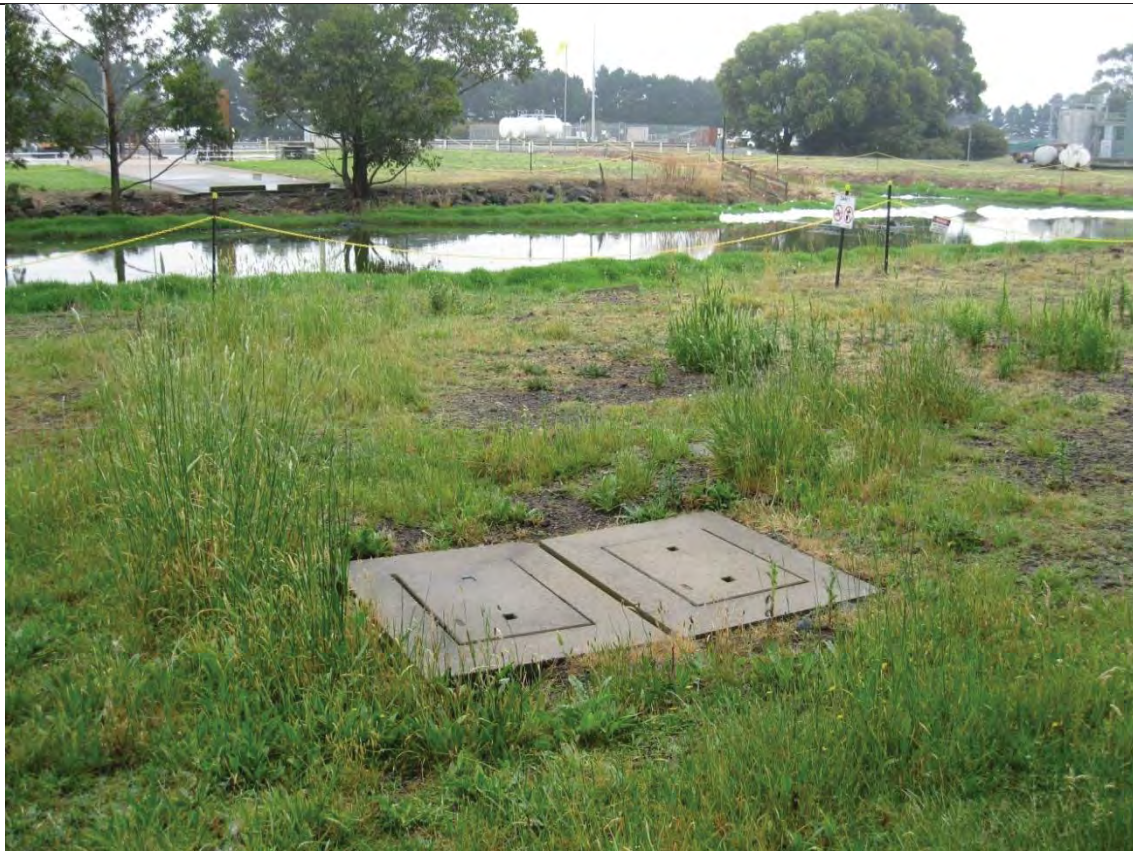
PLATE 6 Effluent pit inspection covers between Dam 1 and the VUT building

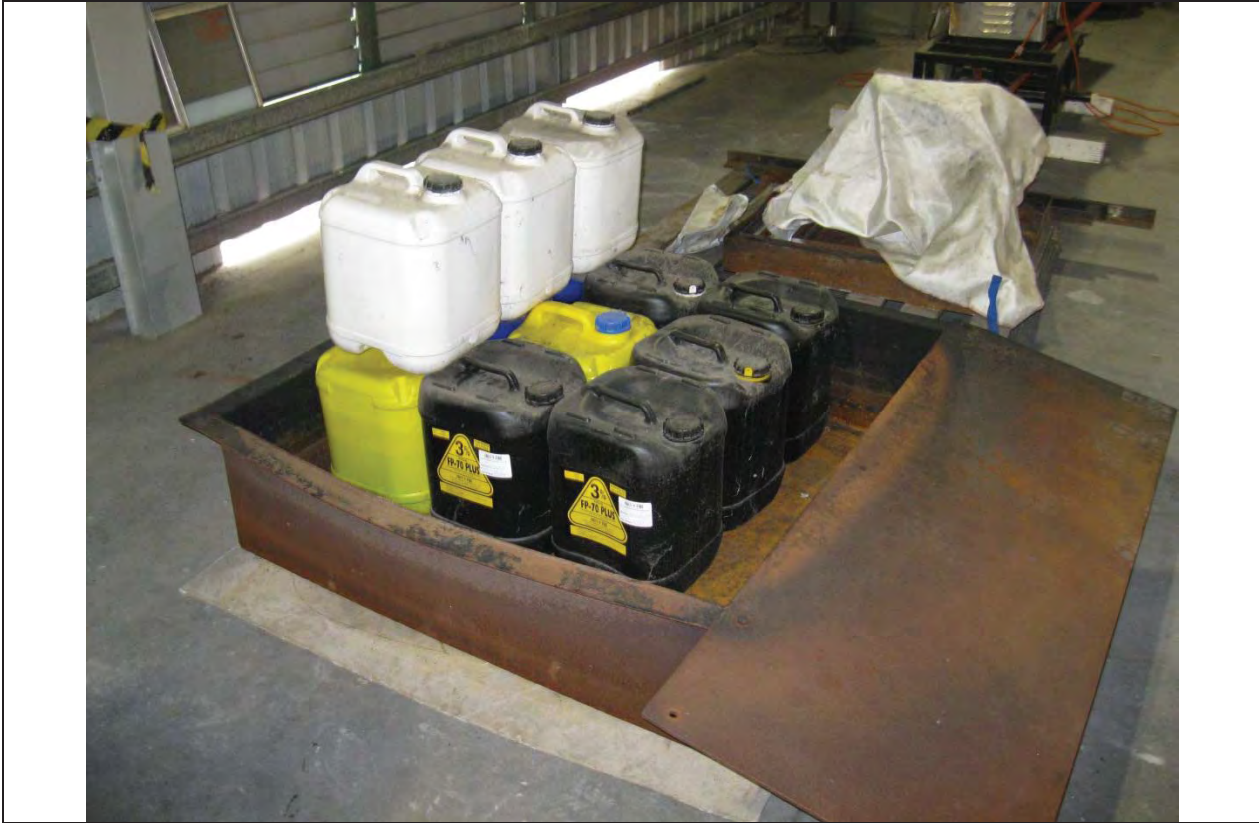
PLATE 7 Foam concentrate in bunded Storage area -

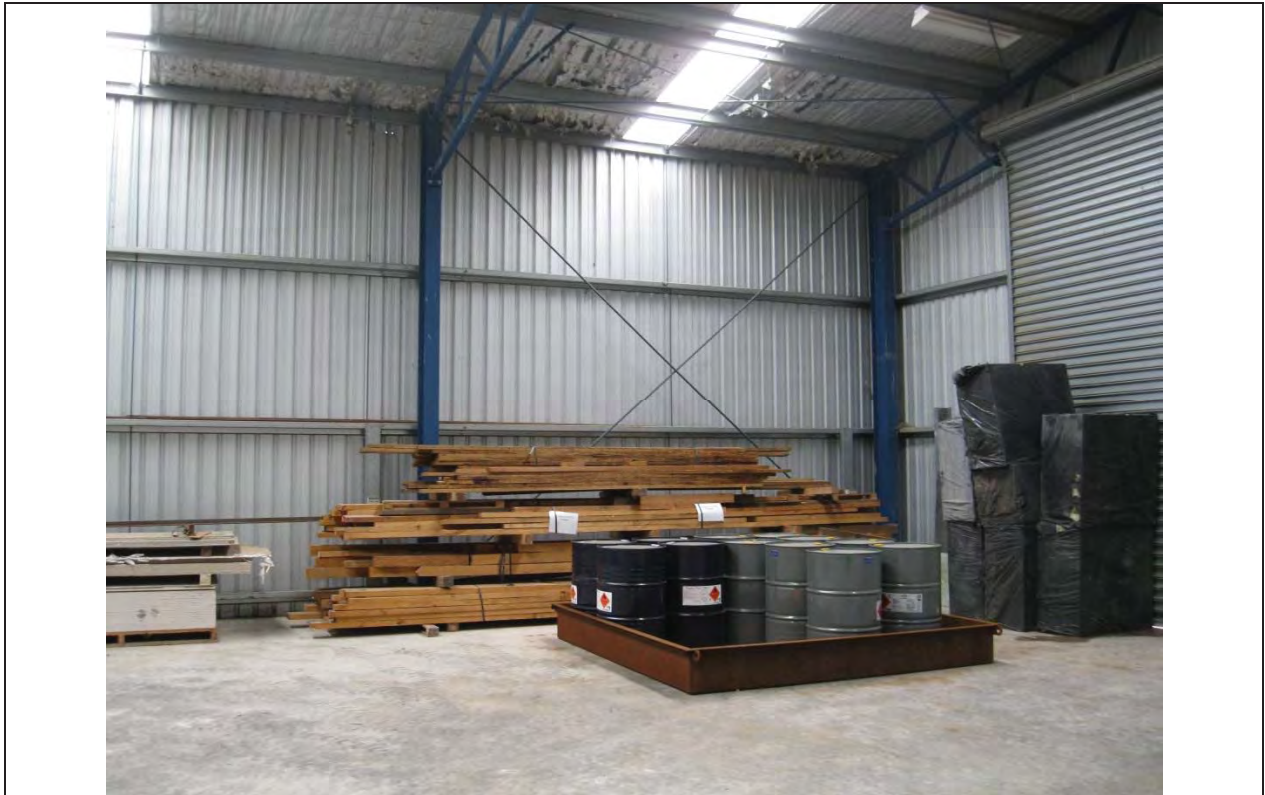
PLATE 9 Storage of liquid fuel drums on bund

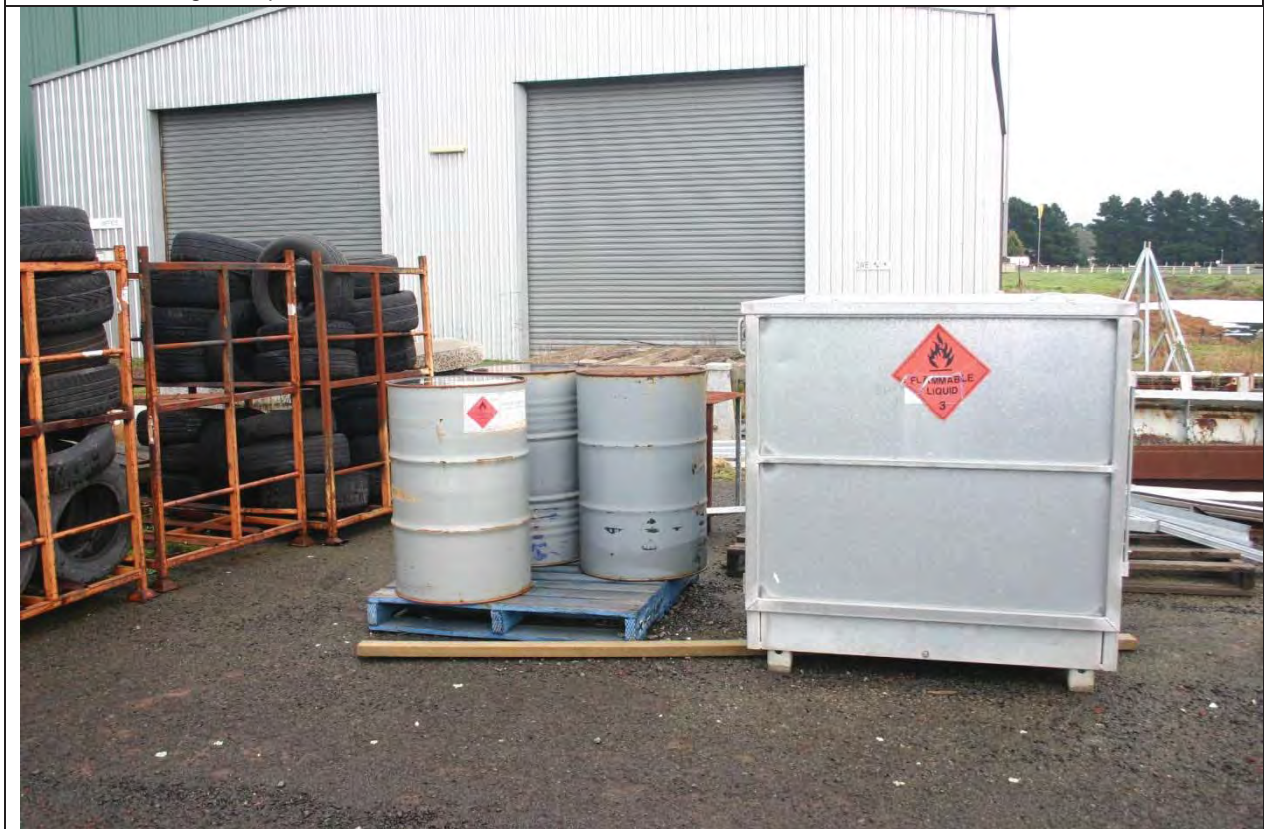
PLATE 10 Aviation fuels - unbundled outside VUT shed and building materials (13 July 2012)

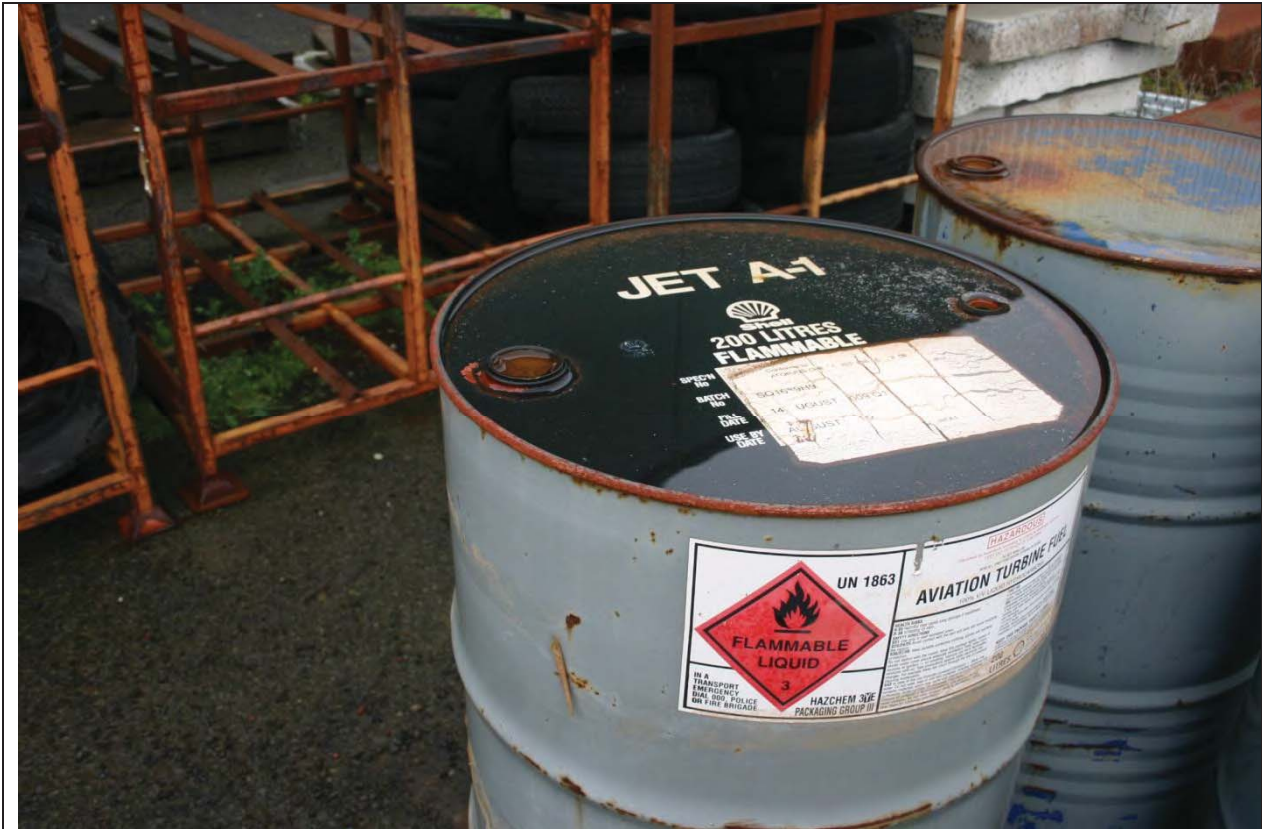
PLATE 11 Drums containing Jet fuel - Unbunded (13 July 2013)
