**A Report prepared for
Country Fire Authority**

**Fiskville Training College
Review of Site Assessments
and Remediation Options**

28 November 1996

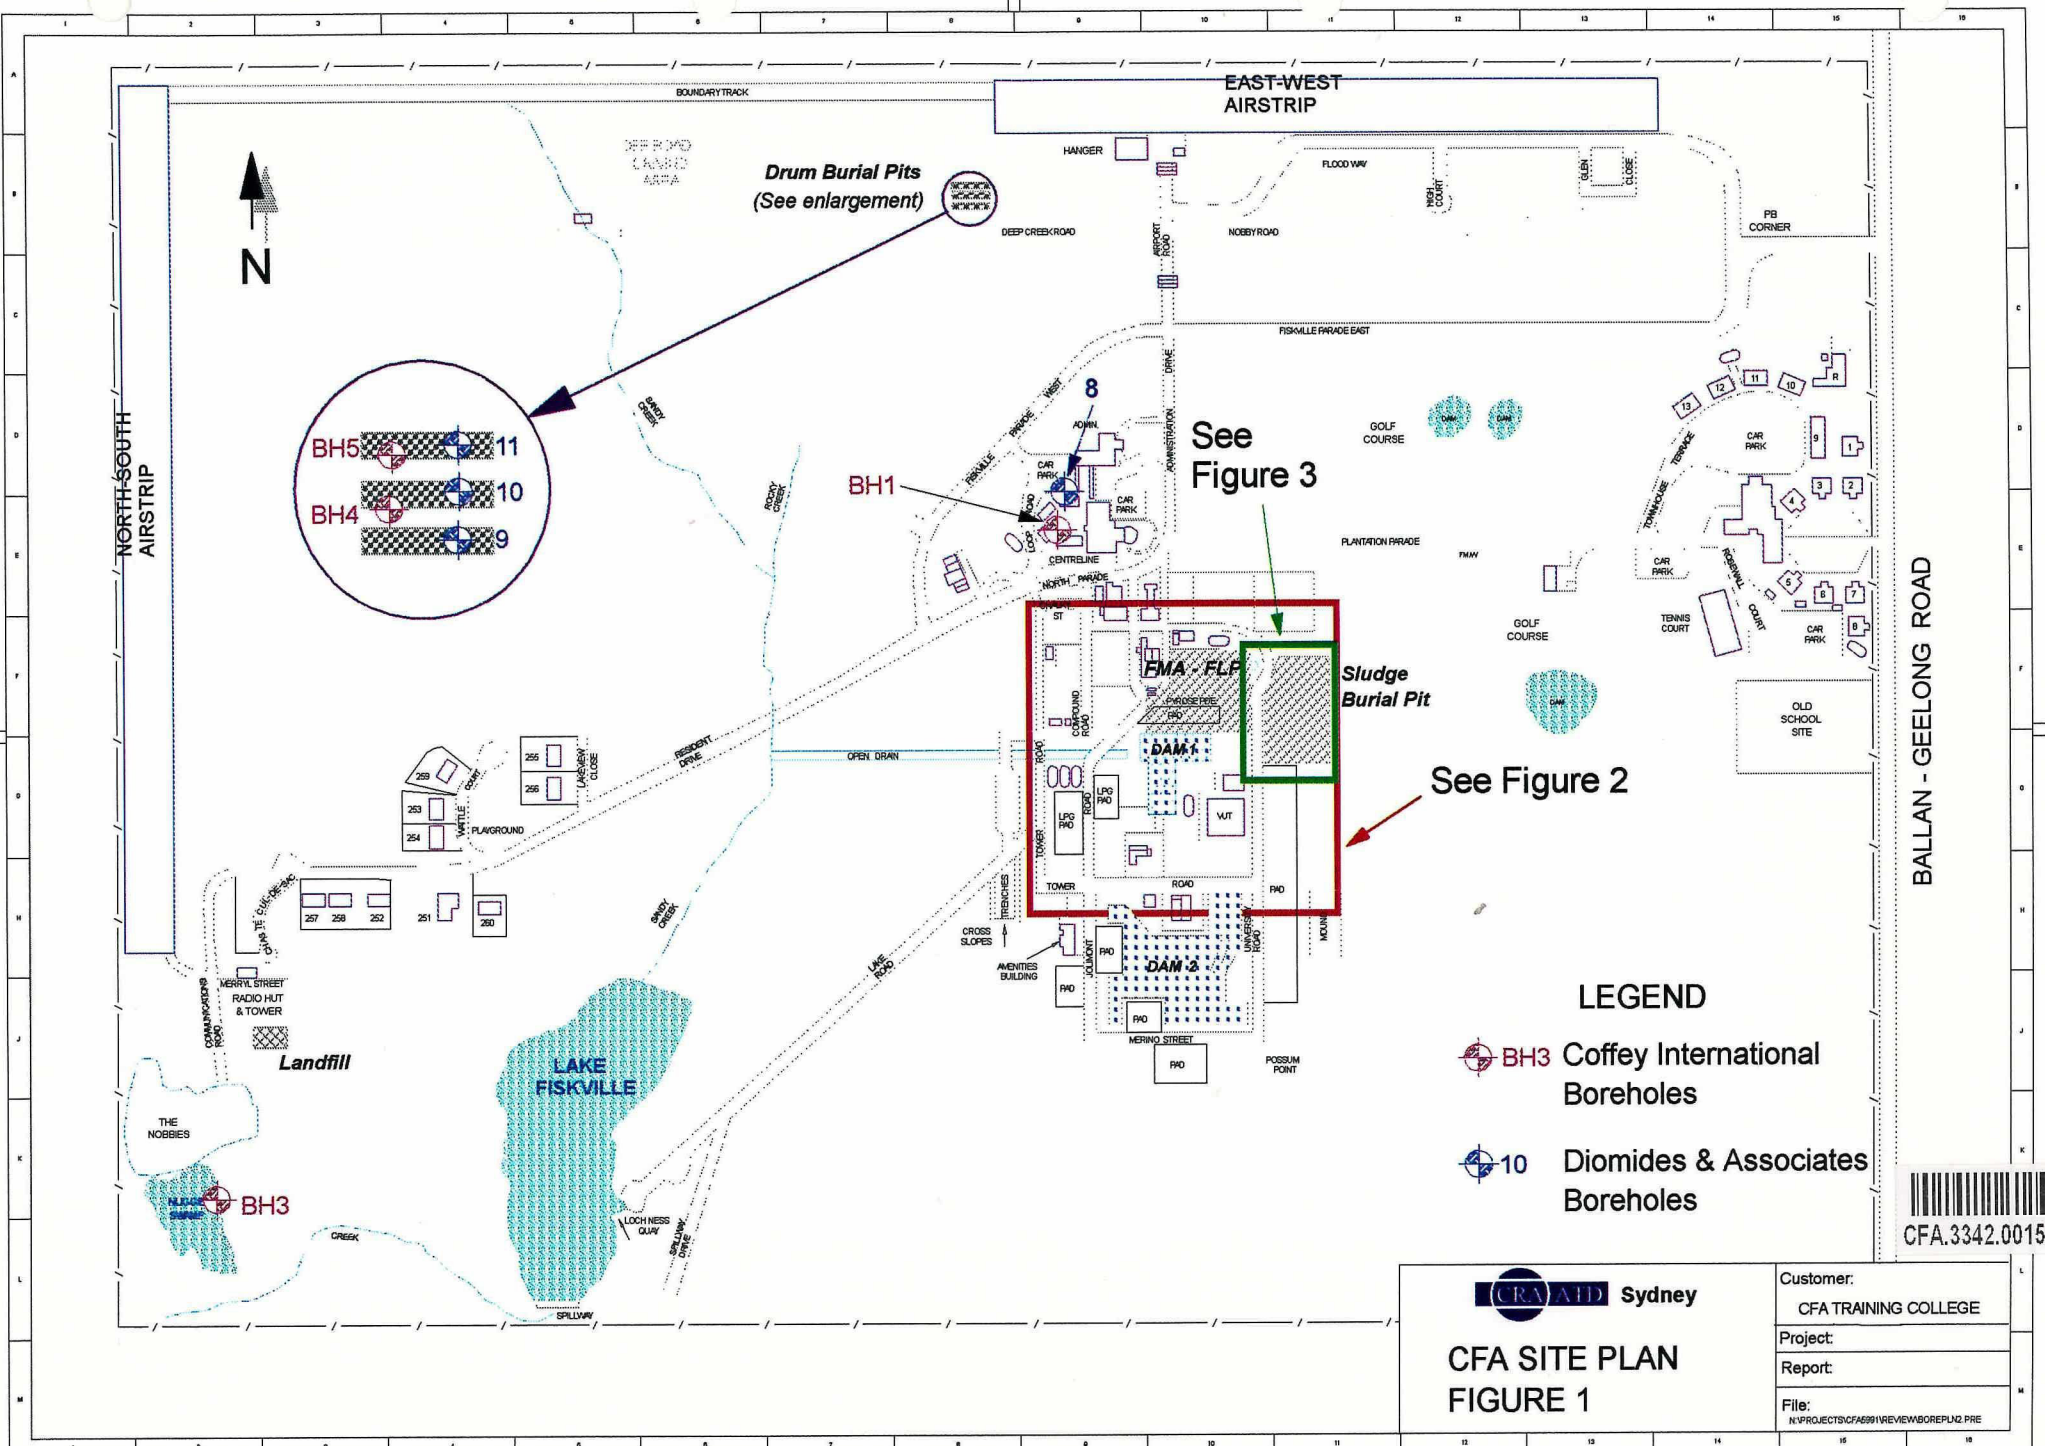
CFA SITE PLAN FIGURE 1	Customer: CFA TRAINING COLLEGE
	Project:
	Report:
	File: N:\PROJECTS\CFA6991\VIEW\BOREPLAN2.PRG

The bore locations are shown in Figures 1 and 2.

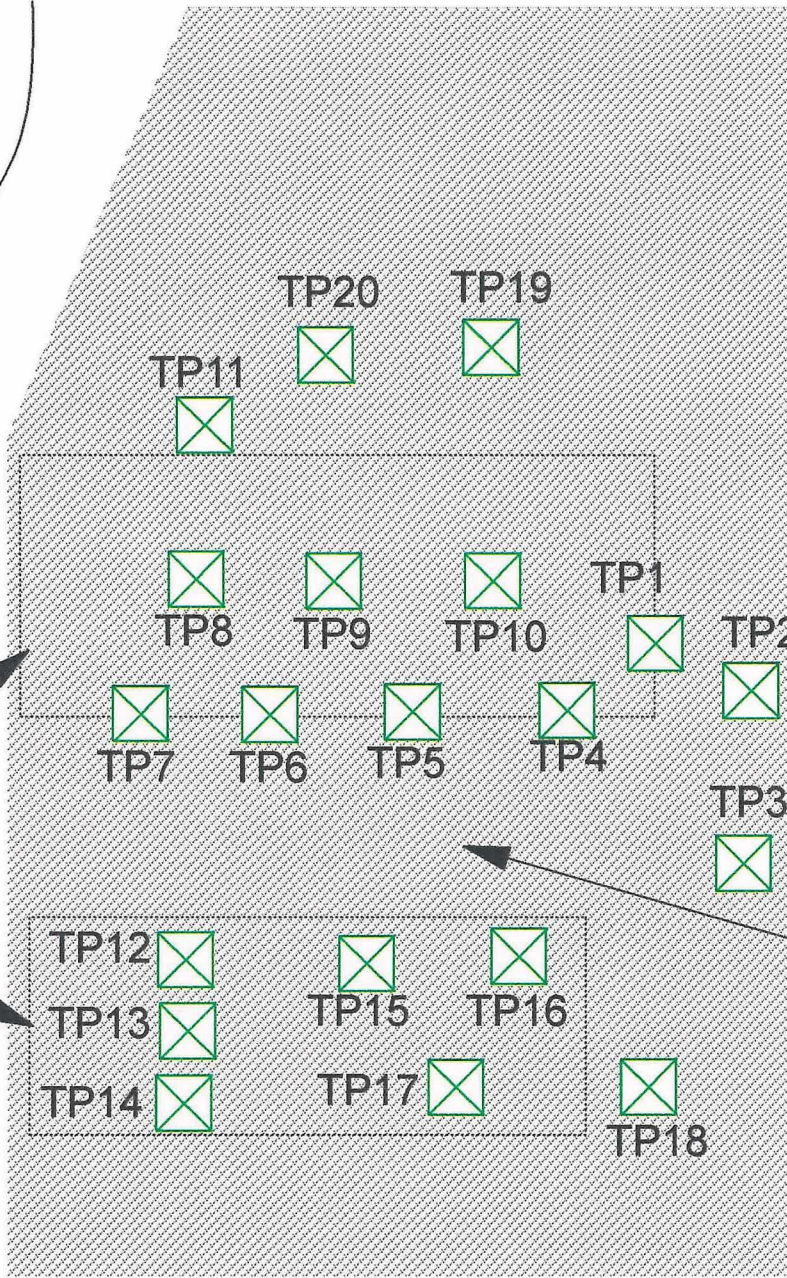
Customer: CFA TRAINING COLLEGE
	Project:
CFA SITE - TESTPITS FIGURE 3	Report:
	File: N:\PROJECTS\CFA5991\REVIEW\FIG3 PRE

to locate and define the extent of hydrocarbon sludge and contaminated soil from the previous fire training pits. Test pit locations are shown in Figure 3.

APPROXIMATE AREA OF BLACK SLUDGE BENEATH SCORIA COVER
