MFB Submission:

Senate Economics Reference Committee Inquiry into Non-Conforming Building Products

Post Incident Analysis Report

**Lacrosse Docklands
673-675 La Trobe Street, Docklands
25 November 2014**

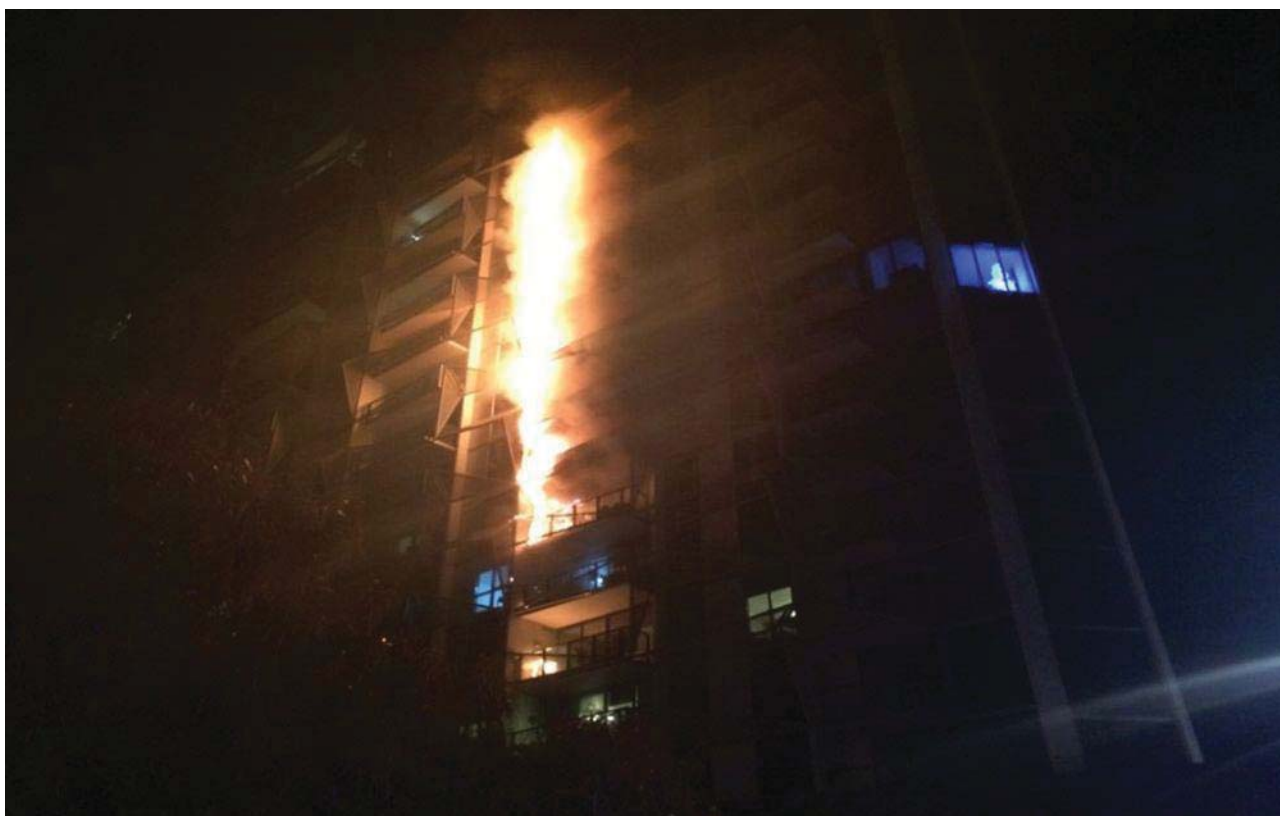
The occupants from Level 6, Apartment 605 reported later to fire-fighters, seeing fire embers and flaming debris falling from levels above their apartment and igniting materials on their balcony. They then evacuated the building. See photograph below.

Figure 2 – Shows fire on level 6 and fire on level 8 (point of origin) extending up to level 14 (02:29)

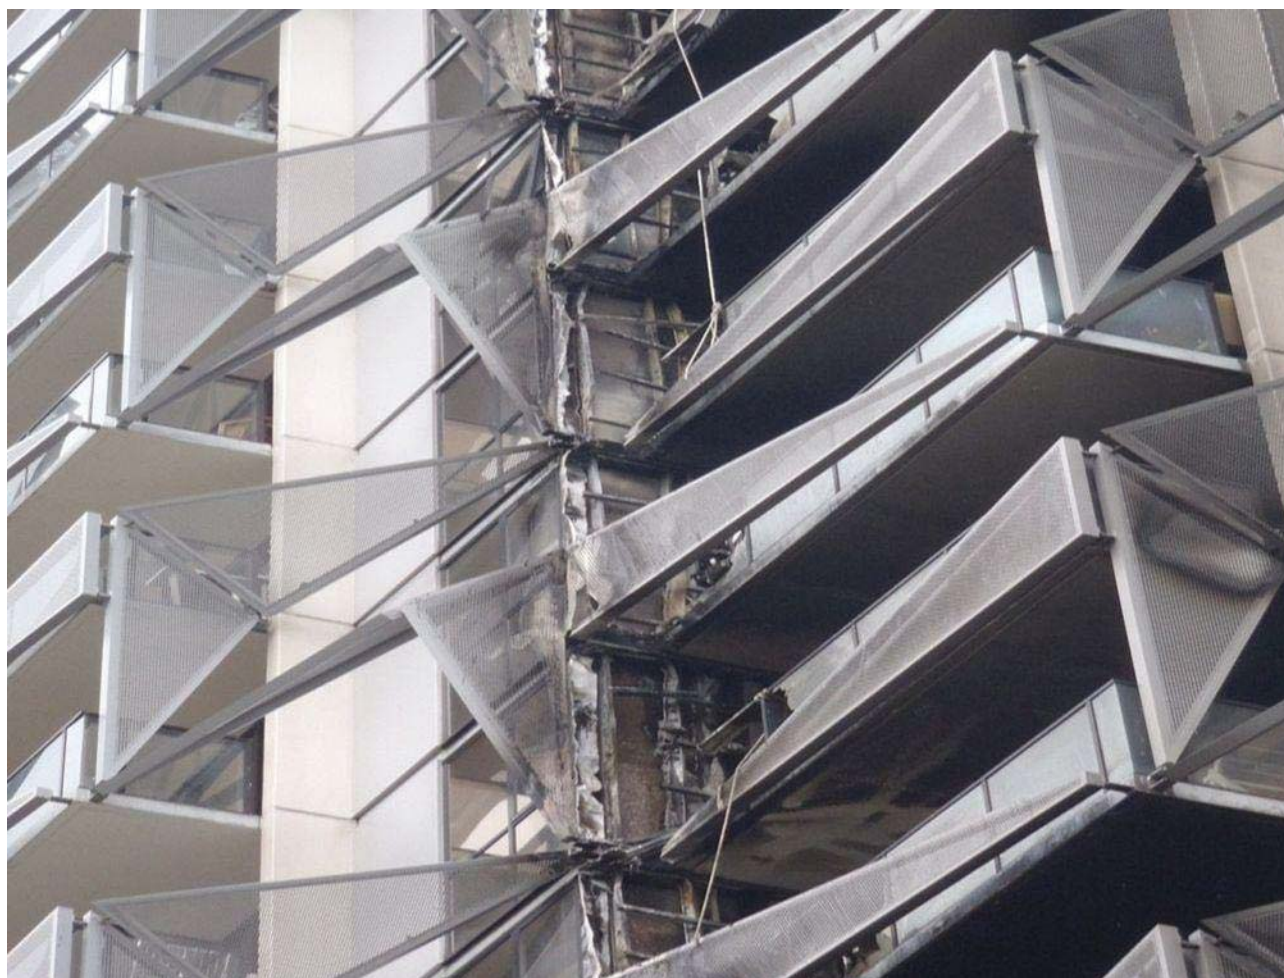
Fire damage was essentially restricted to the façade and external balcony area adjacent to Apartment 605 and Apartments 805 to 2105. Please refer to the [Fire Cause and Origin section](#) of this report for further information on fire damage.

Figure 3 - Fire damage to the external wall cladding and ornamental structures

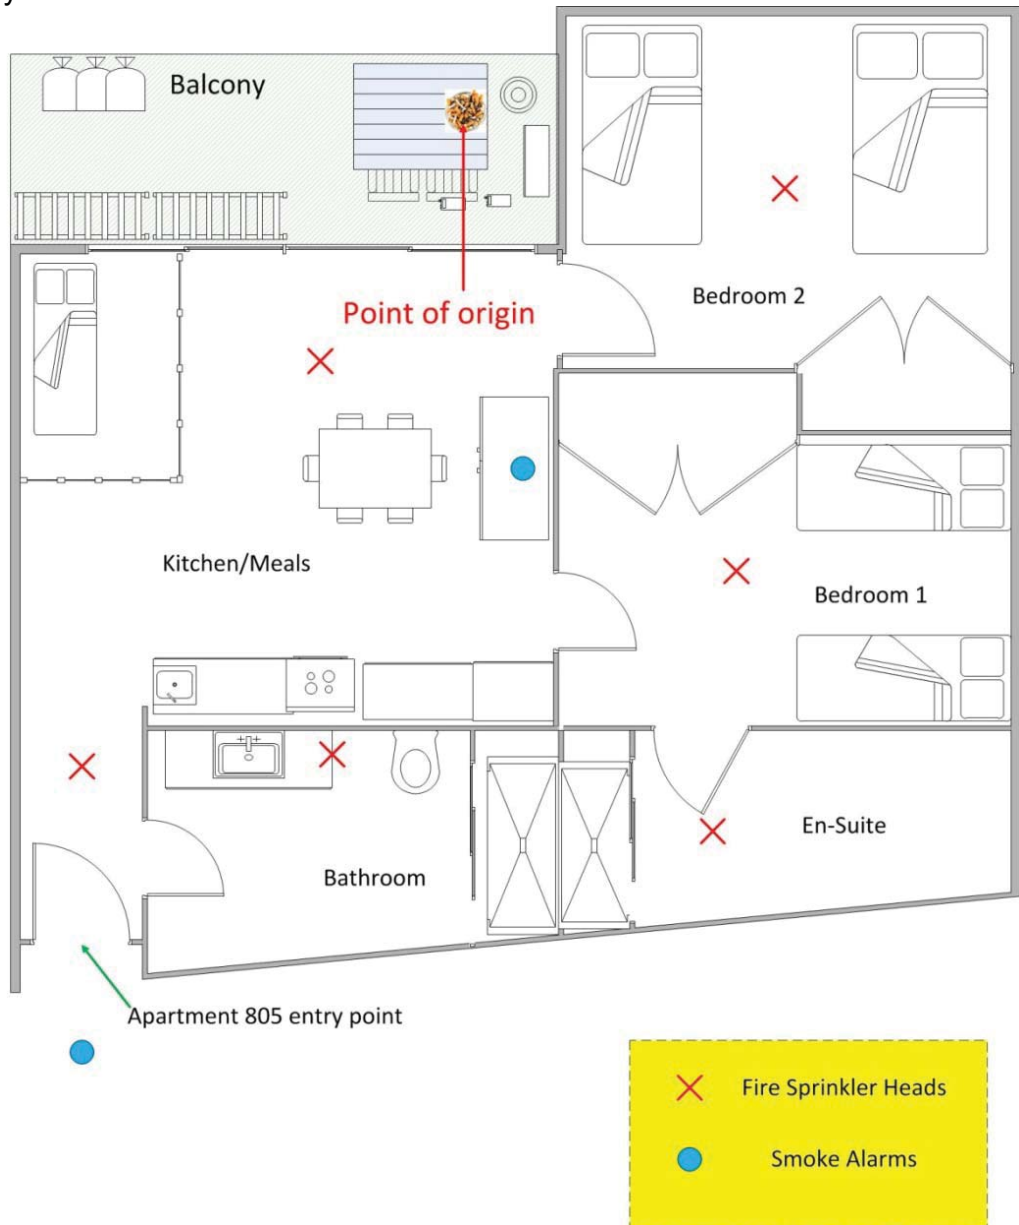
Figure 4 – Point of Origin

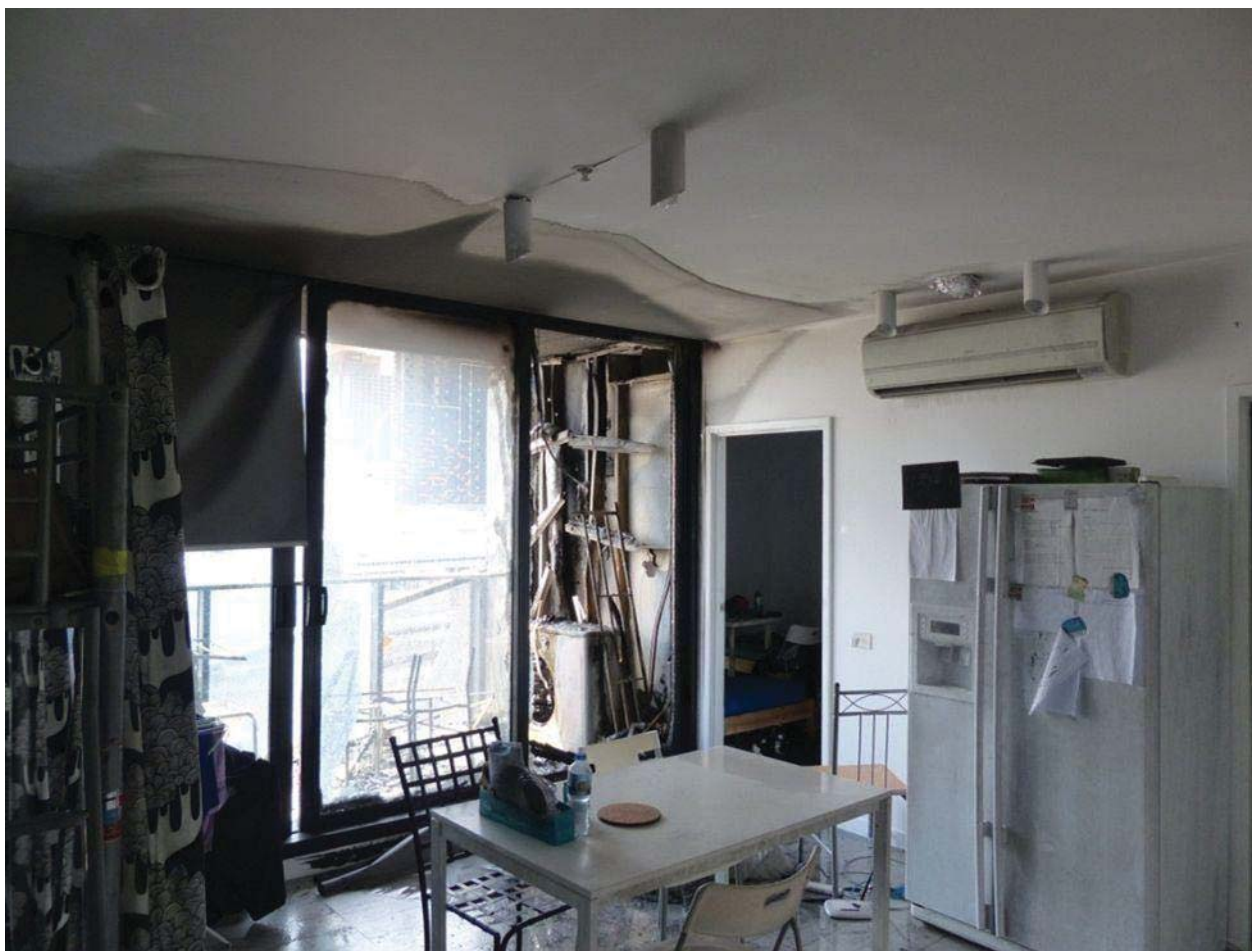
Full height glass double glazed sliding doors gave access to the balcony area from the kitchen. These had sustained heat and fire damage with the glass from the fixed panel located at the southern end of the balcony, breaking and collapsing to the floor areas of the kitchen and balcony. At the time of the investigation the double sliding doors were in the open position, with a visible gap of approximately 50mm between the two sliding doors. Access for investigation purposes was gained through the broken fixed panel at the southern end of the balcony area.

Figure 5 – Picture 4: Inside kitchen looking towards double glass sliding doors leading to balcony area & bedroom 2.

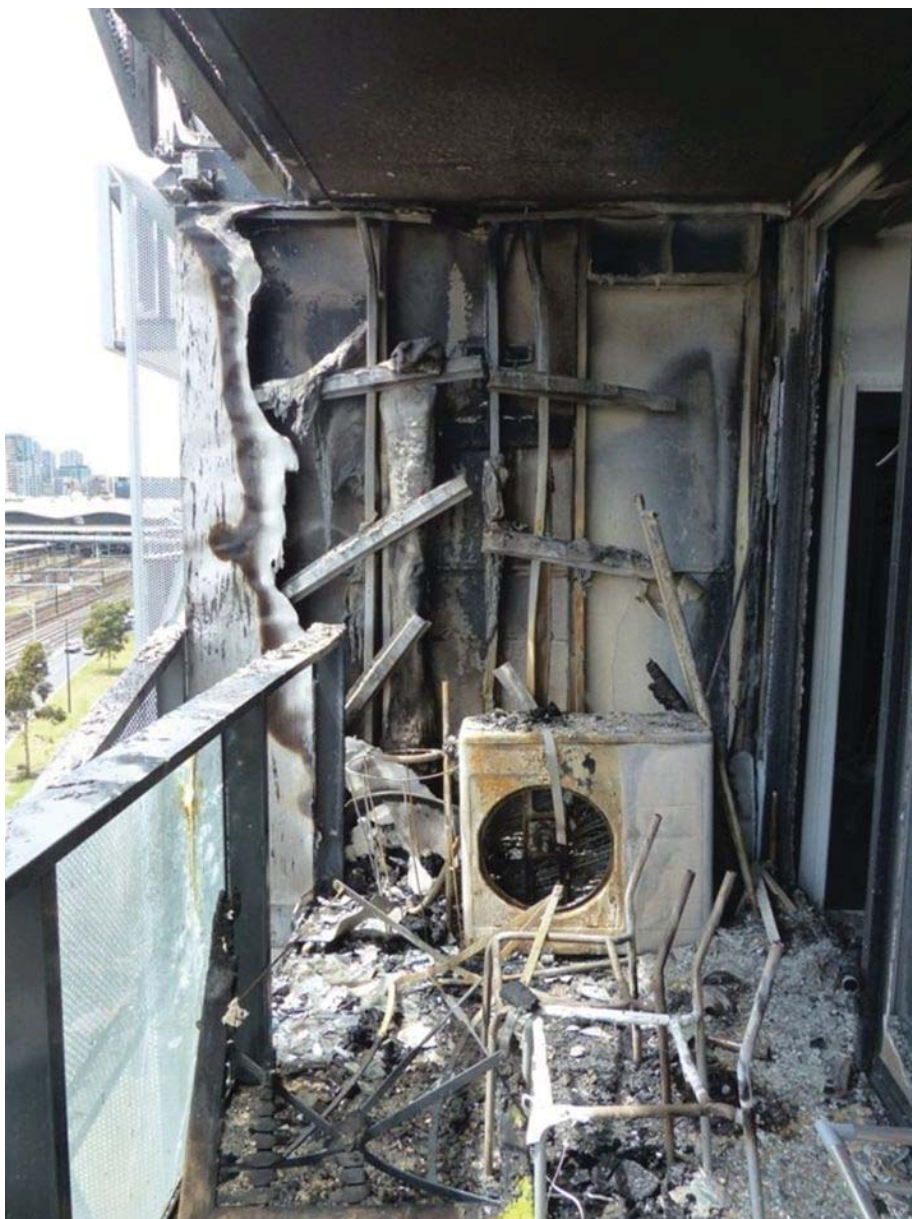
The extremely vertical nature of the burn patterns to the exterior face of the wall suggest that the Alucobest aluminium cladding, along with the foam lagging and the PVC pipe of the building wall, contributed to the fire load and the rapid spread of the fire up the vertical face of the building to the floors and balcony areas located above.

Figure 6 - Picture 5: South Wall Balcony of Apartment 805 before excavation.

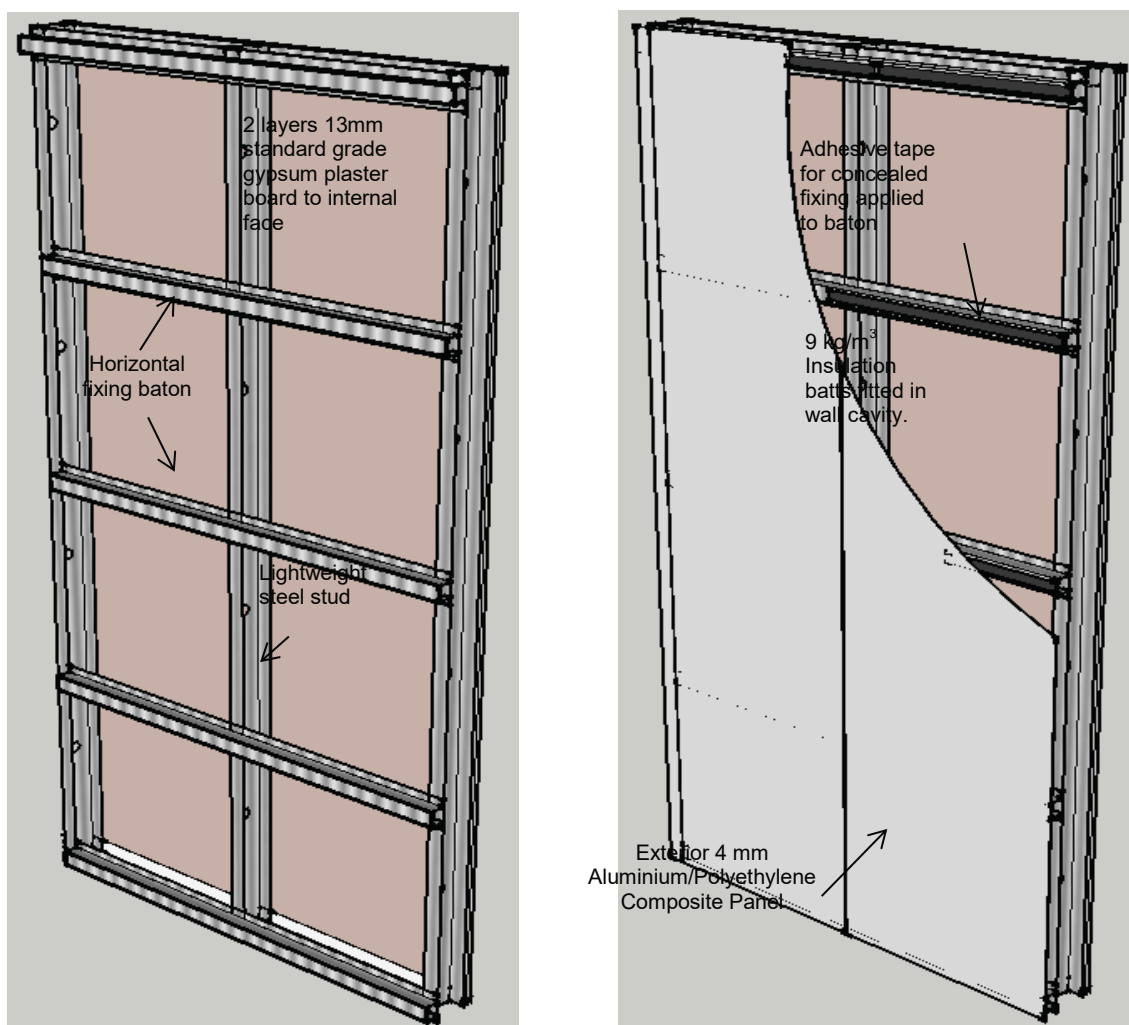
These walls are built of lightweight steel stud construction. The internal face of the walls are lined with two layers of 13mm standard grade gypsum plasterboard, contain insulation batts, along with a combustible PVC stormwater downpipe and several combustible electrical/television cabling and input face plates. The external face is lined with a 4mm aluminium/polyethylene composite panel façade containing a polyethylene core.

Figure 9 - Aluminium/Polyethylene Composite Panel Façade - External Wall Cladding

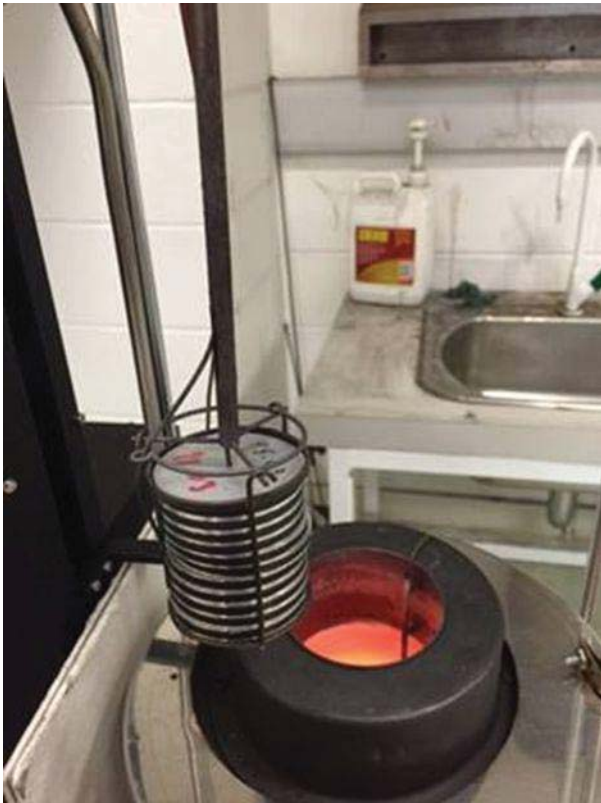
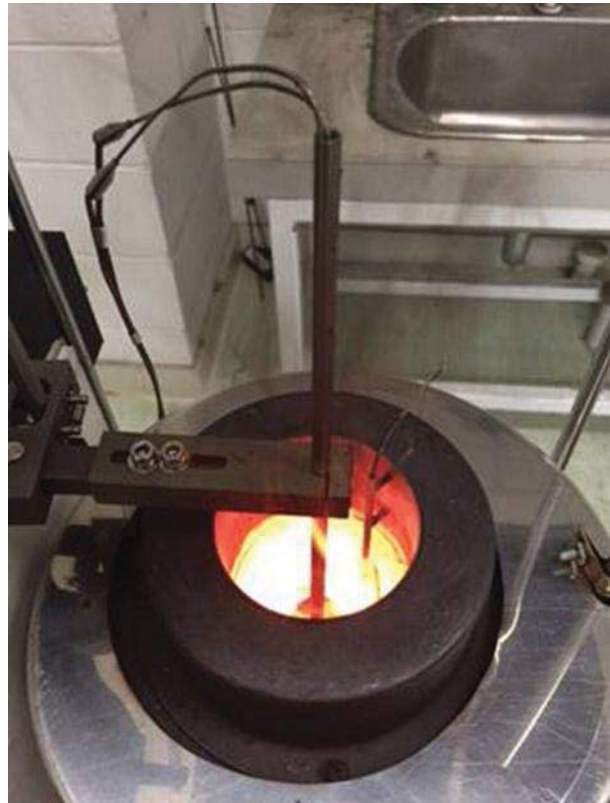
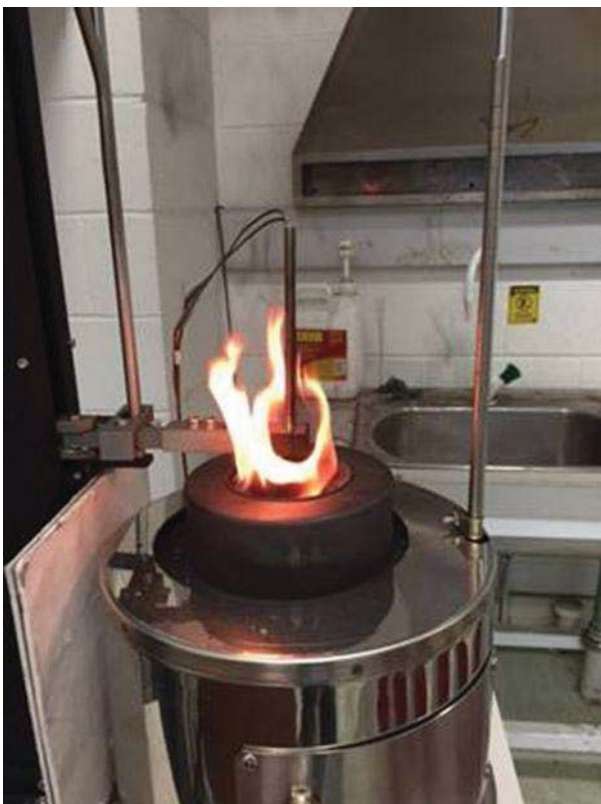
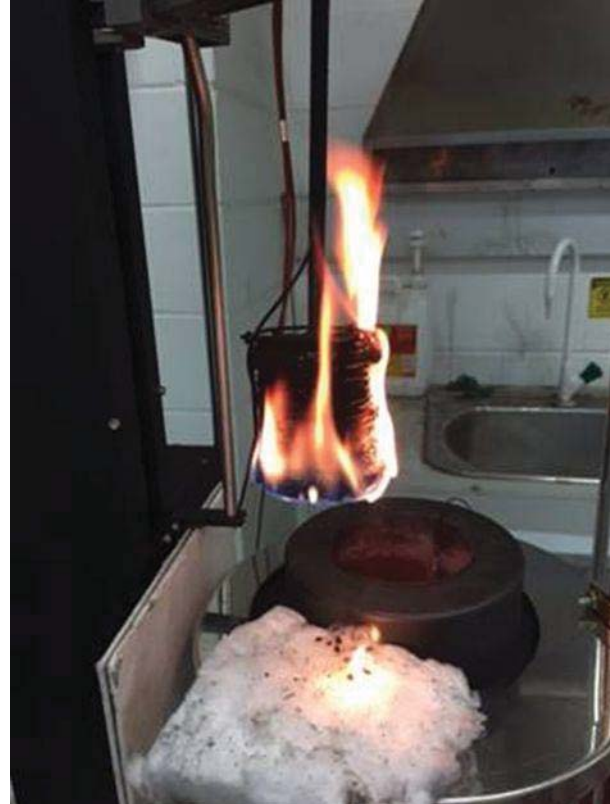
Specimen photos before, during and after the test.

When a sample of the ACP product used as external cladding the Lacrosse Docklands fire (Alucobest) was given to the CSIRO to be tested using the Combustible Test for Materials, it failed to satisfy the test. There was no documentation that Alucobest was tested under the Combustible Test for Materials

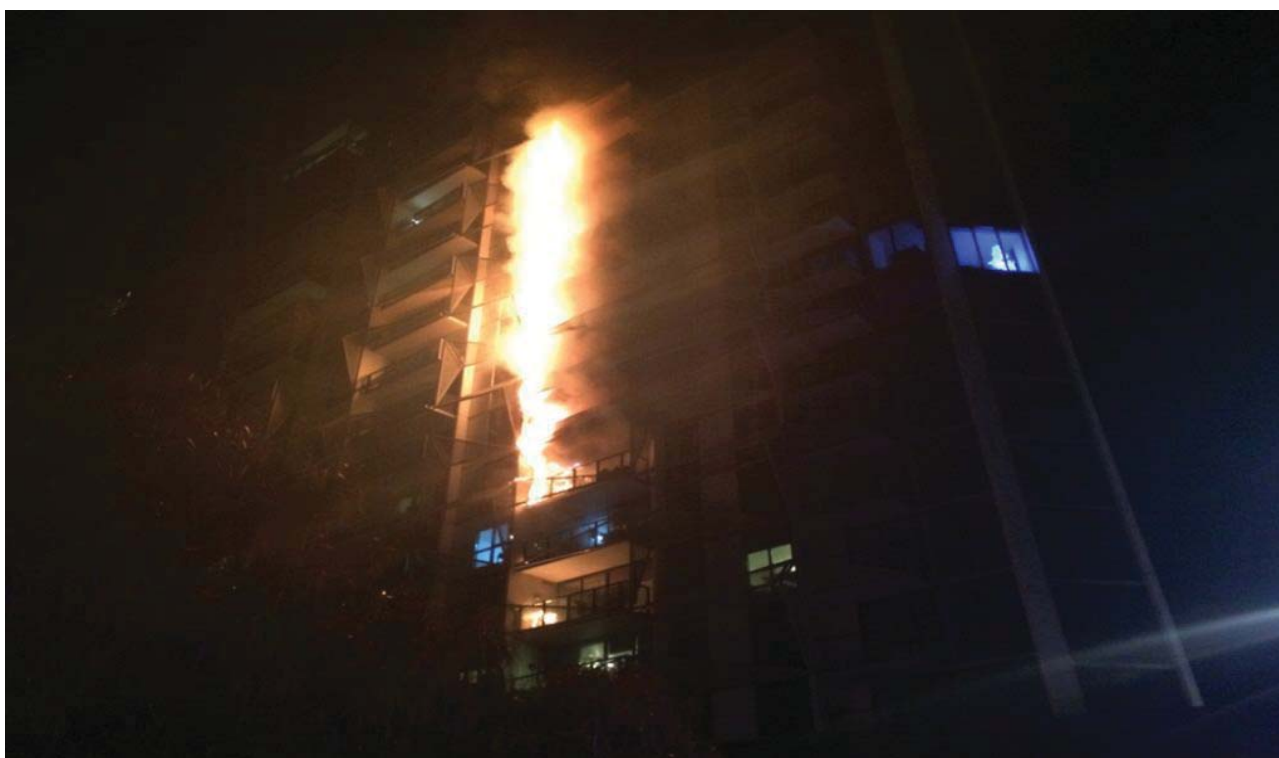
First-hand accounts from attending MFB fire-fighters and residents of the building, describe the fire as appearing to be associated directly with the façade of the building rather than the combustible contents and storage on the external balconies. Burning and flaming facades on high-rise buildings is not a common phenomenon witnessed by the MFB and is of genuine concern. Of even greater concern is the speed and intensity of the fire spread.

Figure 10 - Time 02:29. Photo depicts the rapid vertical fire spread, only 4 minutes after level 8 sprinkler activation

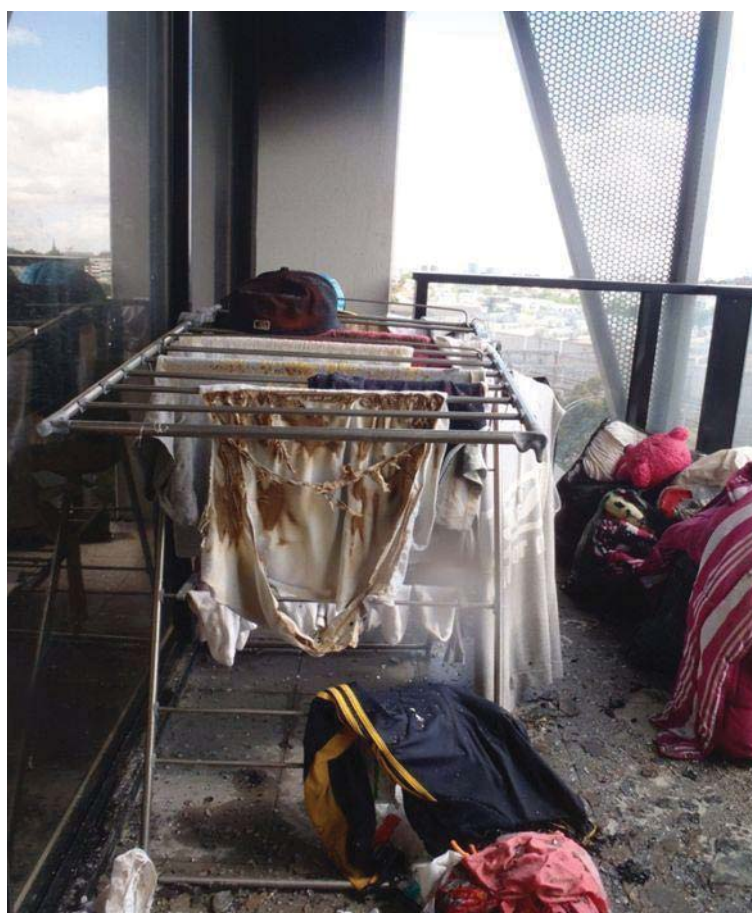
In this instance, typical combustibles identified to be present on balconies throughout the building consisted of clothing, bedding, bicycles, electrical appliances and other miscellaneous combustible materials, notwithstanding the air conditioner compressor units and other combustible furniture items. See Figure 11 below for example.

Figure 11 - Combustibles stored on one of the balconies.

High occupancy rates in apartments can lead to reliance on balconies for additional storage space, increasing the fire load.

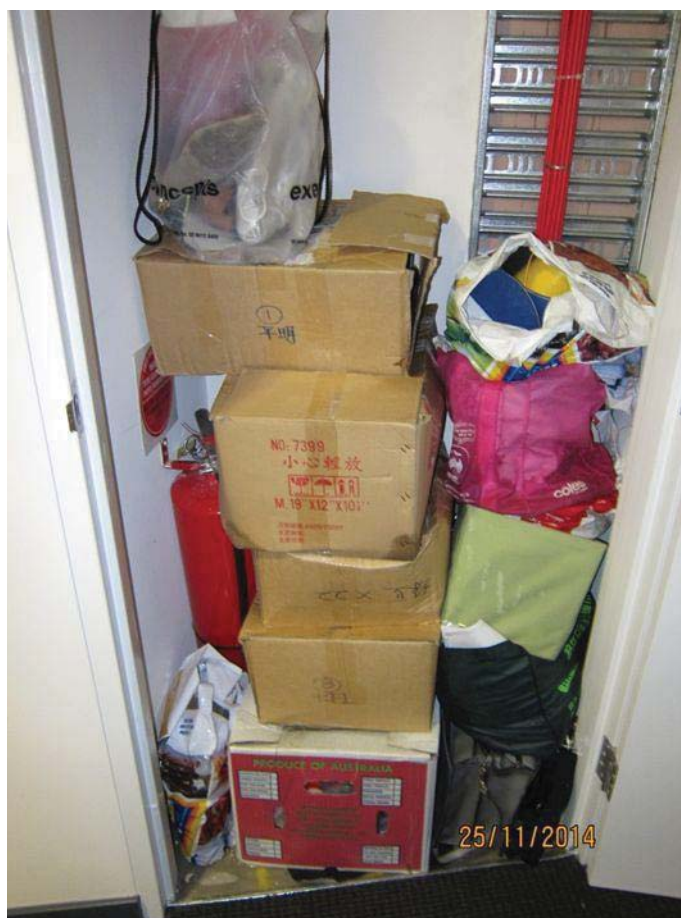
In this instance, a number of the purposely designed extinguisher enclosure housing Extinguishers 1 and 2 shown in [Figure 12 \(refer previous page\)](#), were being used by occupants as storage areas thus blocking access to the extinguishers.

Figure 13 - Fire extinguisher cupboard on Level 6.

The storage of goods and materials in enclosures used to accommodate fire safety equipment, delays access for occupants or fire-fighters who require the equipment in an emergency. These storage items are generally of a combustible nature and present an additional hazard.

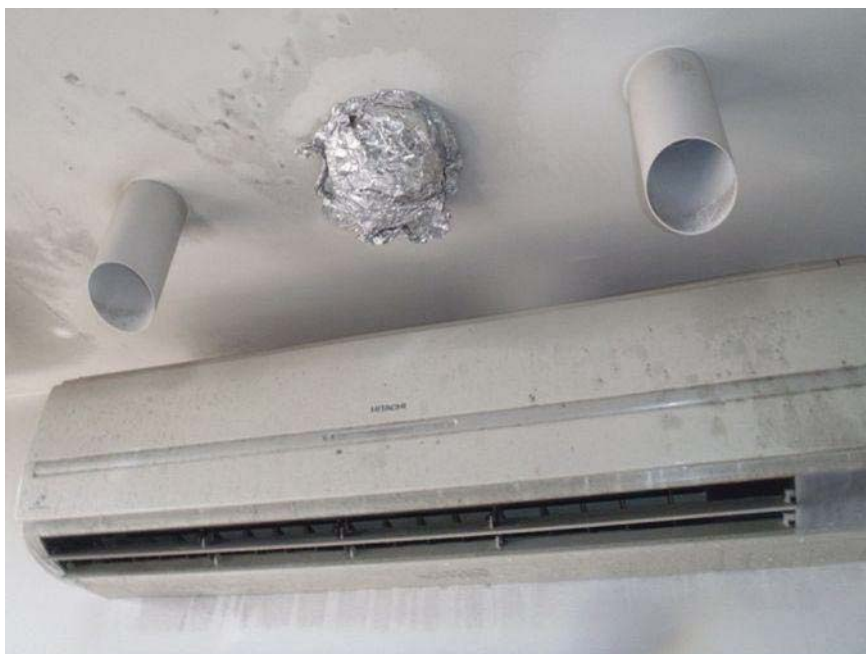
It was observed that within a number of apartments the battery had been removed from the smoke alarm. In addition some smoke alarms had been covered (Refer to Figure 14 below).

Figure 14 - An example of an obstructed Smoke Alarm – Apartment 805

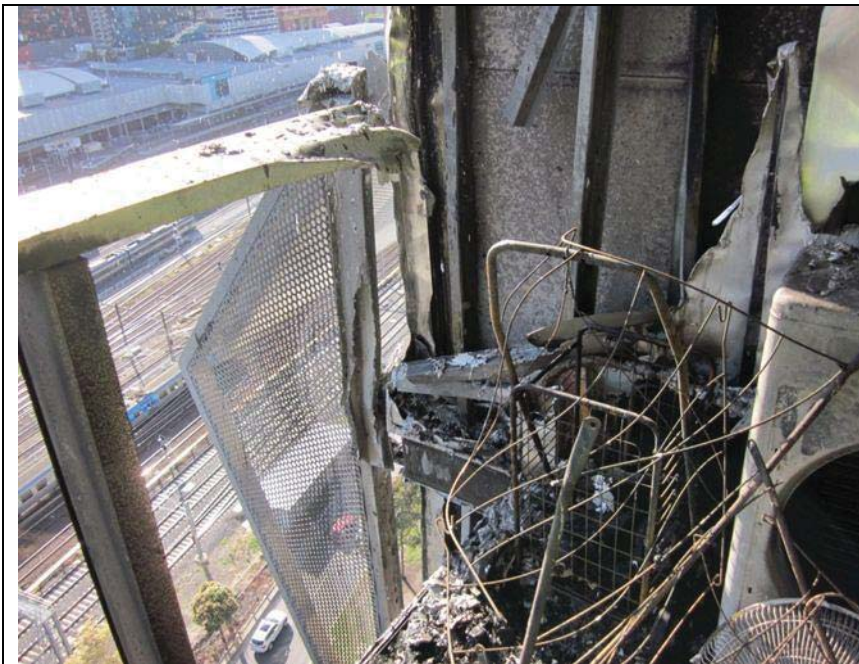
Wall between bedroom and balcony. Construction lightweight wall with steel studs, aluminium type external cladding plasterboard to internal. Material stored on balcony.

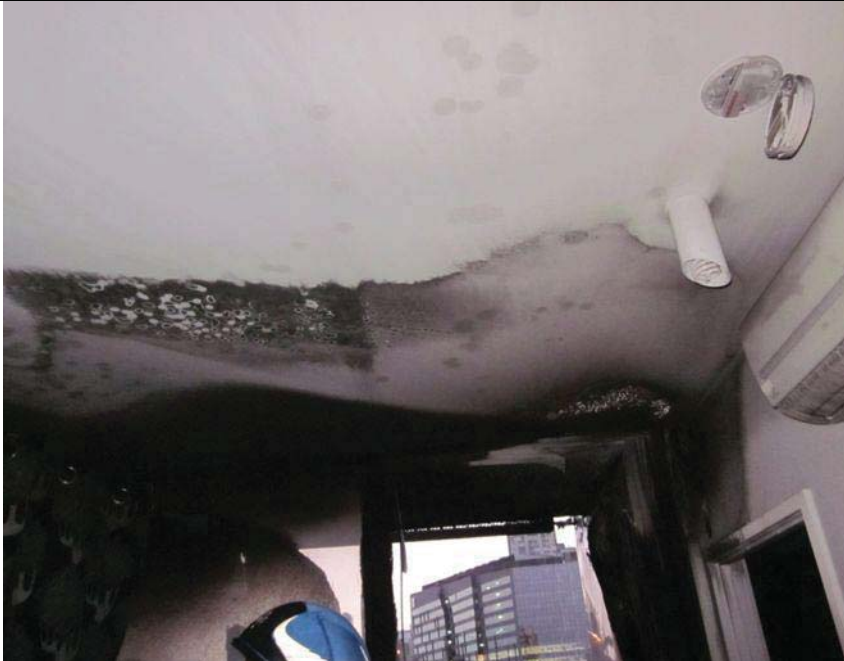
View of damaged wall and smoke detectors made inoperable. Others were covered over.

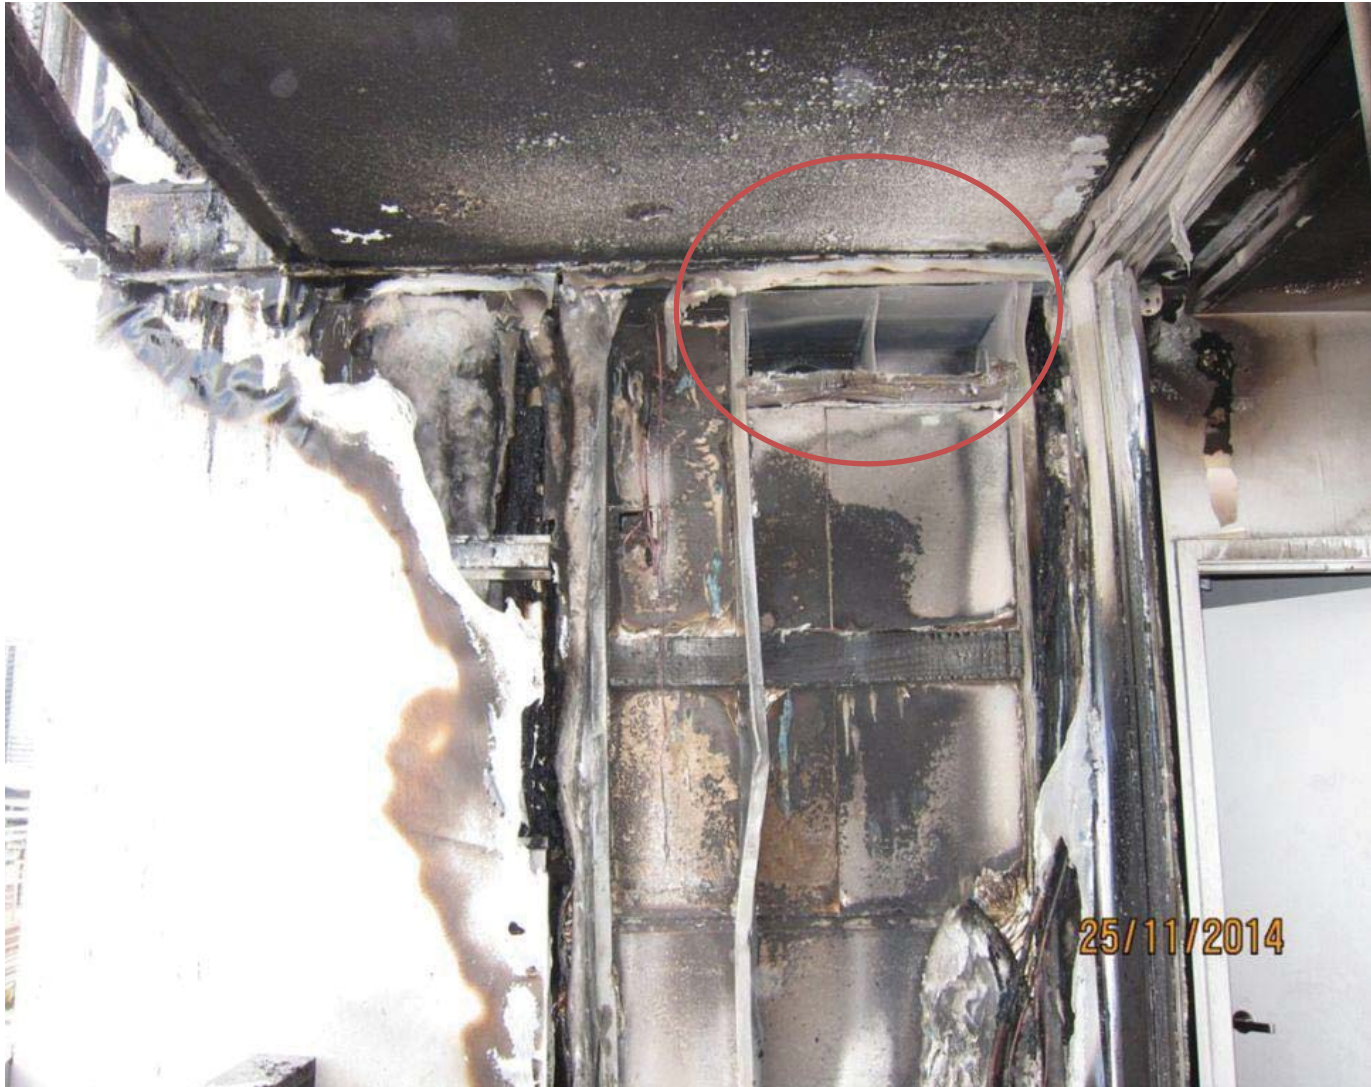
Image depicts apartment exhaust duct, the image also shows how close the door of Bedroom 2 is to the exhaust. The EWIS speaker is located roughly 400mm inside this door.

Figure 19 - Apartment Exhaust Duct

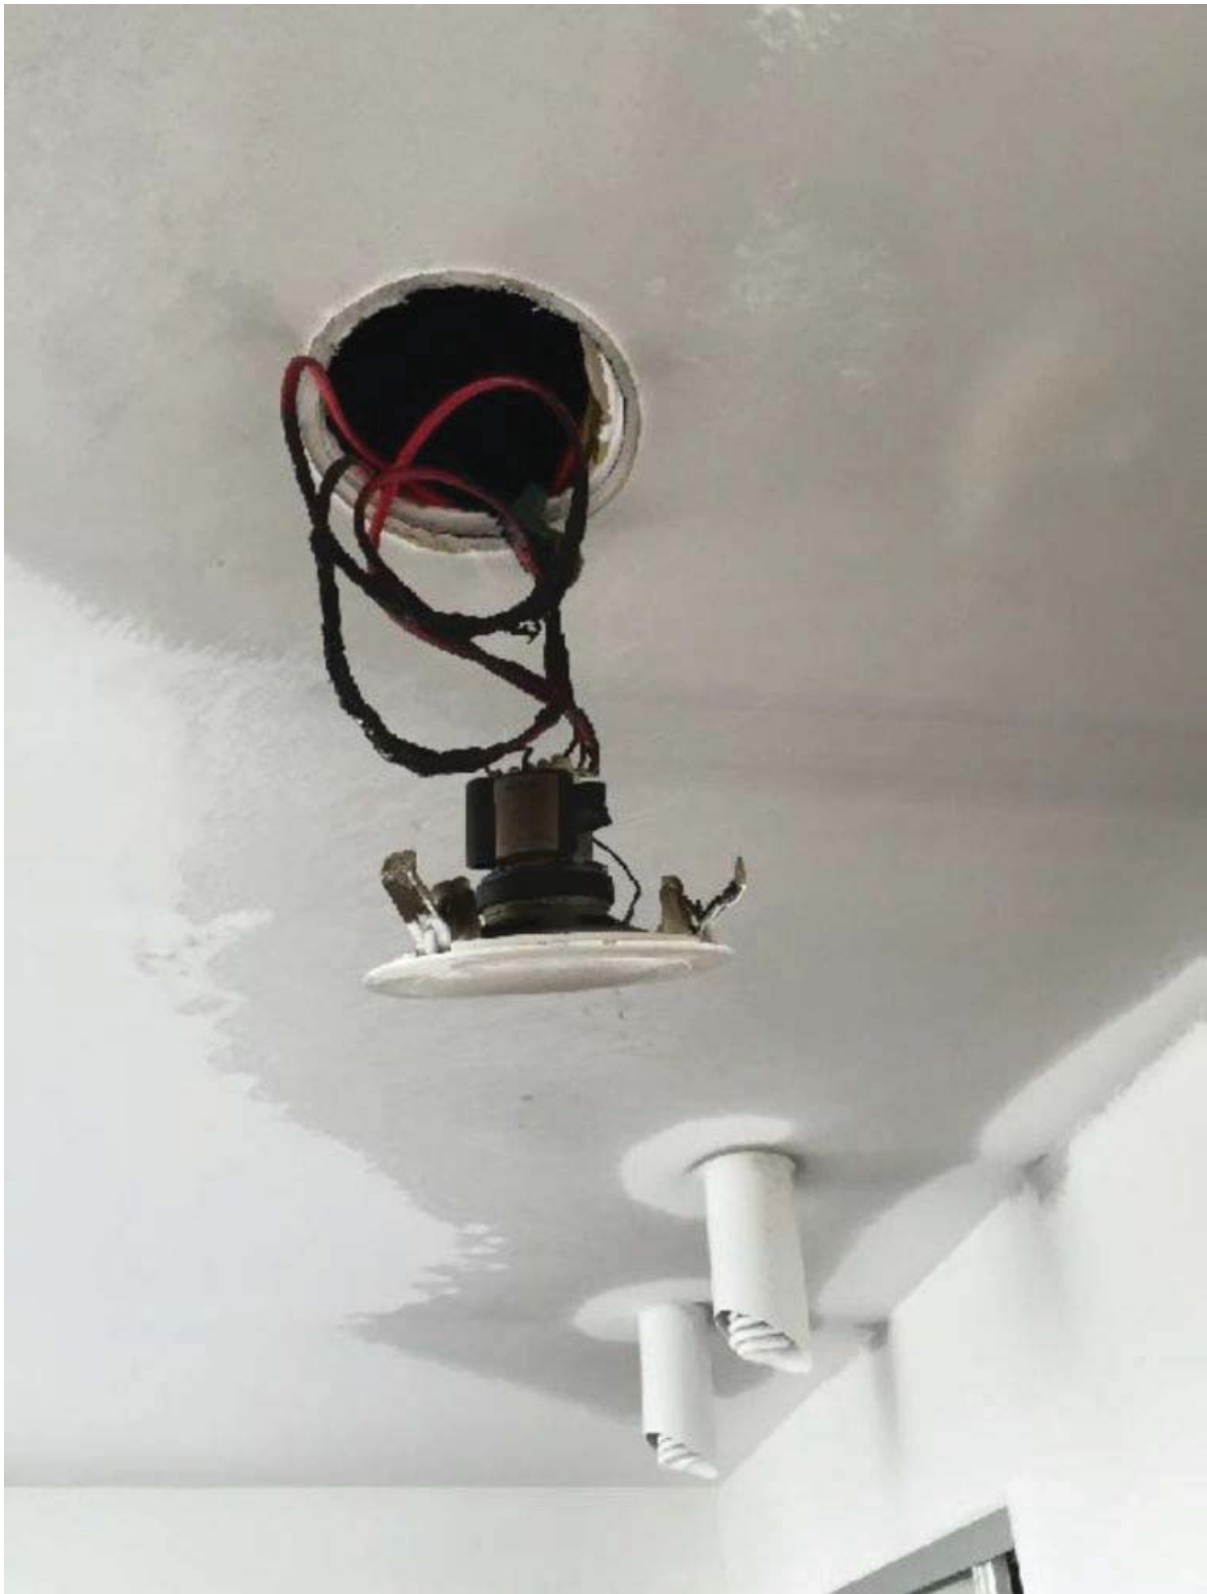
Image depicts the damaged caused to the EWIS speaker cables in Bedroom 2 of the 05 Series Apartments.

Figure 20 - EWIS Speaker and wiring
