VICTORIAN **ombudsman**

**Investigation into allegations concerning rail safety
in the Melbourne Underground Rail Loop**

October 2012

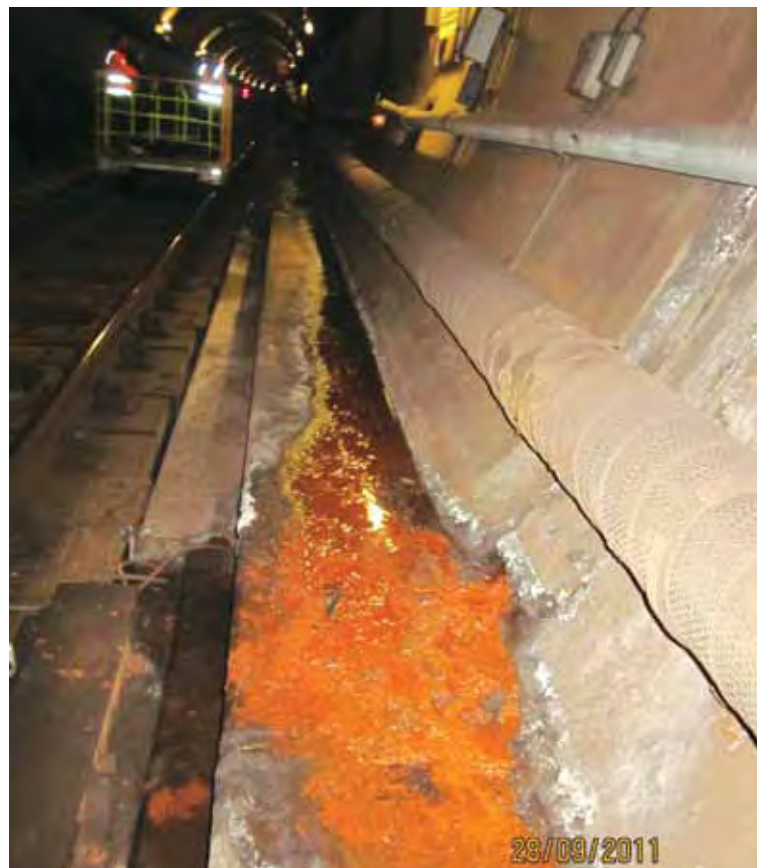
Figure 1: Burnley Loop – severe leached rust water on walkway

During an inspection of the MURL, my investigators observed that parts of the walkways had deteriorated to the extent that walking on them was hazardous (see figure 1).

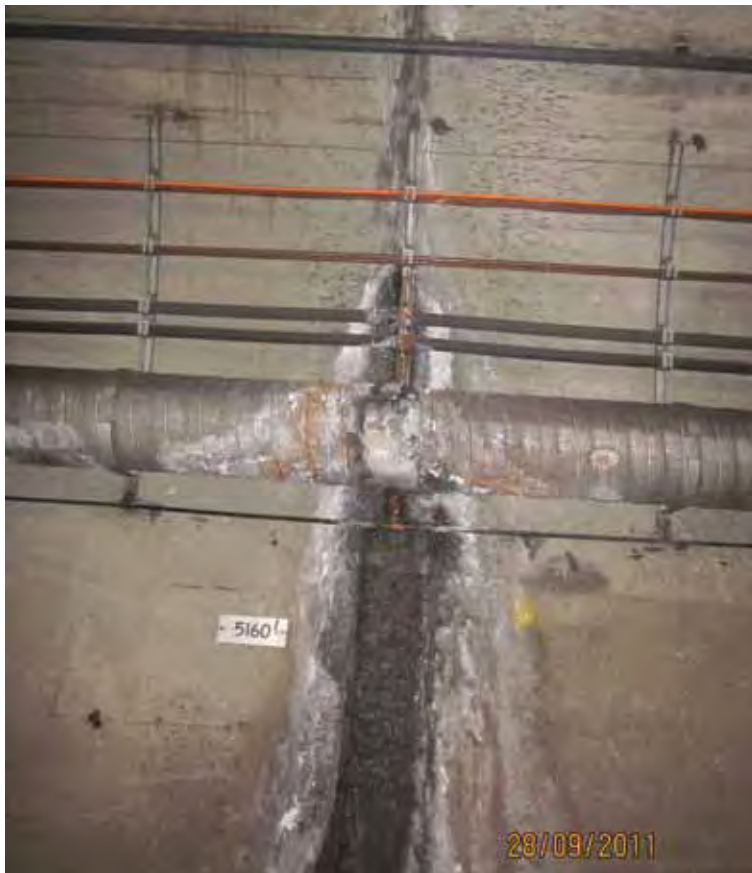
Figure 2: Burnley Loop - high wall cracking and leaching of concrete

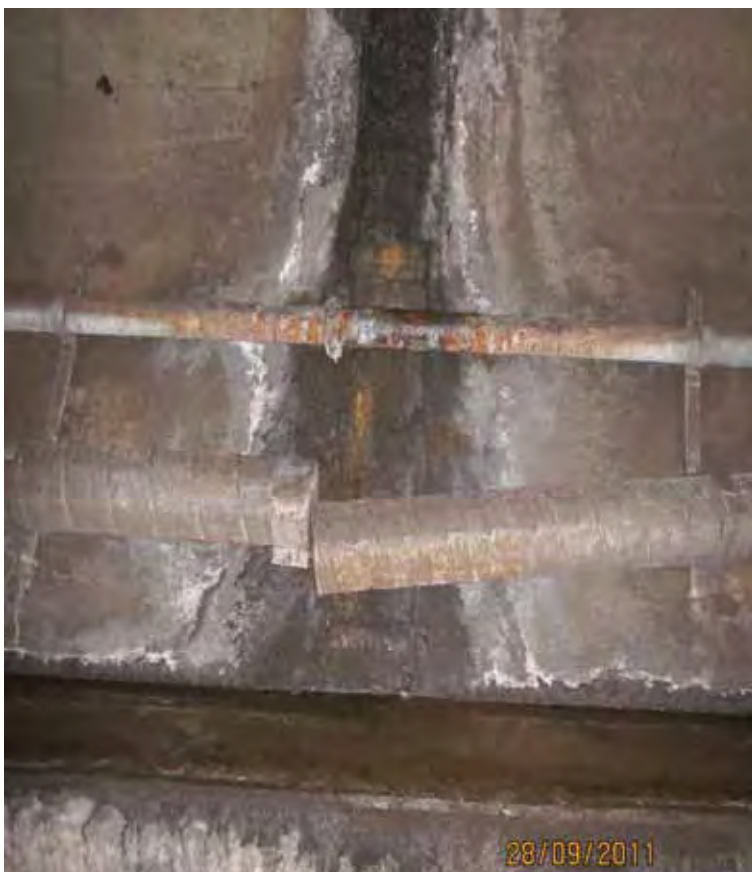
Figure 3: Burnley Loop - corrosion

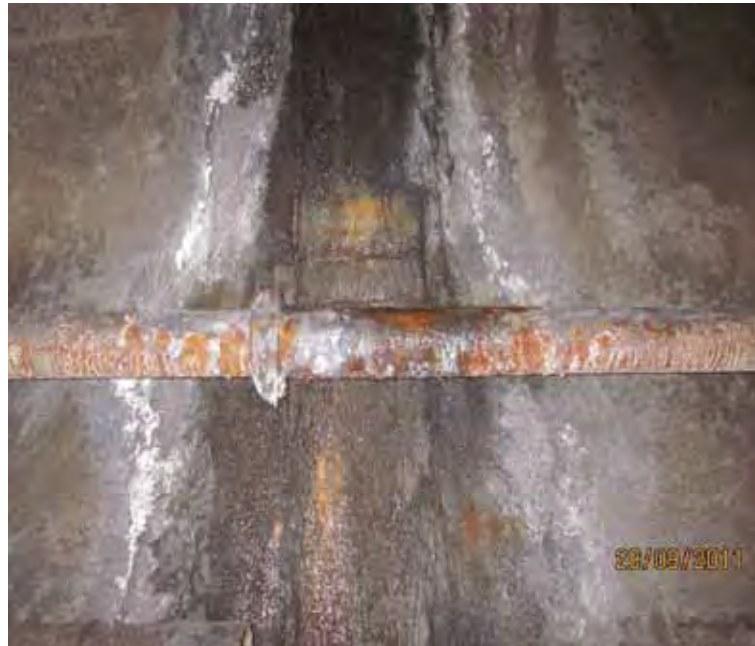
Figure 4: Burnley Loop - severe corrosion on fire line

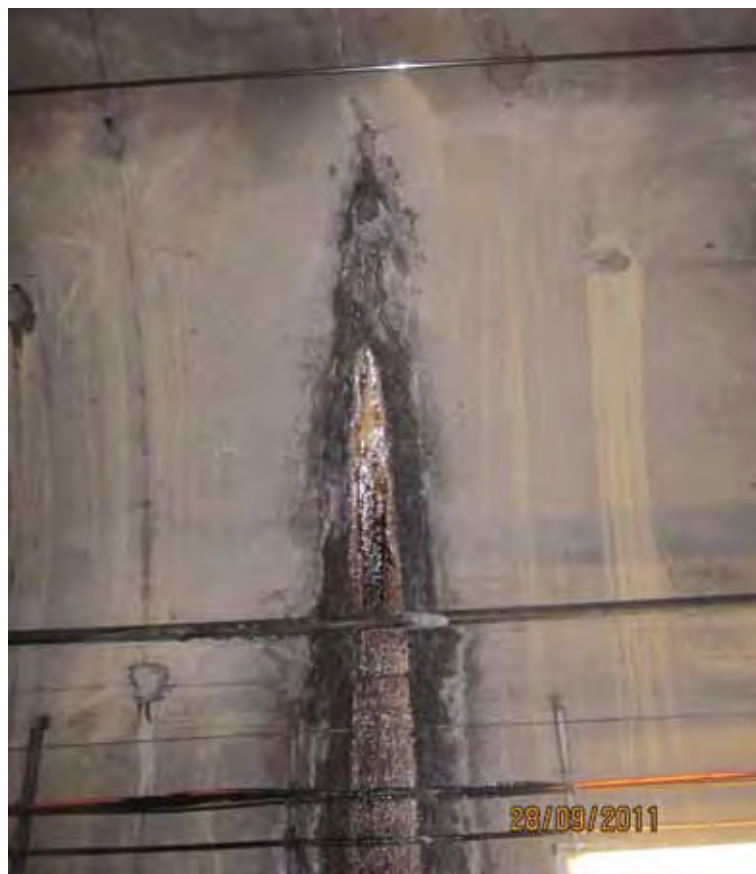
Figure 5: Northern Loop - high wall corrosion and cracking

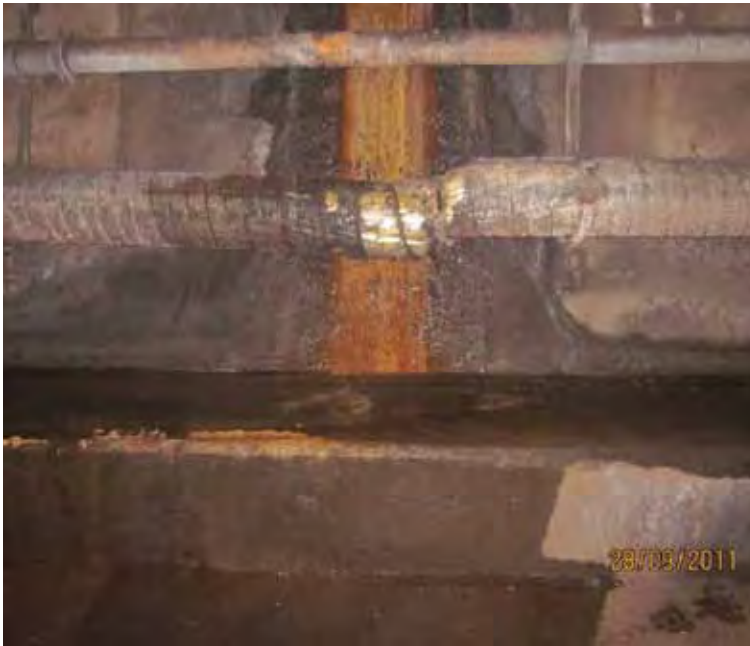
Figure 6: Northern Loop - severe corrosion and leaching
