This report presents the results of a validation workplan for remediation activities conducted by Coffey Partners International Pty Ltd (Coffey) at the Flammable Liquids Pad (FLP) and Old Fire Training Pit (FTP) areas at the Country Fire Authority (CFA) Training College site at Fiskville, near Ballan, Victoria.

Customer: County Fire Authority
 Project: Composting of Hydrocarbon Contaminated Soils at CFA, Fiskville
 Project Code: CA1002
 File: n:\CA1002 - Figure 1.dwg

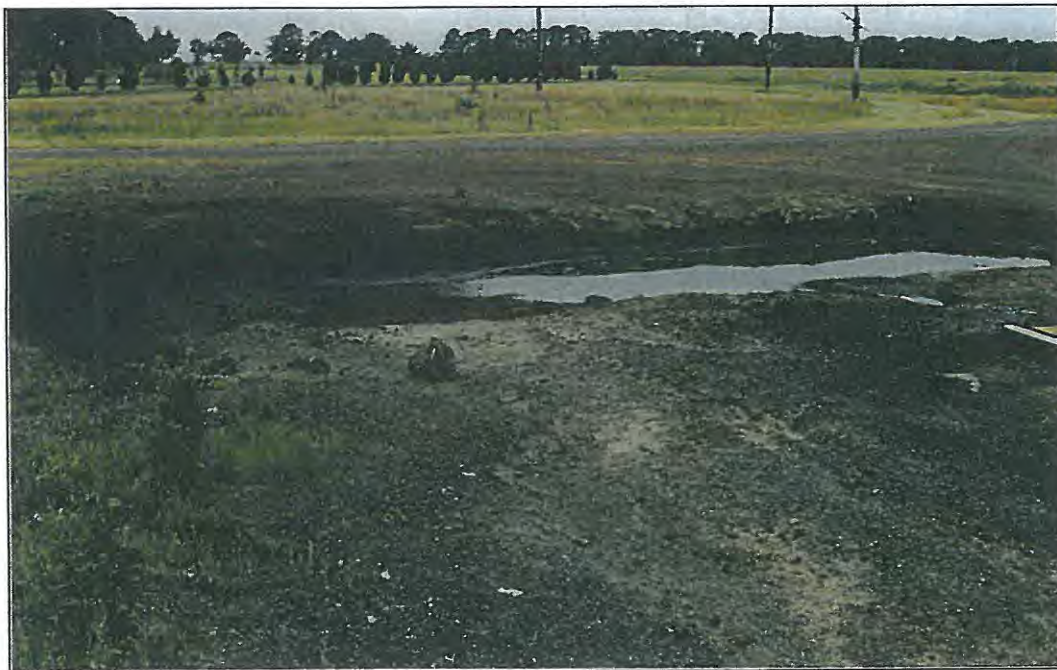
Figure 3. The contaminated site at CFA Fiskville prior to excavation

- **Flammable liquids pad.** This large area contained obvious and unsightly superficial soil contamination with fuel residues from fire training activities. Figure 3 shows the site as it was prior to excavation. Crushed rock fill was contaminated with hydrocarbons at depths of 0.1-0.5 m, but generally no deeper than 0.8 m. Total petroleum hydrocarbon concentrations ranged up to 1600 mg/kg.

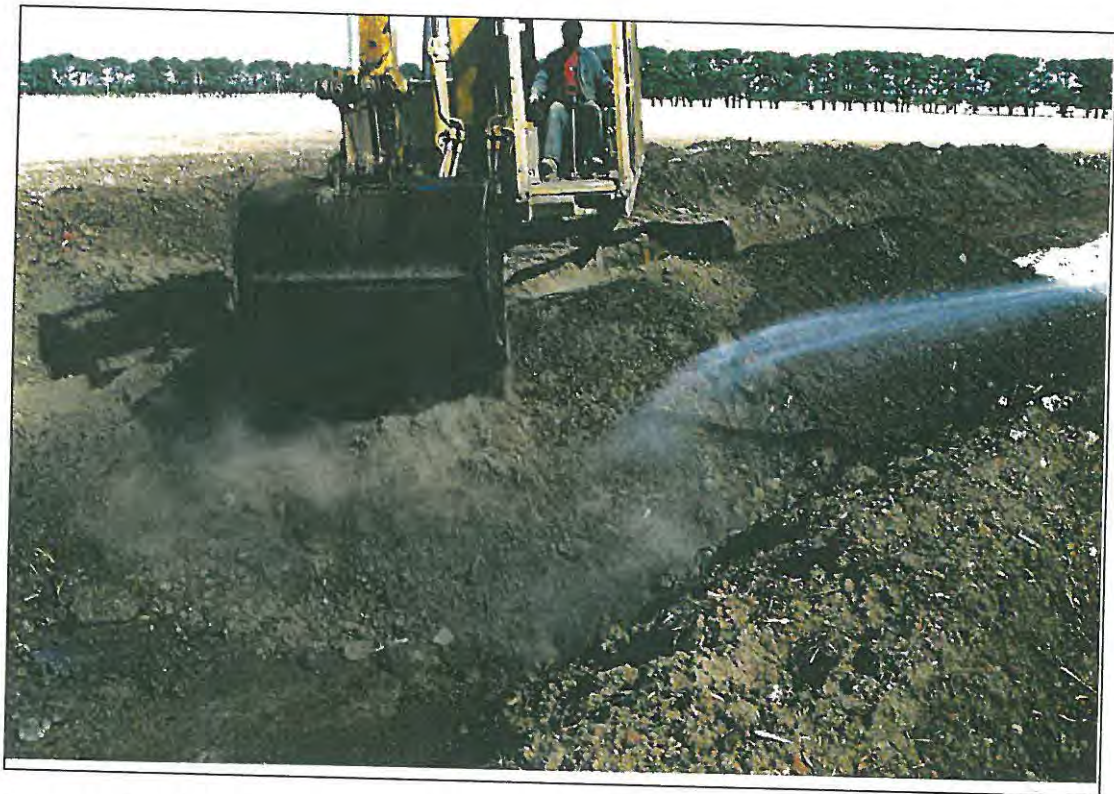
Figure 4. The mixing process during the formation of the windrows

Table 2. Composition of soil compost windrows
