CFA TRAINING COLLEGE, FISKVILLE, VIC

Preliminary Site Assessment

Report Number. 117613201-002-R-Rev0

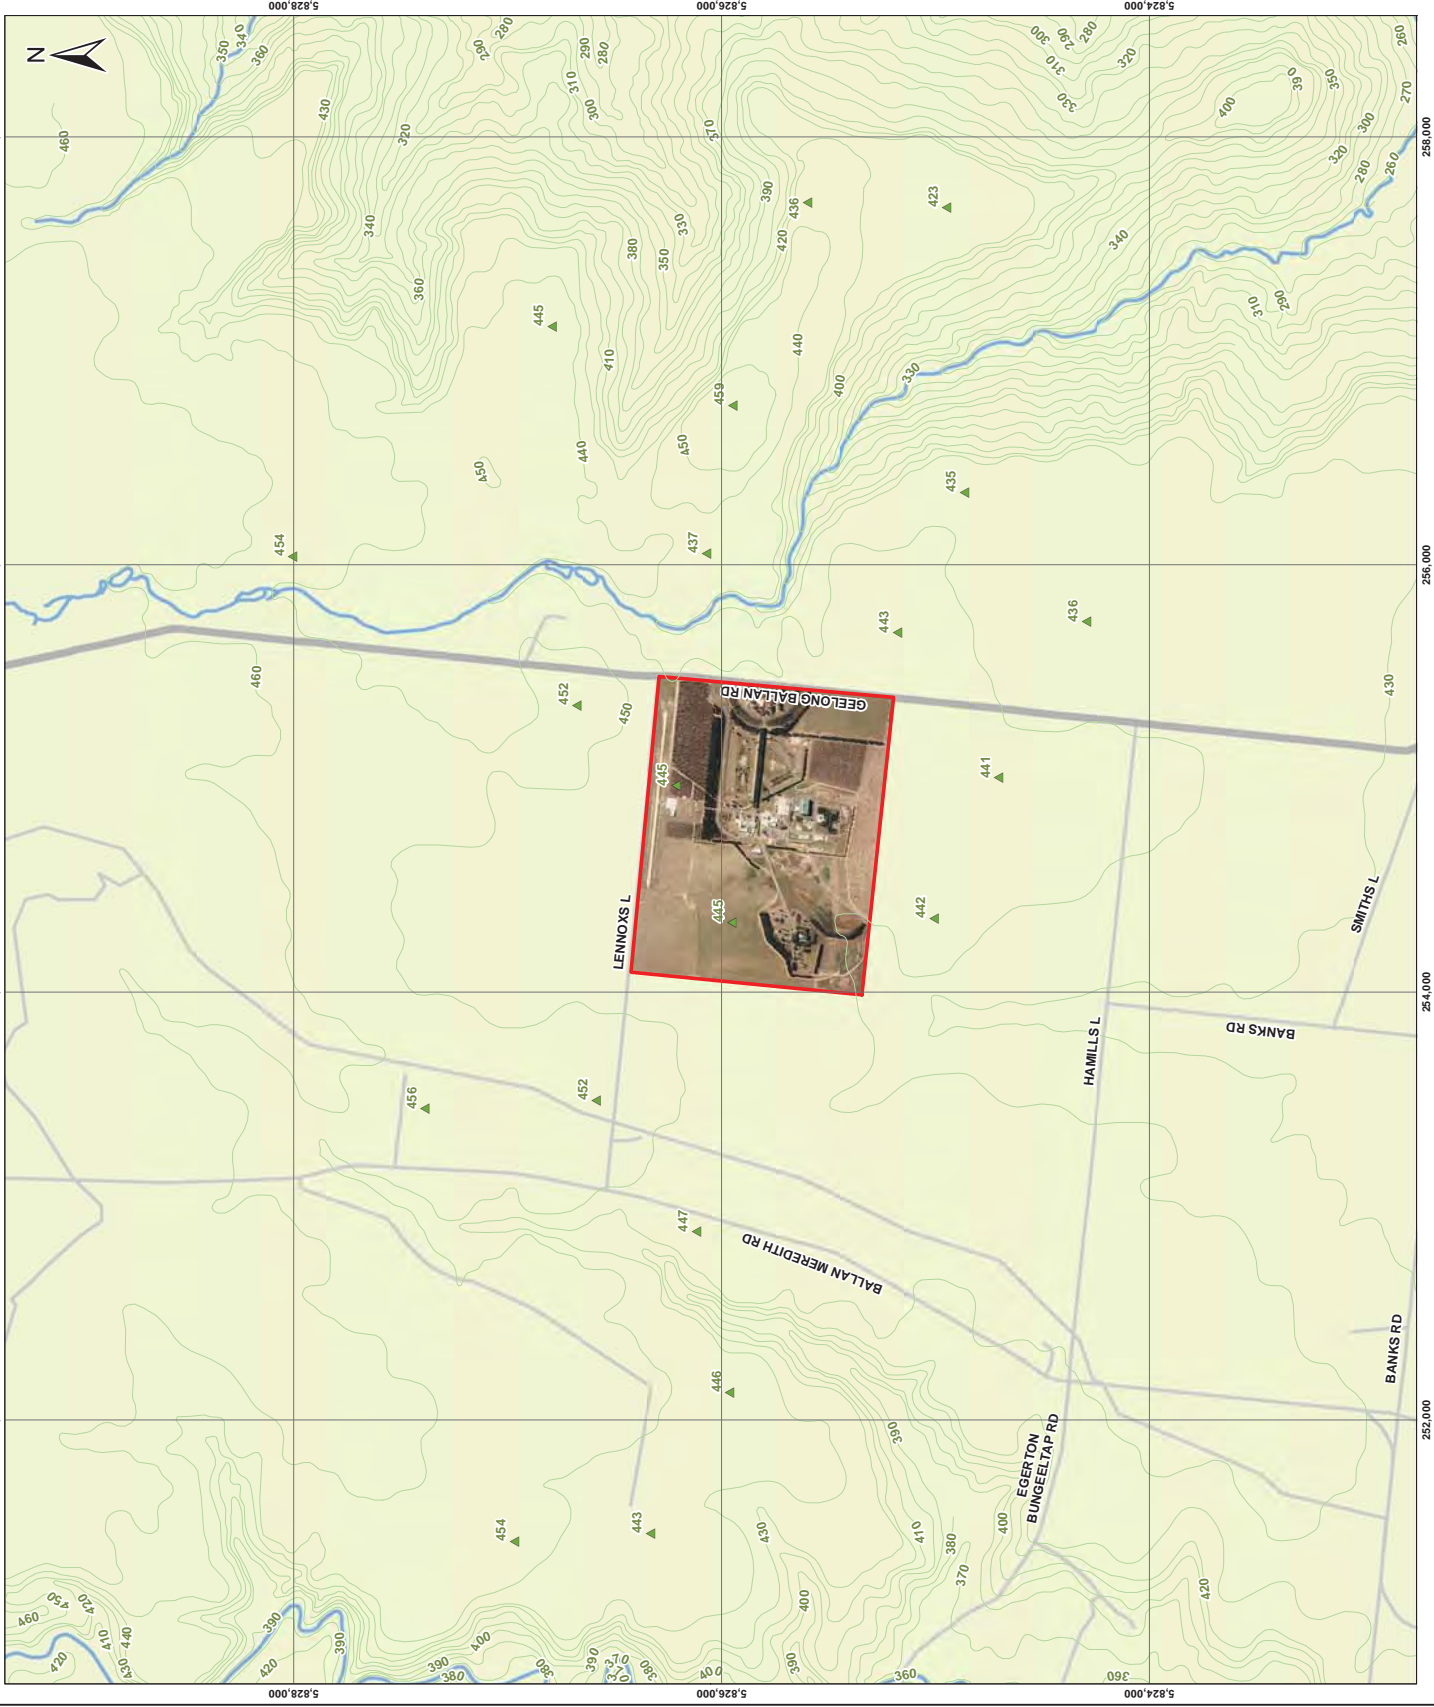
SITE TOPOGRAPHY

- ▲ Elevation Spot Heights (m AHD)
- 10m Elevation Contour (m AHD)
- River
- Main Road
- Street
- Land
- Approximate Site Boundary

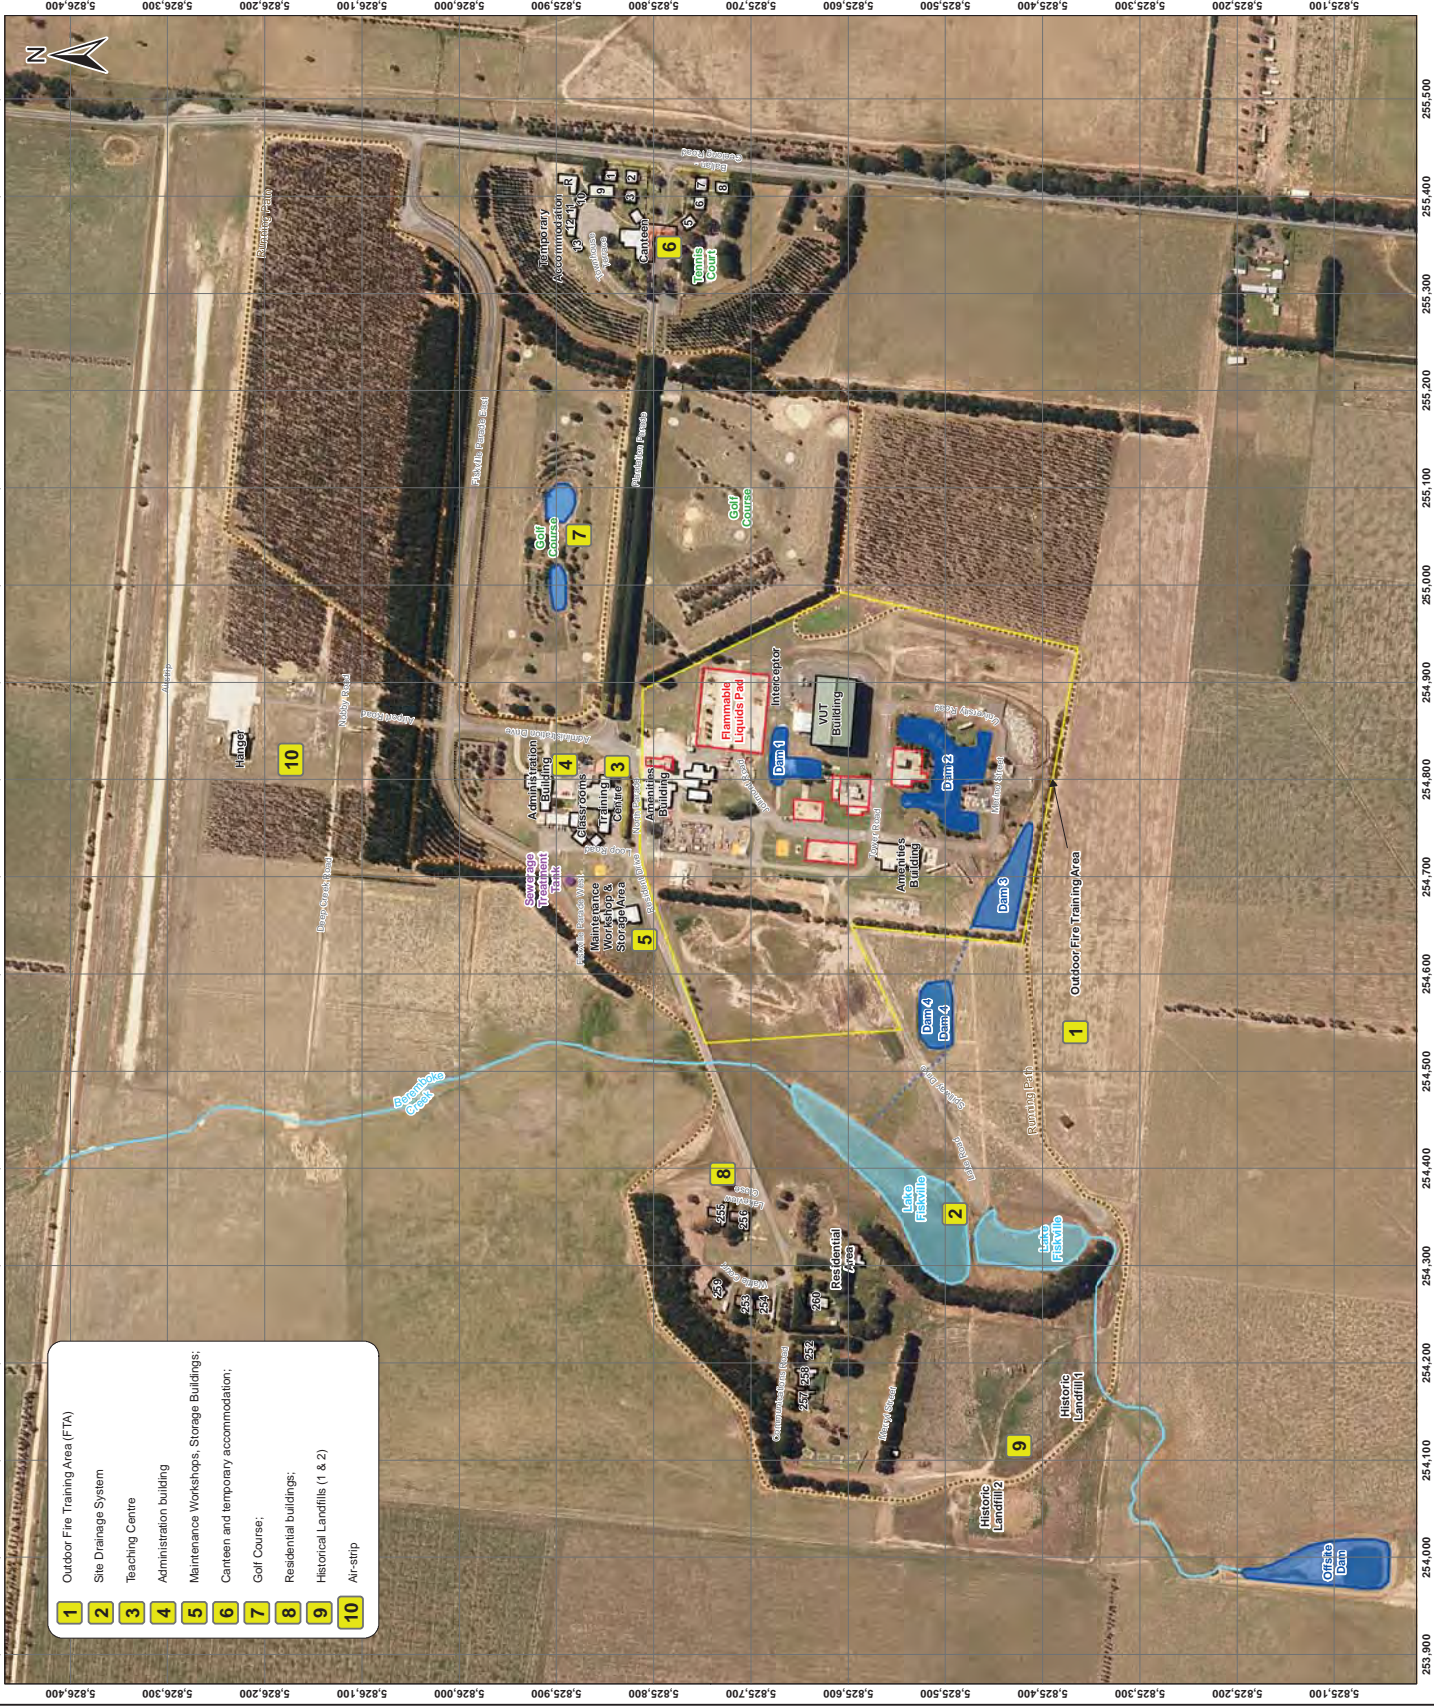
INDEPENDENT FISKVILLE INVESTIGATION
CURRENT SITE LAYOUT

- 1** Outdoor Fire Training Area (FTA)
- 2** Site Drainage System
- 3** Teaching Centre
- 4** Administration building
- 5** Maintenance Workshops, Storage Buildings;
- 6** Canteen and temporary accommodation;
- 7** Golf Course;
- 8** Residential buildings;
- 9** Historical Landfills (1 & 2)
- 10** Air-strip

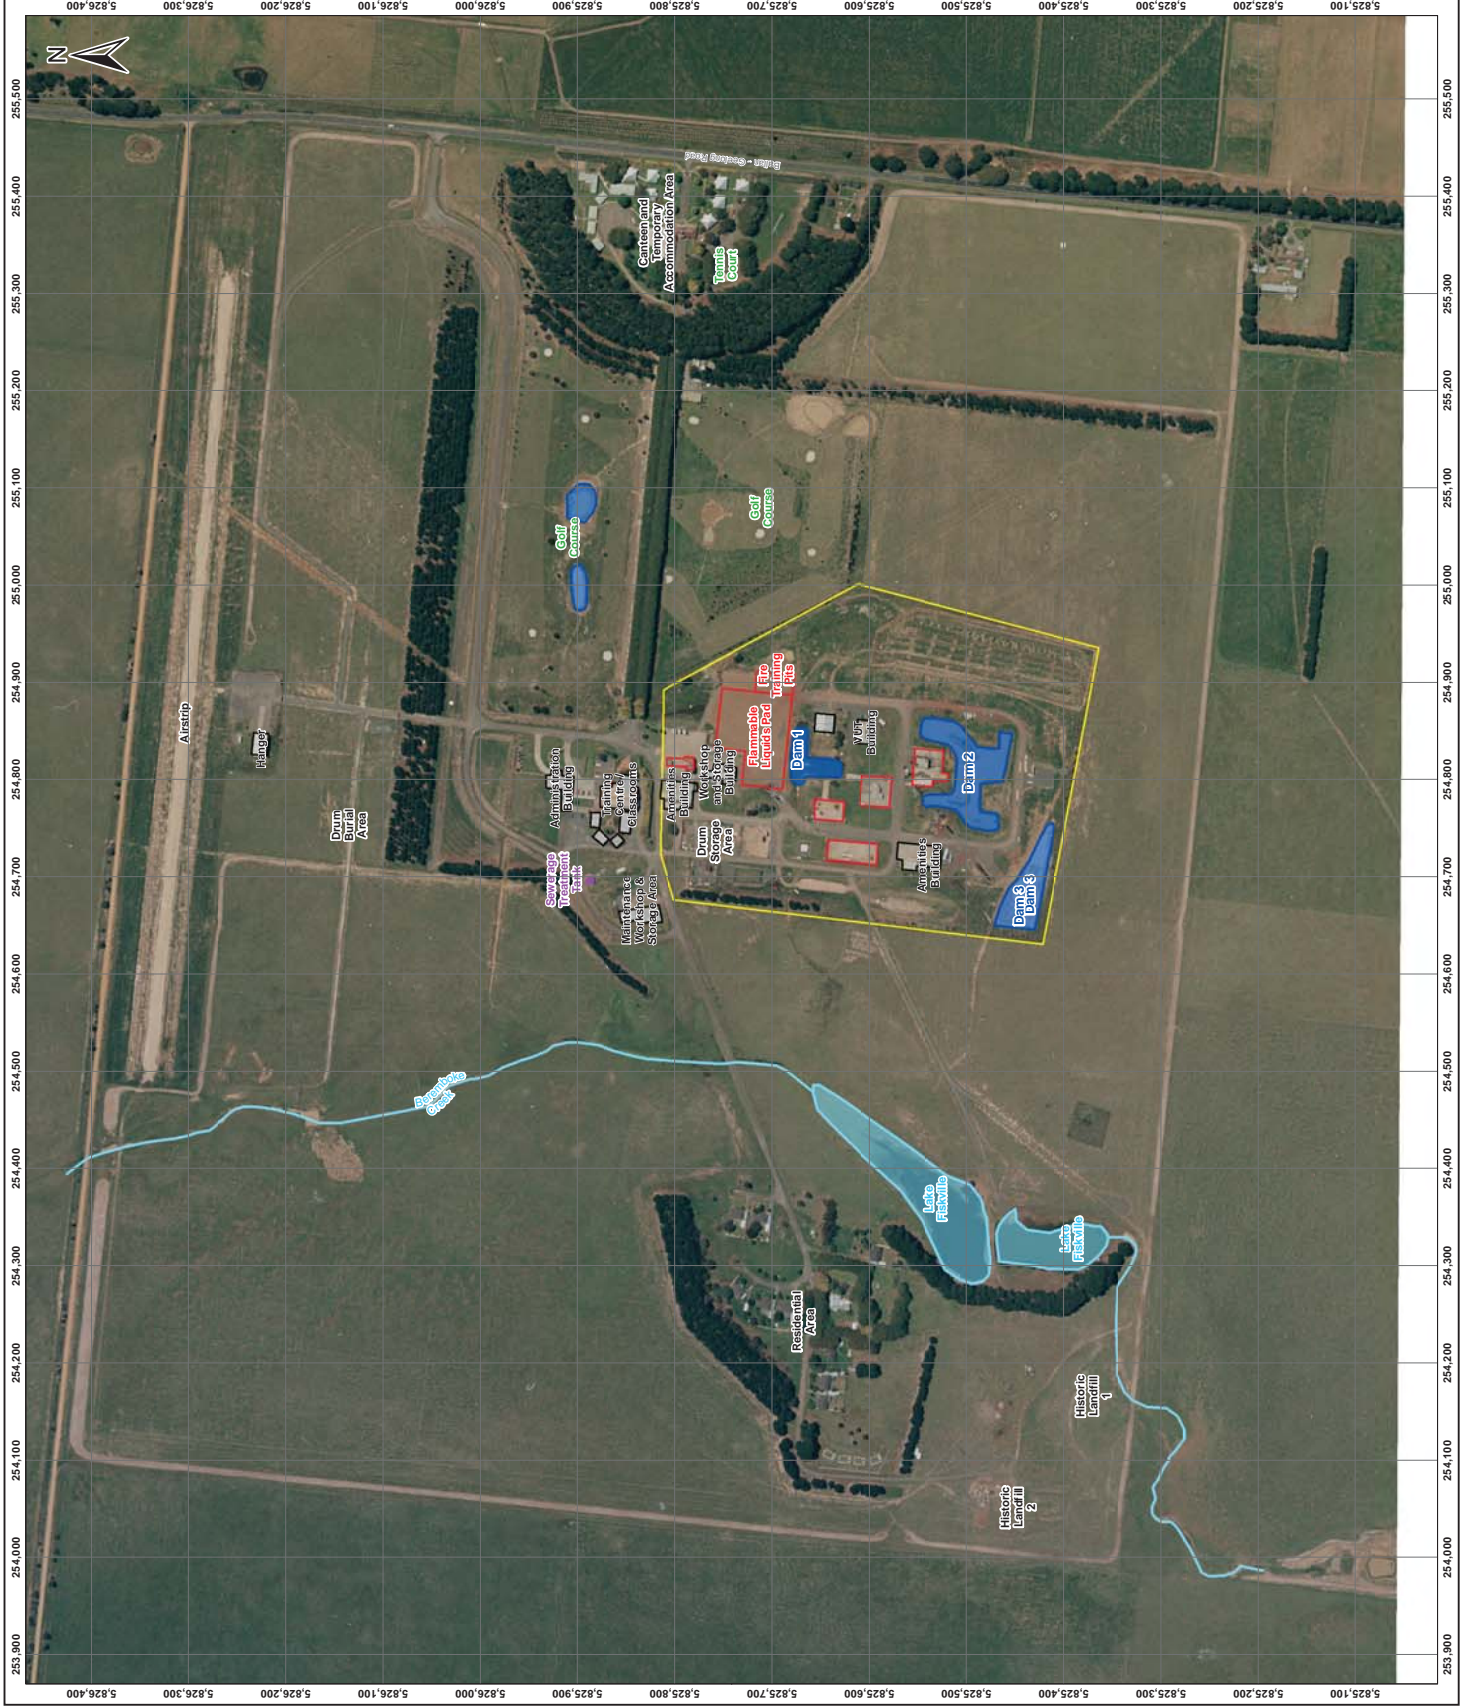
1990'S SITE LAYOUT

- Stream / Waterway
- Lake
- Dam
- Sewerage Treatment Plant
- Fire Training Props
- Fire Training Area
- Building Footprints

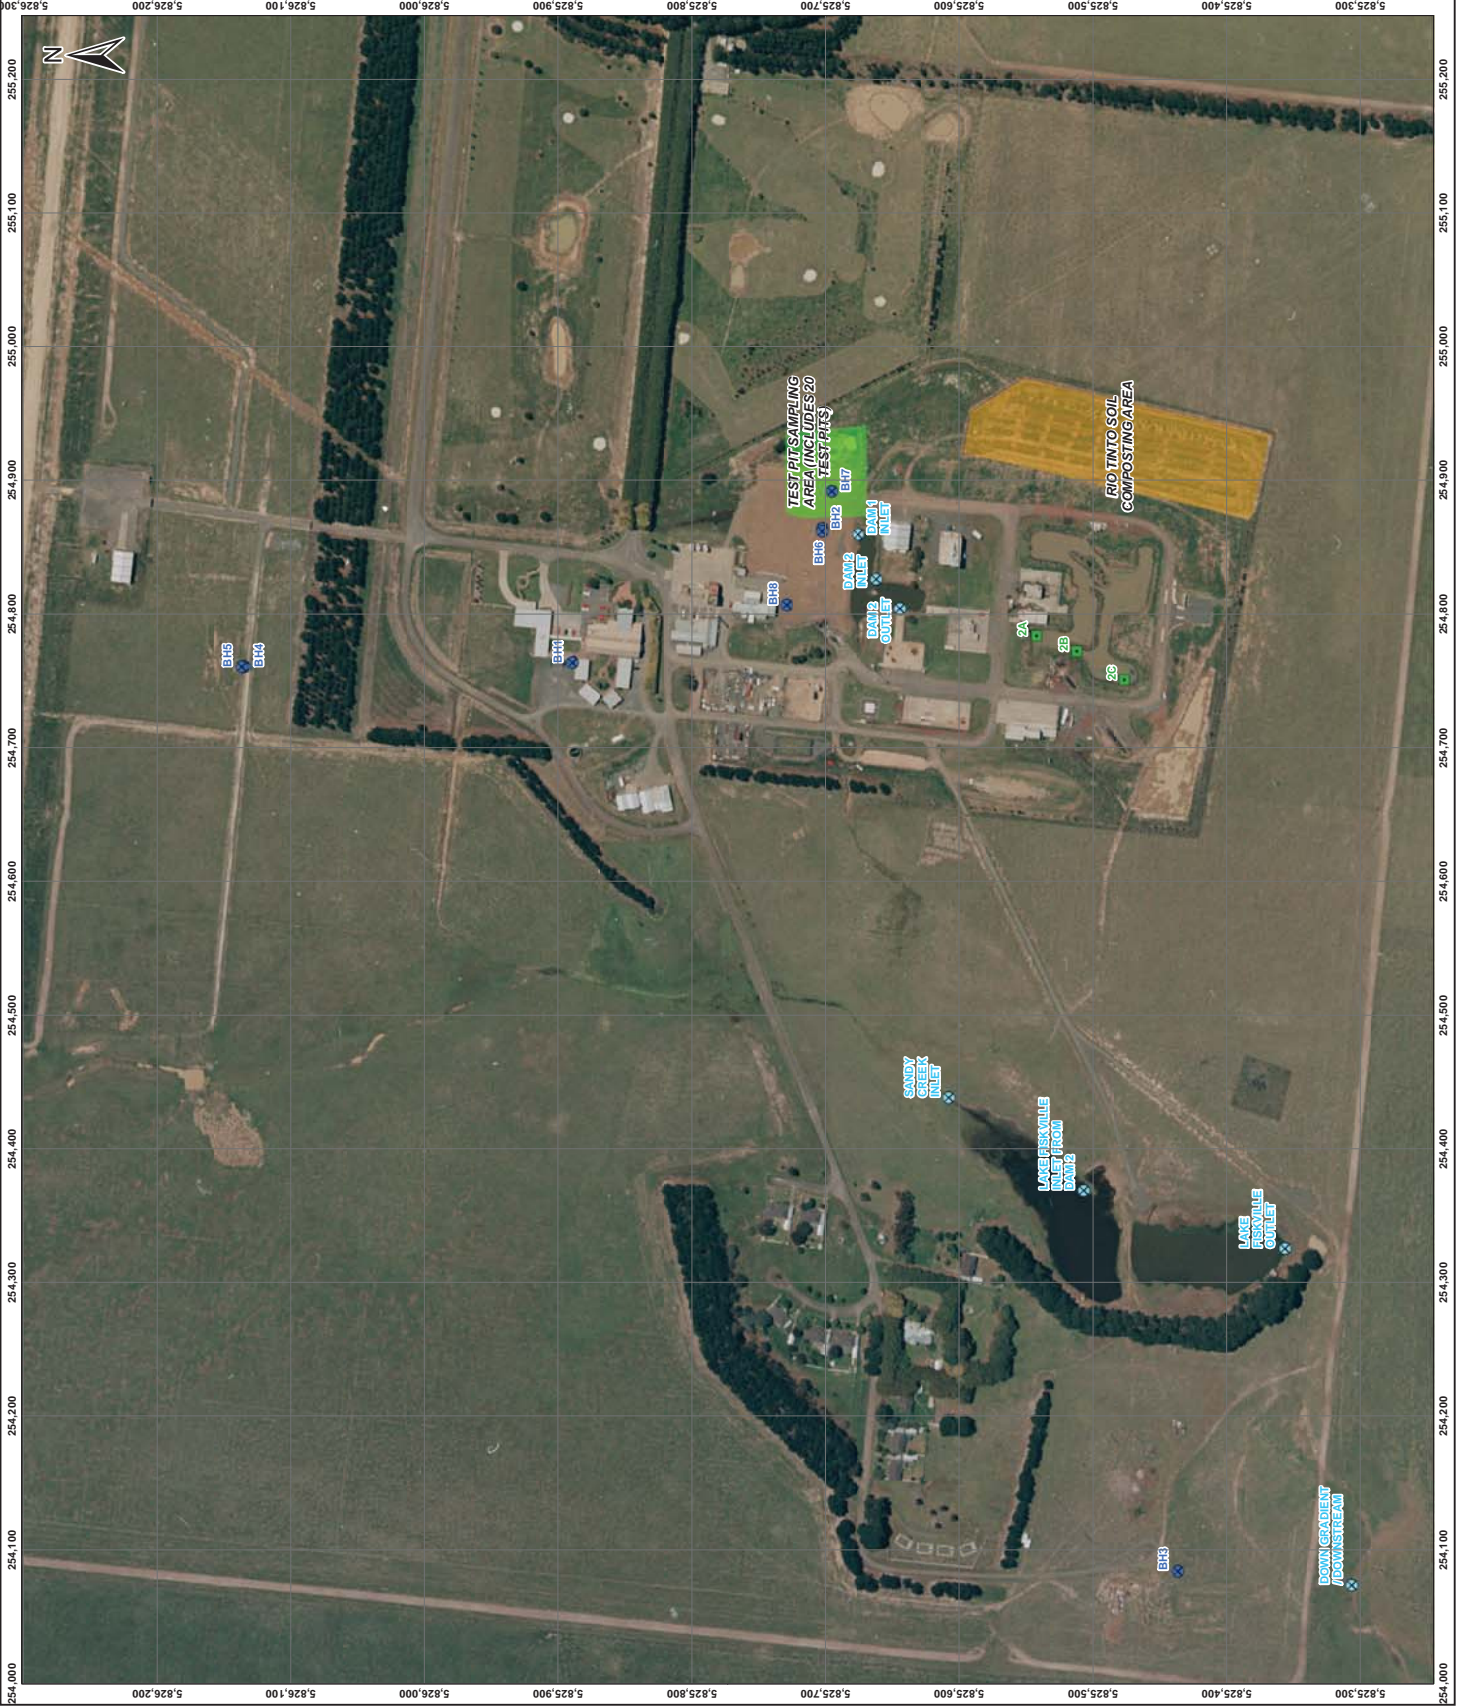
FIGURE 6

2012 SAMPLE LOCATION PLAN

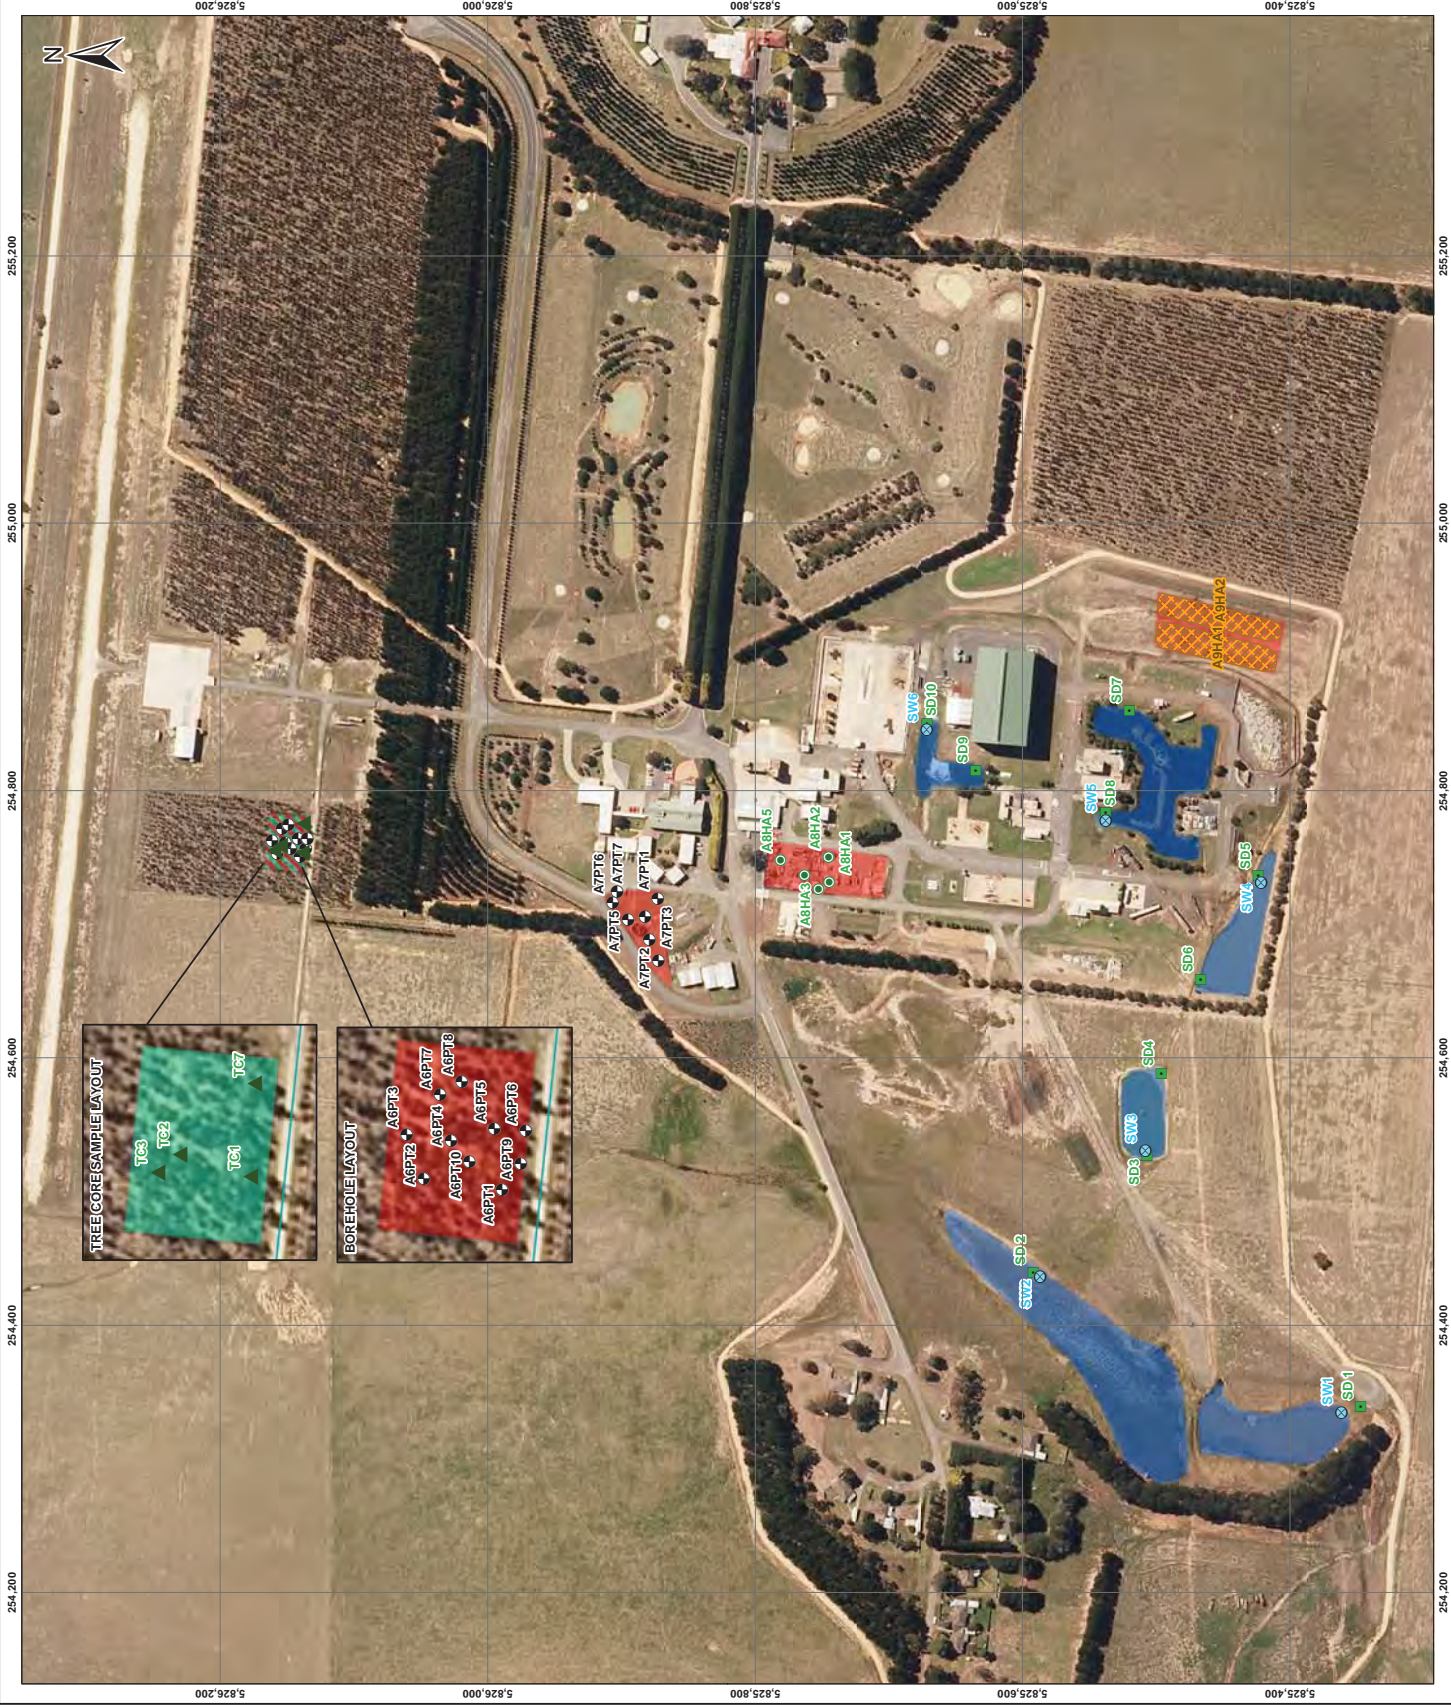
2012 Investigation Locations

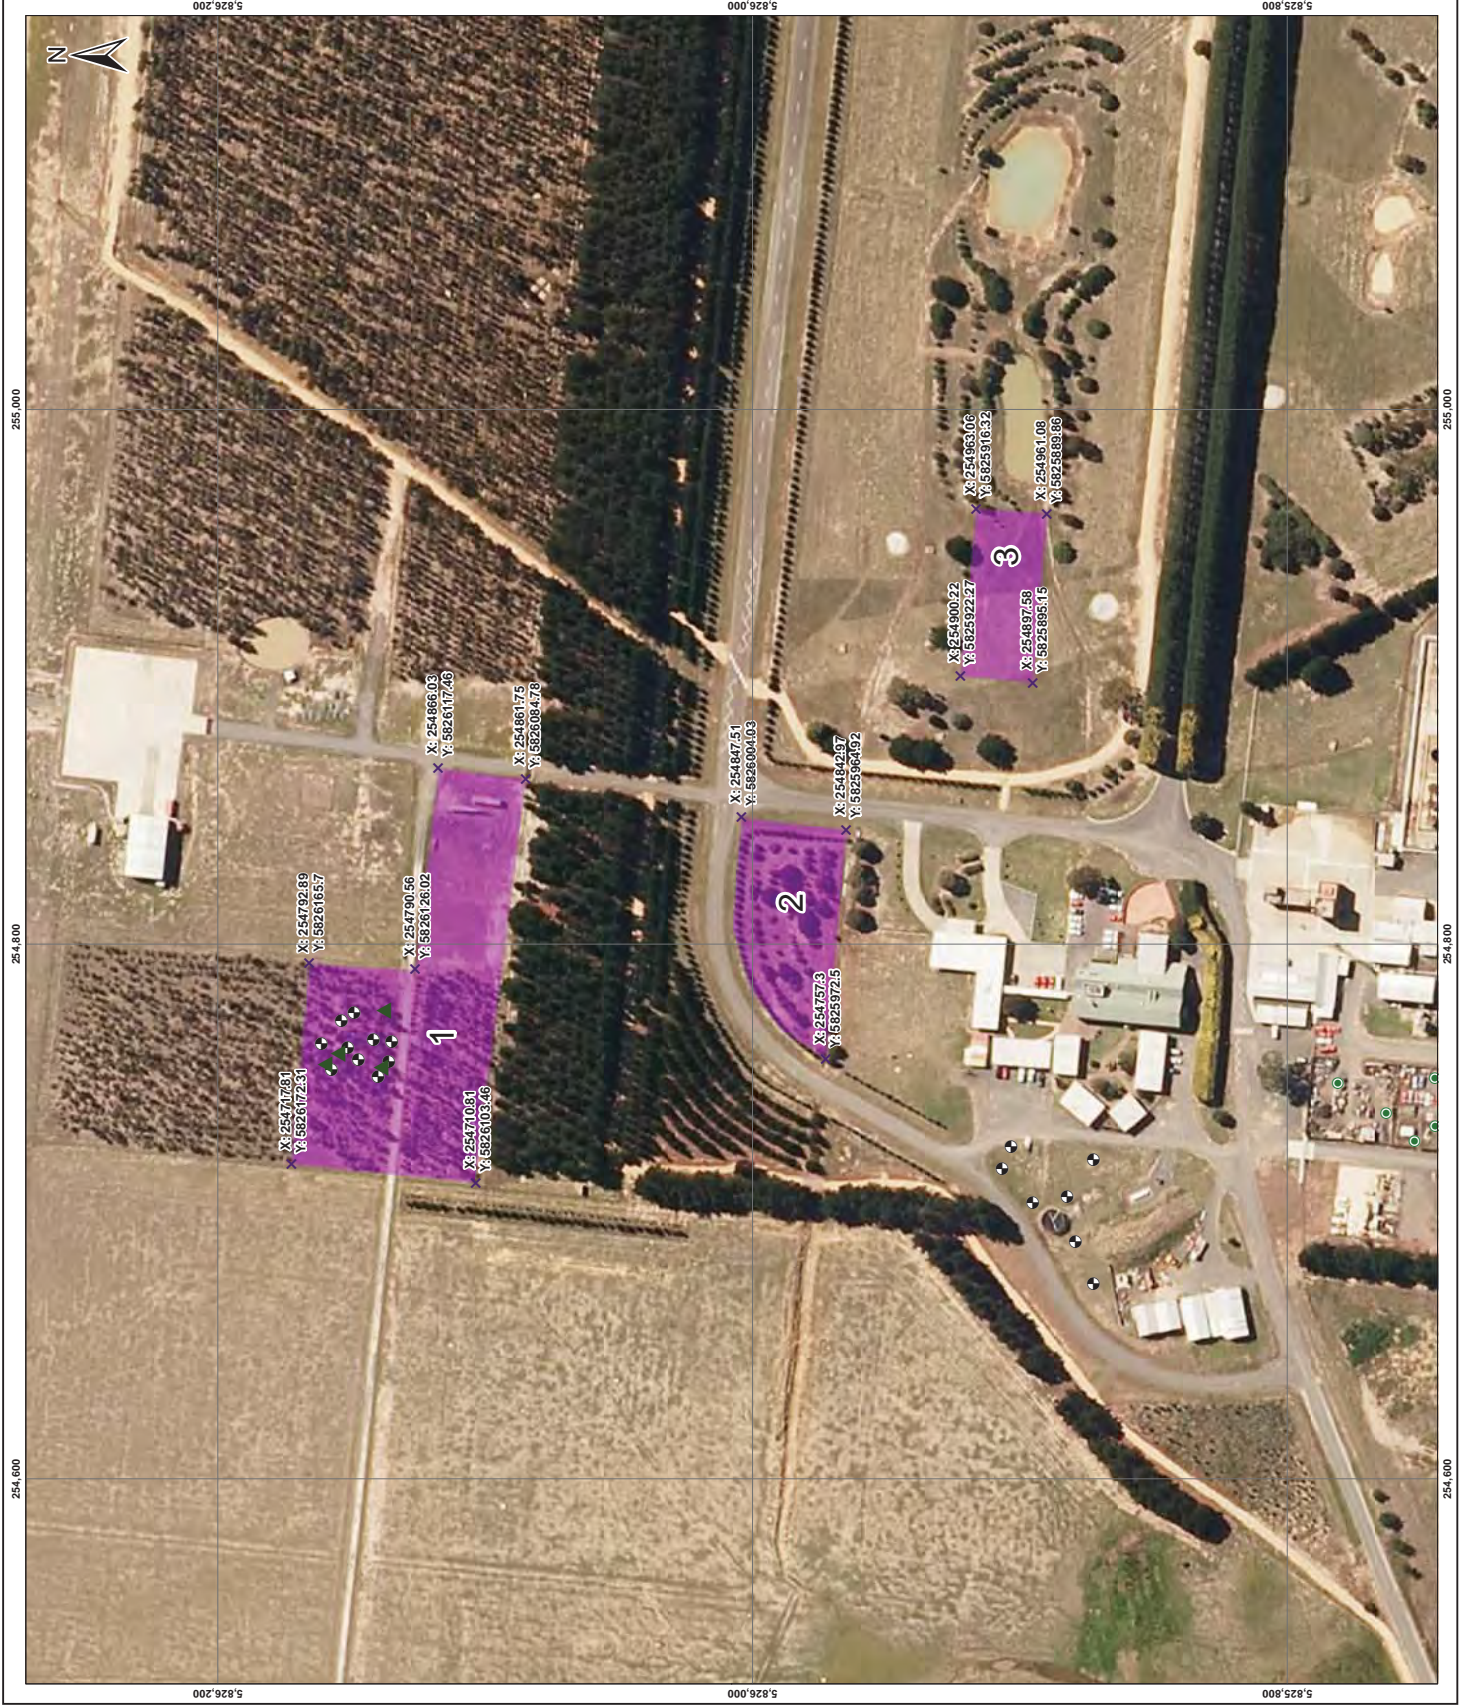
FIGURE 9

CFA personnel reported to the Independent Investigation Team, that drums were also buried in an area to the south of the Airstrip during the 1980s, the exact date of the burial is unknown. The approximate locations of the three (3) suspected Drum Burial Areas are presented in Figure 9 in Appendix C.

When Golder Associates commenced this PSA, the Independent Investigation Team was only aware of one (1) Drum Burial Area which was a small area within Drum Burial Area 1. The additional two (2) Drum Burial Areas (2&3) and remainder of Drum Burial Area 1 were identified by the Independent Investigation Team based on advice from CFA personnel, following the completion of the Golder Associates intrusive investigation. Therefore only a small area of Drum Burial Area 1 to the south of the Airstrip and north of Deep Creek Road was intrusively investigated during this PSA. However, subsequent to the completion of the intrusive investigation, the three (3) suspected Drum Burial Areas were surveyed with Ground Penetrating Radar (GPR) to assess if any subsurface features (e.g. drums or trenches) were present. The results of this GPR are discussed in Section 9.2.4 and the suspected Drum Burial Areas are presented in Figure 9 in Appendix C.

The suspected Drum Burial Areas are presented in Figure 9 in Appendix C.
