Groundwater Contamination Assessment

Fiskville Training College
4549 Geelong-Ballan Road, Fiskville, Vic

Job No. 212163.2

March 2014

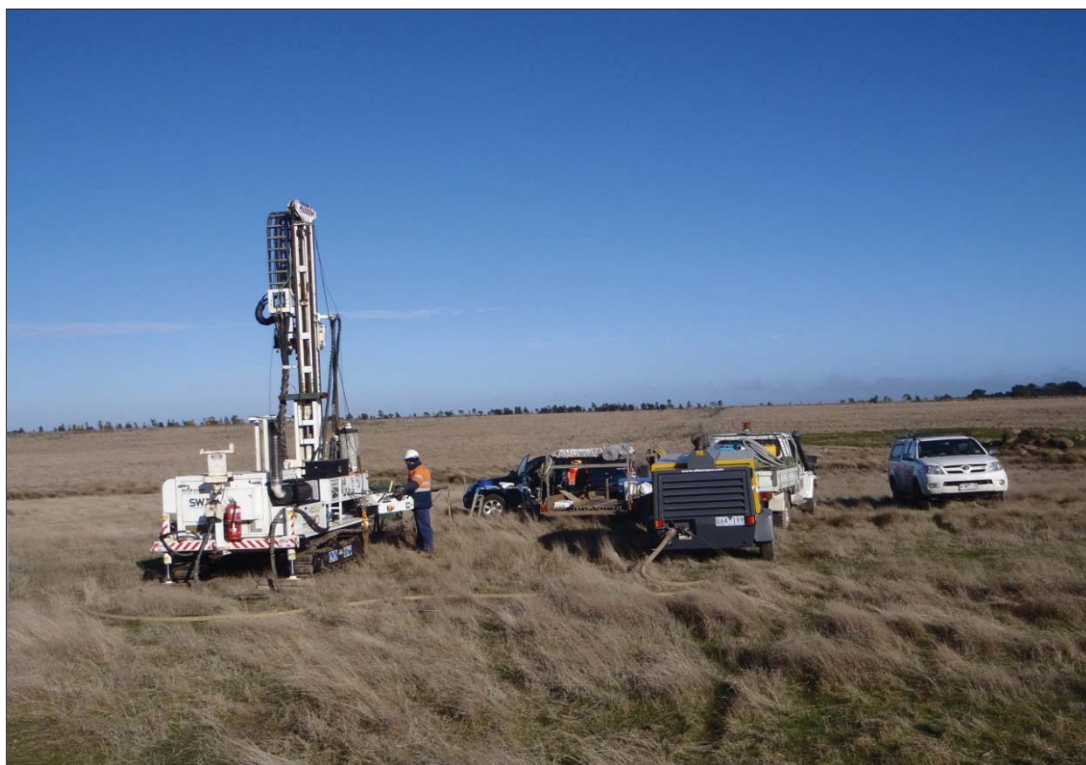
Figure 4-1: Drilling of Groundwater Bore GW102

Prior to the commencement of drilling, Cardno Lane Piper obtained (from Southern Rural Water) a Bore Construction Licence (BCL) on behalf of the CFA, for the installation of groundwater monitoring bores at the site. The BCL is included in Appendix C. The drilling contractor, South Western Drilling Pty Ltd, provided two water bore drillers who are licensed for this work under the *Water Act* 1989. A photograph taken at the location of bore GW102, showing the type of drilling equipment, is presented as Figure 4-1.

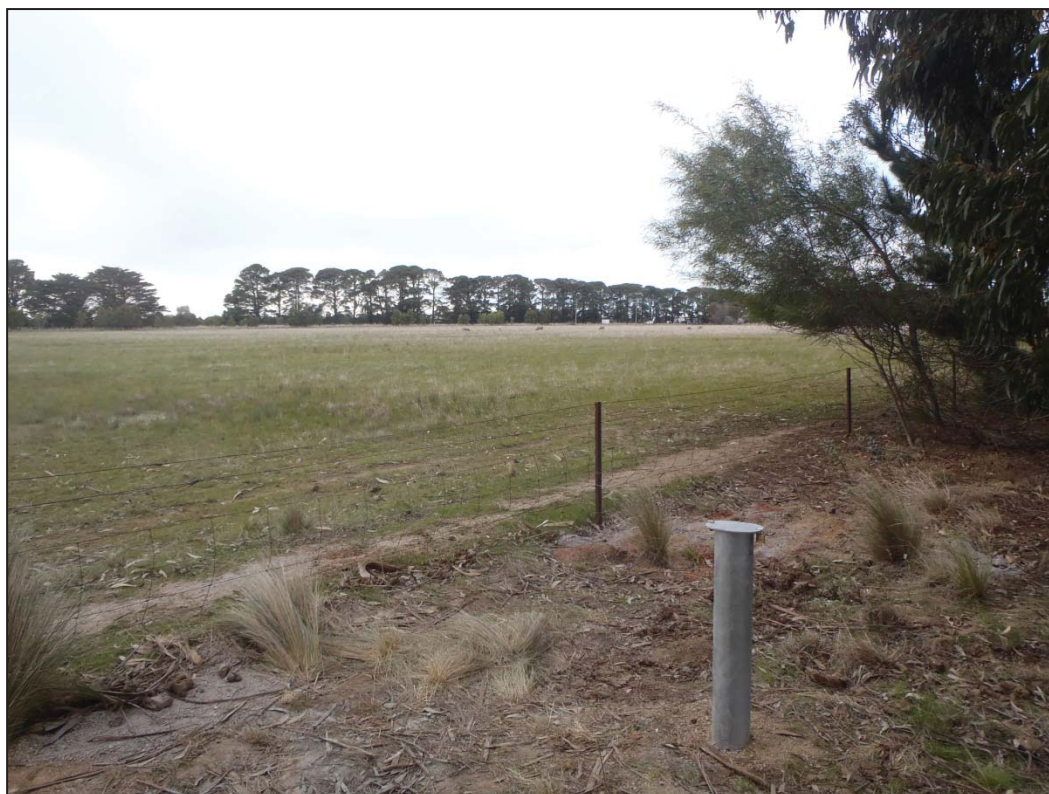
Figure 4-2: Protective Cover on Bore GW104

Bores in the 'regional' areas were fitted with a pad-locked protective cover (metal standpipe/monument cover) to preserve the bores for future monitoring. Figure 4-2 shows an example of this completion method at bore GW104, installed as a background bore in the Newer Volcanics Aquifer in the south-eastern part of the site.

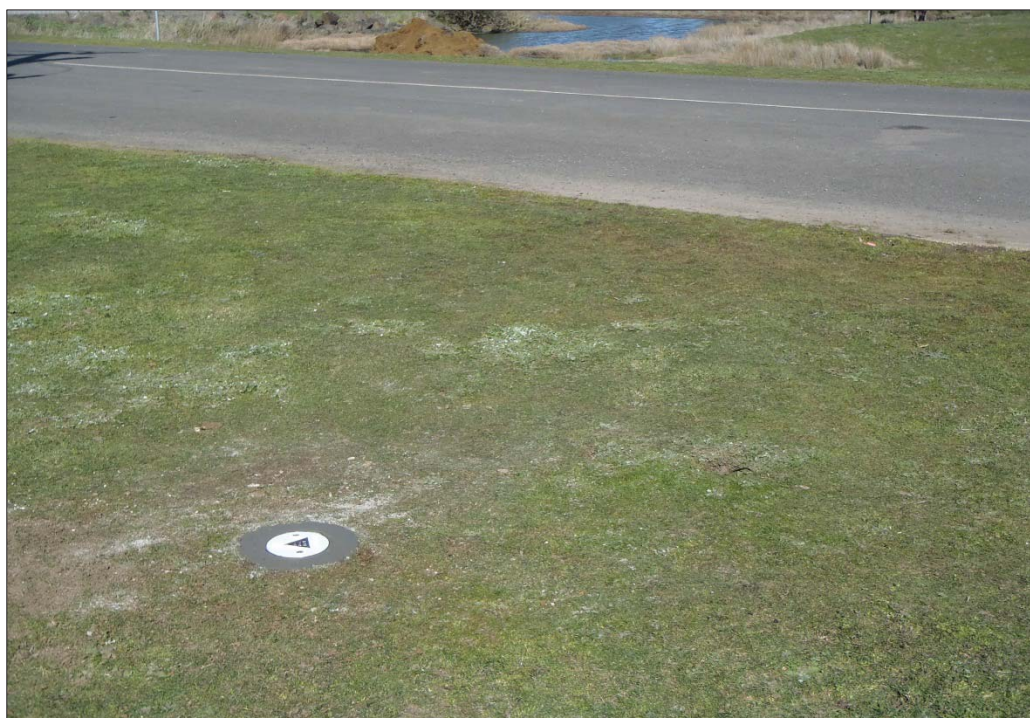
Figure 4-3: Protective Cover on Bore GW107

Bores in the Operational Areas were installed with a flush-mounted road box. Figure 4-3 shows an example of this completion method at bore GW107, installed in fill near the service station prop area.
