Privileged & Confidential
Buried Drums Assessment
Fiskville Training College,
4549 Geelong-Ballan Road, Fiskville, Victoria
Ref: 212163.3
Prepared for Ashurst
March 2014

BURIED DRUMS ASSESSMENT

CFA Fiskville Training College, 4549 Geelong-Ballan Road, Fiskville, Victoria

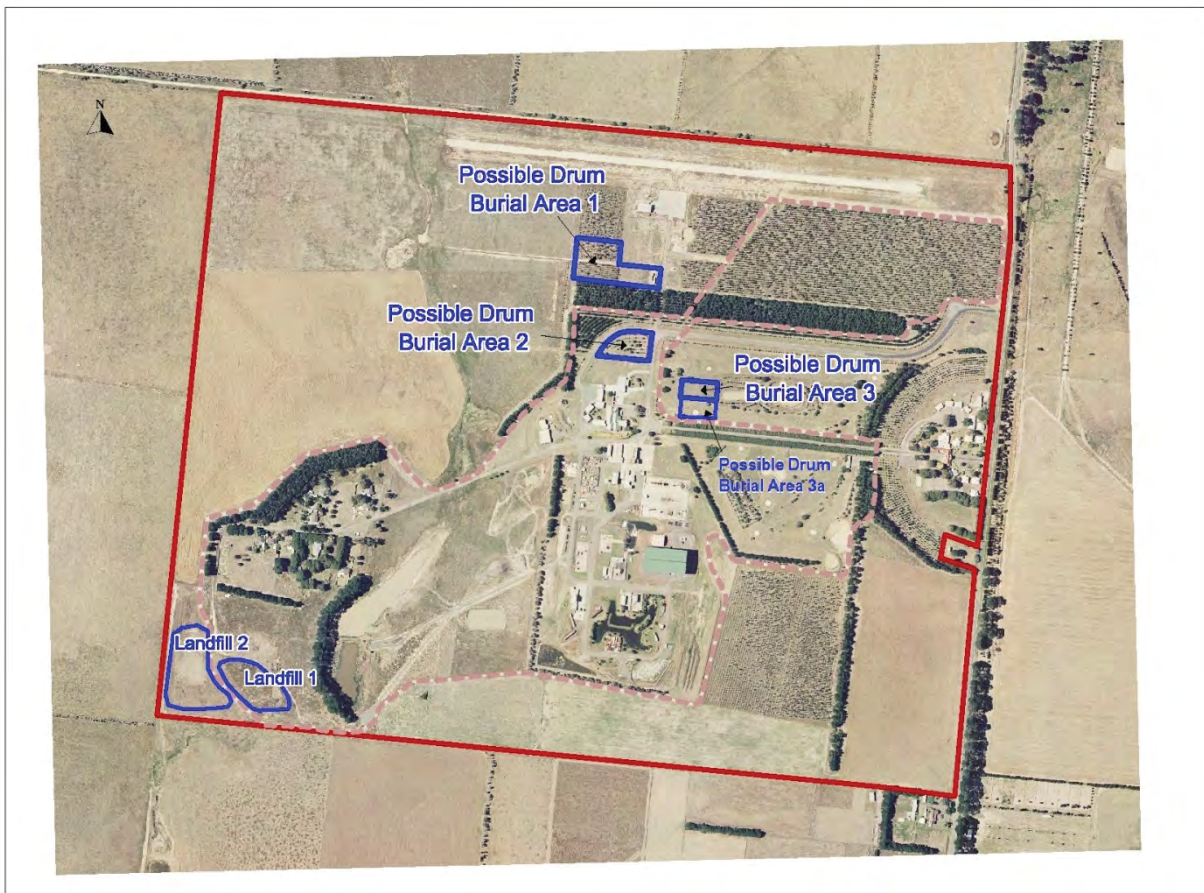
Figure 3-1: DBA and Landfill Locations

- **DBA 3a (Feature 48a):** This is located immediately south of DBA3 and was identified by a geotechnician employed on the AS James investigation in 1988 who approached CFA with anecdotal information on a burial area following the publication of the IFI Report.
- **DBA 1 south Feature 46b:** This area is immediately to the south of Deep Creek Road, within DBA1 and was interpreted on the basis of a site plan in a report by Minenco as showing a potential trench line when compared with contemporary aerial photographs.

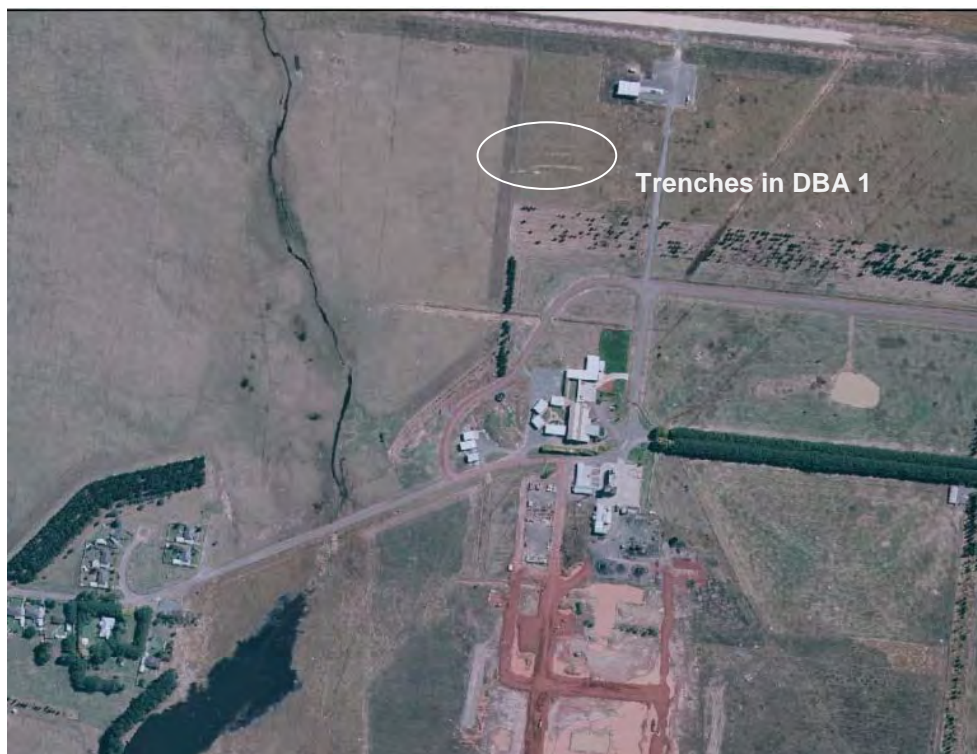
Figure 3-3: 1990 Aerial Photograph Showing Trenches in DBA 1

The information about the burial and extraction of drums at the site that is described in the IFI Report and the environmental investigation reports provided to Cardno Lane Piper is presented in Table 3-1. A summary and interpretation of the information is presented as follows:

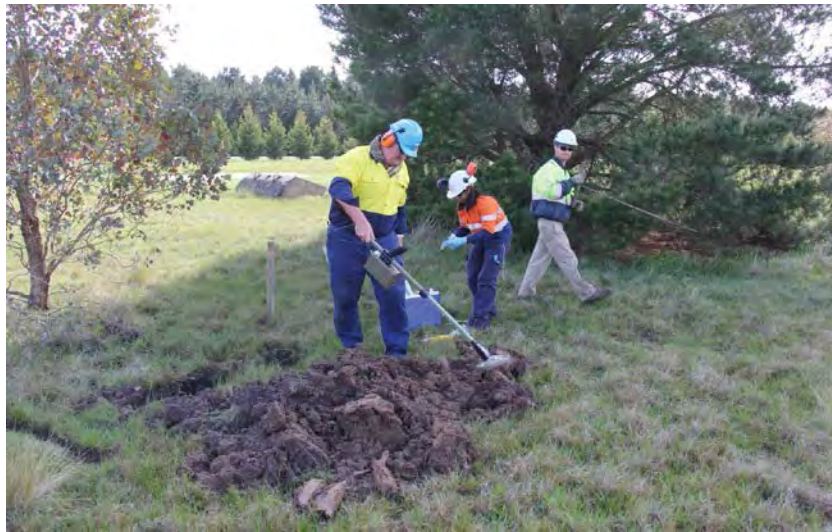
Figure 4-2: Metal Detector Scanning EM Anomaly during Intrusive Investigations

The identification of an EM anomaly does not confirm that buried drums are present. EM anomalies can indicate changes in ground conditions of electromagnetic fields such as that caused by the presence of buried metal objects such as drums. Contrasts in soil and soil moisture can also cause EM anomalies. As a result, test pitting was conducted to confirm the presence or absence of drums at EM anomalies.

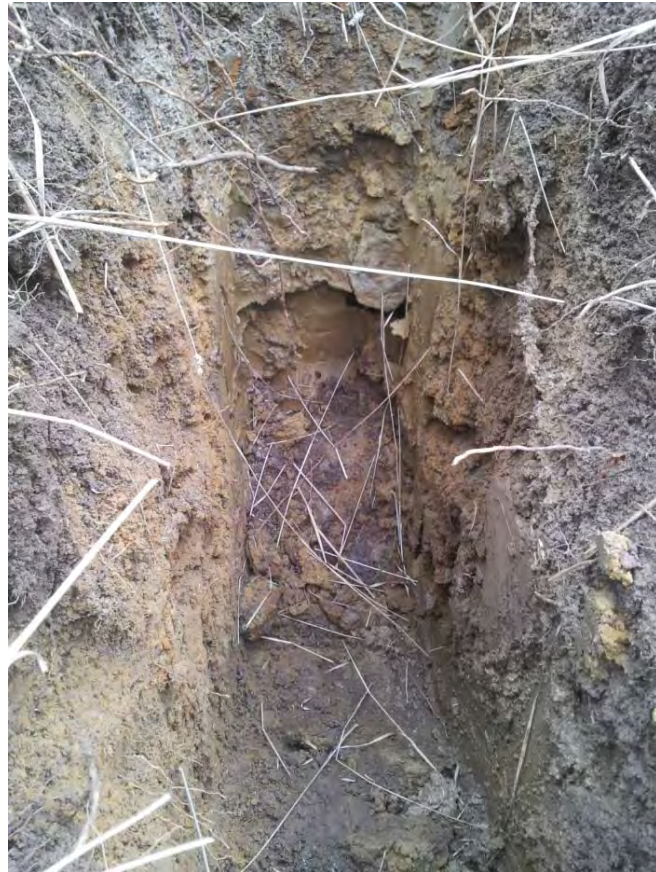
PLATE 1 Area 1 Testpit 1

Location ID	Investigation Depth (m)	Depth of Fill (m)	Observation
TP-A1-1	1.8	0.5	No drum or other metal object was observed
BH-A1-2	0.6	>0.6	No drum or other metal object was observed
TP-A1-3	0.85	>0.85	No drum or other metal object was observed
TP-A1-4	1.7	0.4	No drum or other metal object was observed
TP-A1-5	1.6	0.4	No drum or other metal object was observed
TP-A1-6	1.5	0.2	No drum or other metal object was observed.
TP-A1-7	-	-	This area was not investigated as an underground service is present (and as such, the probability of a drum being present is low).
TP-A1-8	0.9	0.3	No drum or other metal object was observed or identified by the metal detector.

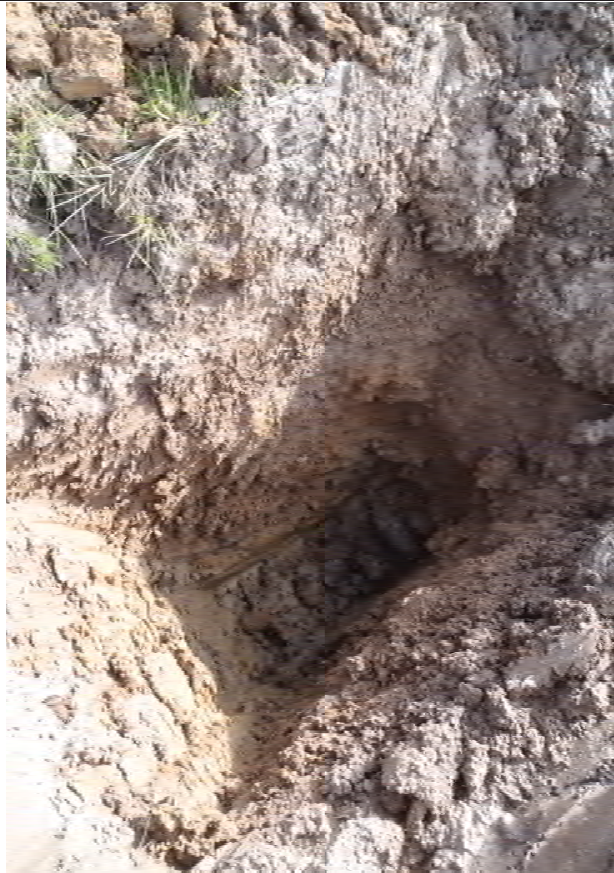
PLATE 6 Area 1 Testpit 8

Location ID	Investigation Depth (m)	Depth of Fill (m)	Observation
TP-A1-9	-	-	This area was not investigated as an underground service is present (and as such, the probability of a drum being present is low).
TP-A1-10	-	-	This area was not investigated as an underground service is present (and as such, the probability of a drum being present is low).
TP-A1-11	0.15	>0.15	No drum or other metal object was observed
TP-A1-12	-	-	This area was not investigated as an underground service is present (and as such, the probability of a drum being present is low).
TP-A1-13	0.15	>0.15	No drum or other metal object was observed
TP-A1-14	0.15	>0.15	No drum or other metal object was observed
TP-A1-15	0.15	>0.15	No drum or other metal object was observed
TP-A1-16	0.15	>0.15	No drum or other metal object was observed
TP-A1-17	0.6	0.4	No drum or other metal object was observed
TP-A1-18	0.5	>0.15	No drum or other metal object was observed

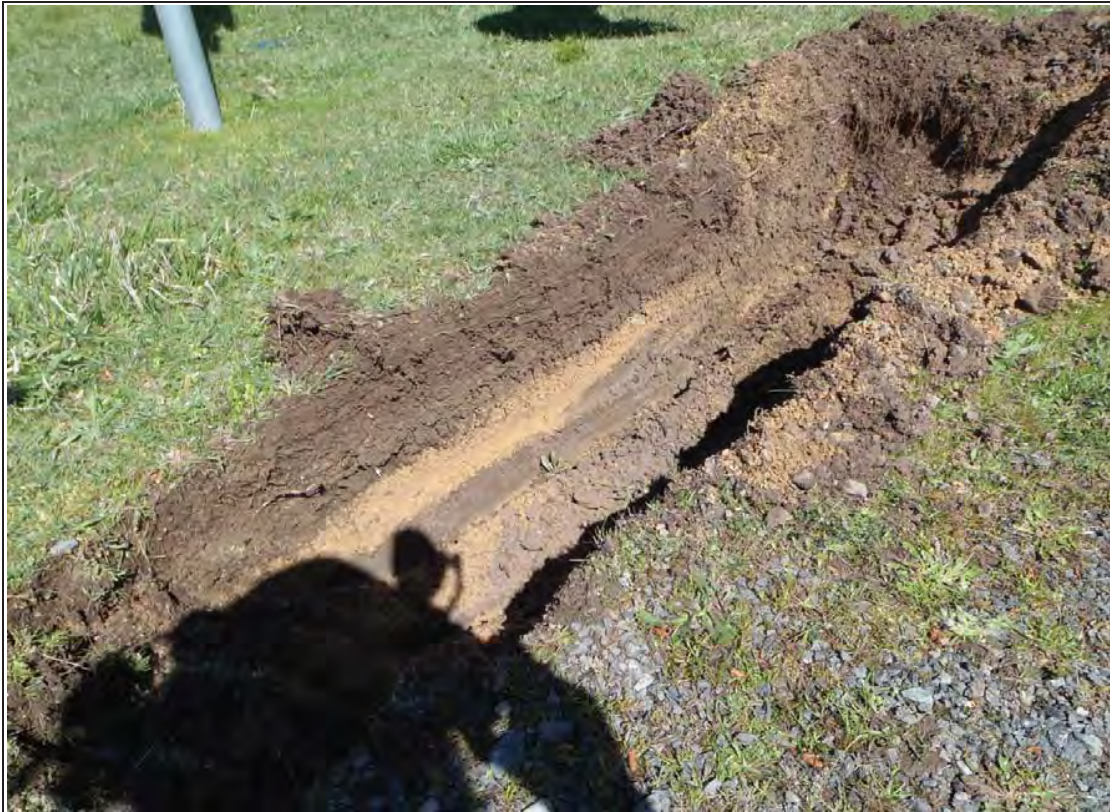
PLATE 9 Area 1 Testpit 20

TP-A1-19	0.15	>0.15	No drum or other metal object was observed
TP-A1-20	0.4	>0.15	No drum or other metal object was observed
TP-A1-21	0.15	>0.15	No drum or other metal object was observed
TP-A1-22	1.1	0.2	No drum or other metal object was observed
TP-A1-23	0.3	>0.15	No drum or other metal object was observed
TP-A1-24	1.4	0.6	No drum was encountered. One metal object (steel strapping observed).
TP-A1-25	1.3	0.6	No drum or other metal object was observed
TP-A1-26	1.7	>1.7	No drum or other metal object was observed
TP-A1-27	1.7	>1.7	No drum or other metal object was observed
TP-A1-28	1.0	0.2	No drum or other metal object was observed
TP-A1-29	0.6	0.4	No drum or other metal object was observed
TP-A1-30	0.95	0.95	No drum or other metal object was observed
TP-A1-31	0.6	0.3	No drum or other metal object was observed
TP-A1-32	0.7	0.4	No drum or other metal object was observed
TP-A1-33	0.6	0.3	No drum or other metal object was observed
