COUNTRY FIRE AUTHORITY FISKVILLE TRAINING COLLEGE WATER REUSE INVESTIGATION REPORT

February 2012

Client: Country Fire Authority
Project Title: Fiskville Training College
Report Title: Water Reuse Investigation Report
Document No: 212927-2012-001
Document Status: Final
Date of Issue: February 2012
Comments:

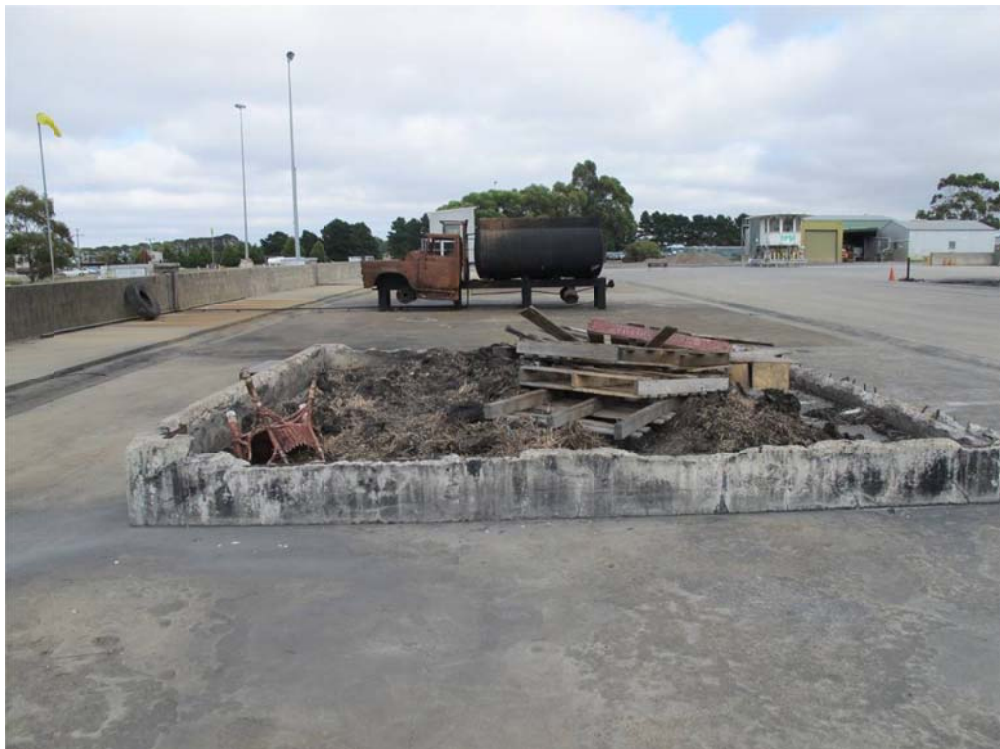
Figure 4-1 Raw materials

The Fiskville site uses gas, unleaded petrol or diesel to activate and/or fuel their fires. The CFA runs a variety of training exercises which include the burning of old cars, wood, hay, straw, plastic, wooden pallets (see Figure 4-1).

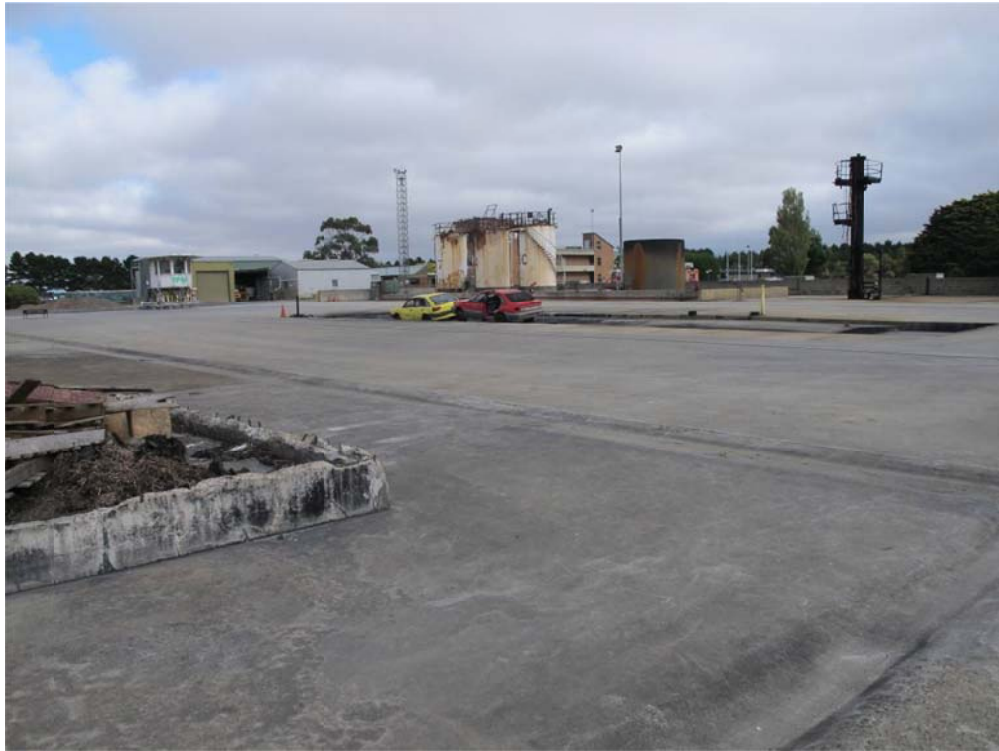
Figure 4-2 Main fire training area

The site has several areas where gas, unleaded petrol and petrol are stored with no bunding. Runoff from these sites will either be adsorbed into the ground or flow into neighbouring paddocks. Figure 4-2 displays the main fire training area which captures the majority of the water used via the slope of the large slab and a series of drains.

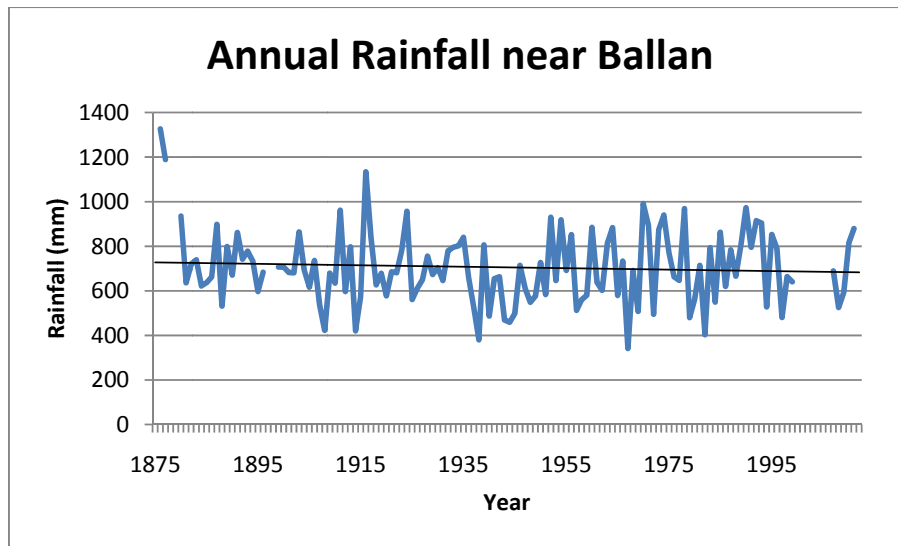
Figure 4-3 Rainfall data

Rainfall data for the area was acquired from the Bureau of Meteorology (BOM) website. As shown below (see Figure 4-3), the rainfall trend appears to be decreasing with time.

The small downward trend with respect to rainfall would have minimal impact on the site assessment.

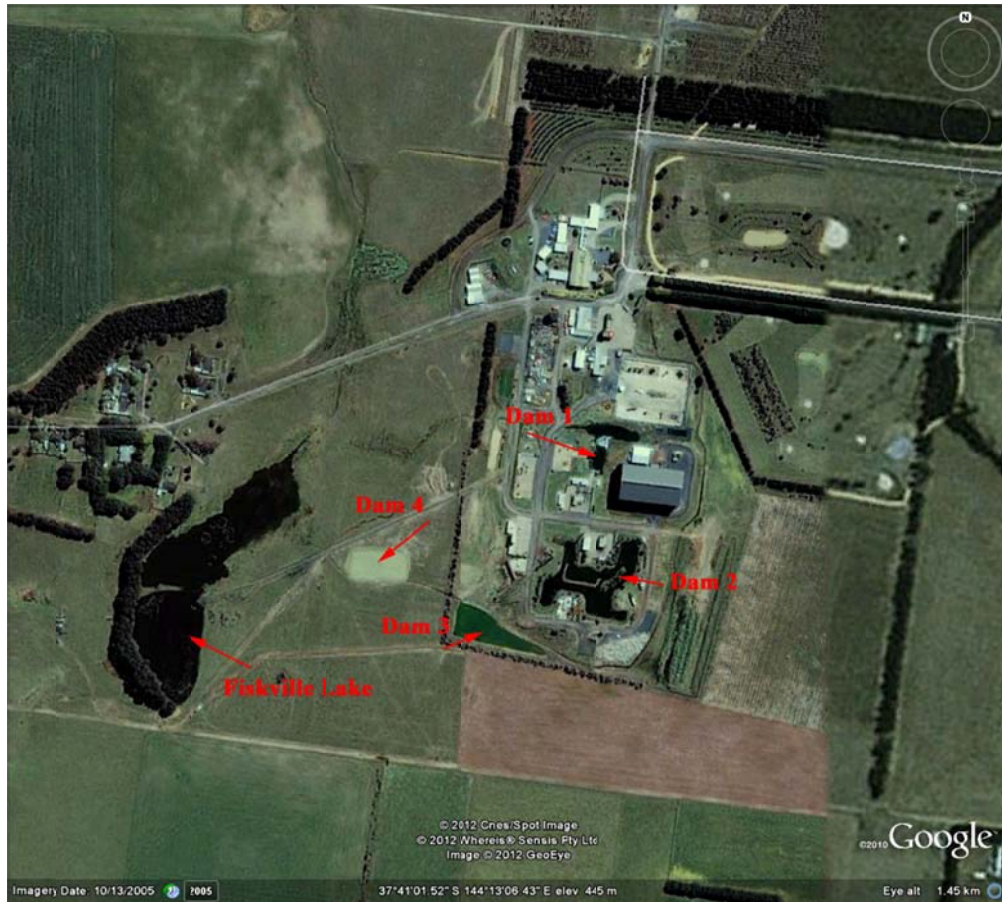
Figure 4-4 Fiskville dams and lake layout

Fiskville CFA utilise five ponds for the supply and backup for provision of water for training purposes. Figure 4-4 displays the positioning of each dam at the CFA site in Fiskville.

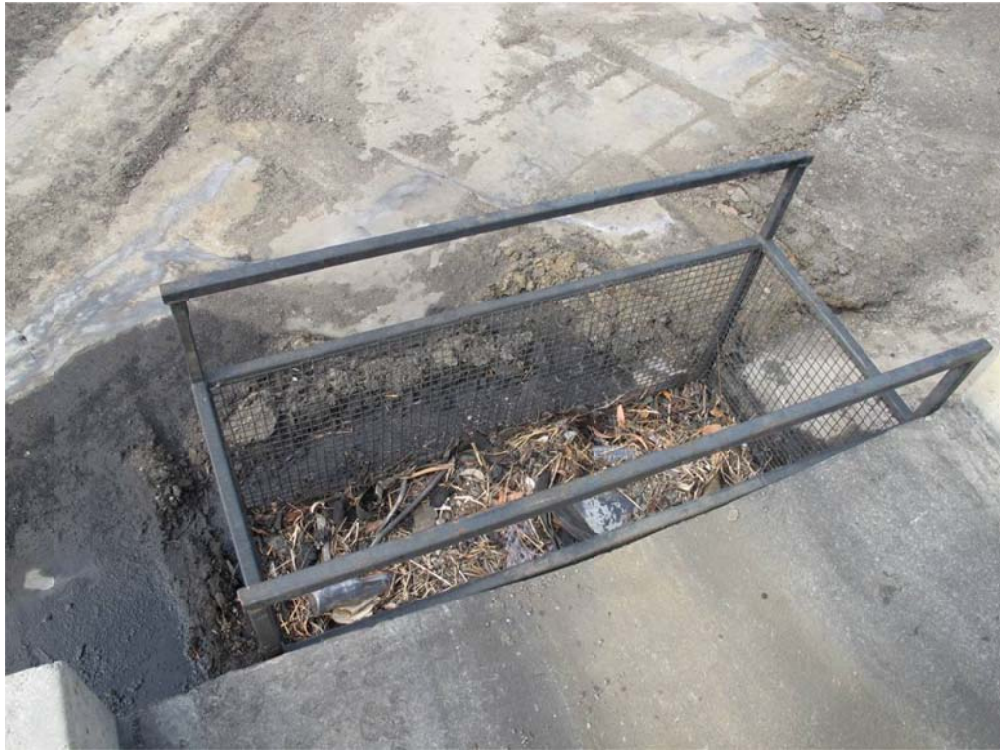
Figure 4-5 Coarse filter basket

The immediate runoff from the training site passes through a coarse filter basket (Figure 4-5).

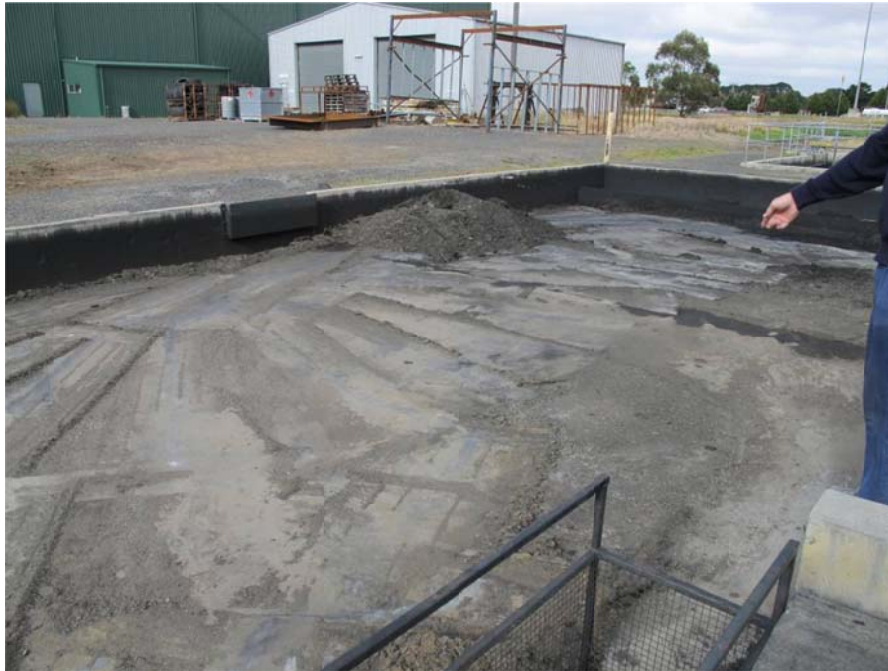
Figure 4-6 Dried and piled settled waste

Once filtered, the water flows into a large holding basin (Figure 4-6) which settles the solids and allows the supernatant to flow into another separation cell (Figure 4-7). The settling, separation and mixing design is based on triple interceptor concept.

During times where the training area is not used, the solids produced in the settling tank is dried and shovelled into piles, removed and stockpiled for future attention. The oil fraction from the grease separator is also removed with the solid waste. Appropriate disposal of this waste may need to be considered.

1. Functionality of the triple interceptor.
2. Management of the solids from the initial settling chamber.
3. Dam sizes and linkages.
4. Establishing wetland for treatment.
5. Investigate need for large storage tanks.
6. Investigate rainwater capture options.
7. Establish reliable disinfection options.

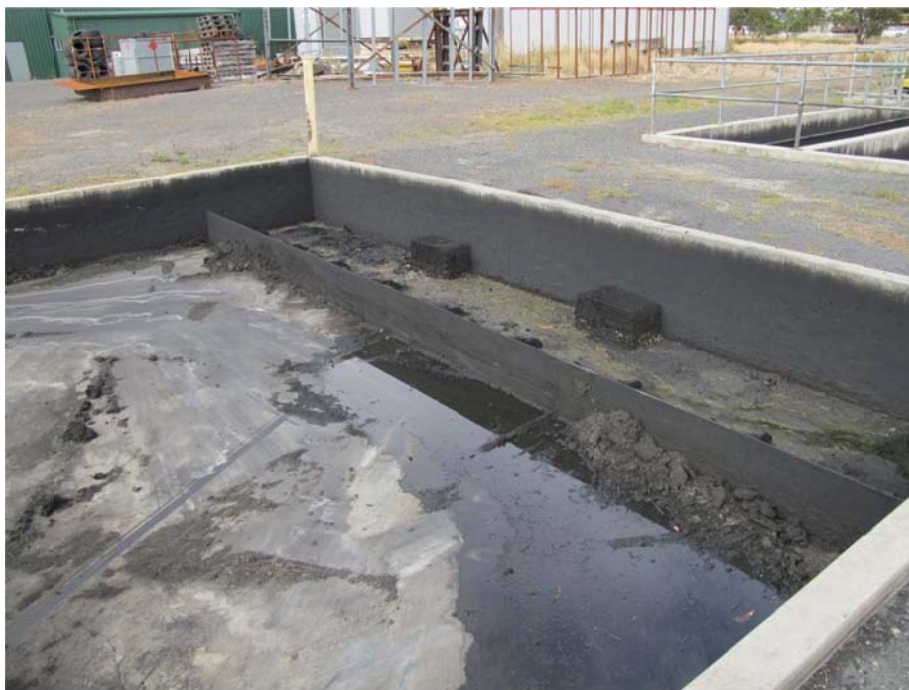
Figure 4-7 Grease interceptor cell

CFA noted that large flows into the system reduced the effectiveness of the triple interceptor to adequately treat the wastewater.

The reuse water requires further treatment before use. The whole treatment system will need to be improved to ensure that continuous good quality reuse water is supplied. The triple interceptor functionality needs to be accessed and upgraded. The residual contaminated sediment needs to be removed from Dam 1 to ensure the incoming water is not contaminated from the pollutants in the sediment. The dam system may need to be improved to ensure the required contaminant reduction is carried out. The pump shed may need to be moved to either Dam 3 or 4 and a wetlands may need to be establish to ensure a reduction in BOD, suspended solids, turbidity and organics will occur.

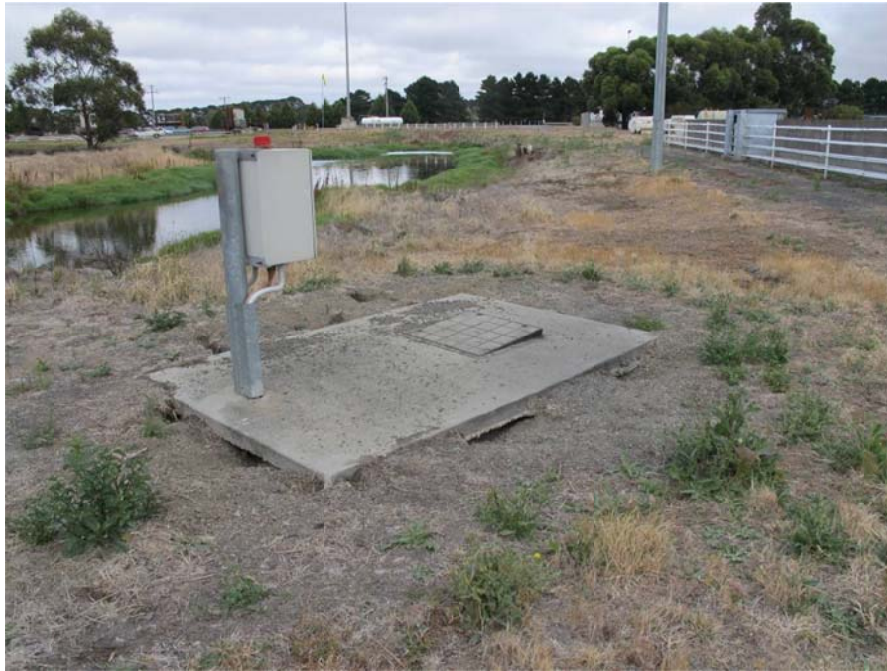
Figure 4-8 Dam 1 and pump station

The final effluent from the triple interceptor system enters Dam 1 (Figure 4-8) via a pump system. At the time of the visit an aerator was operating in Dam 1.

The results for the other dams and Fiskville Lake are reported in Appendix 1. Dam 1, which collects the treated water from the triple interceptor, had one outlier in regards to organics concentration. The ANZECC Guidelines specify for recreational waters for organics⁵ a limit of 200 µg/L. The sum of individual petroleum hydrocarbons (TPH) for Dam 1 was found to be 1,600 µg/L.

Sediment samples were collected from the entry point and exit point of Dam 1. As the sludge was a by-product of the runoff from the training site, it was considered an Industrial Waste. Based on the EPA Victoria's Industrial Waste Resources Guidelines, the waste was classified as Category A.

Removal of sludge from Dam 1 to a secure site on the property is recommended. Dewatering Dam 1 and removing the sediment by mechanical means or via a suction pump may need to be considered. The removal of the sediment from Dam 1 would ensure that the water entering Dam 1 is not contaminated by the sediment present. Once the sediment has been removed, some remediation is required. Treatment processes such as bioremediation, dilution using non contaminated fill and/or immobilisation are some of the options available for remediation.

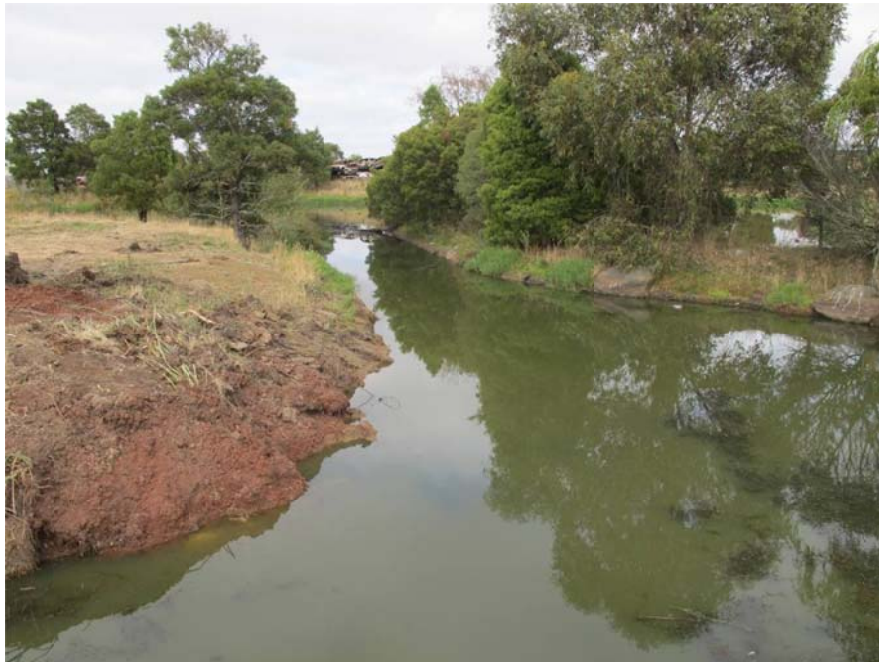
Figure 4-9 Dam 2 near pump station

The overflow from Dam 1 gravity feeds into Dam 2 which consists of a series of bends and an island. The water is extracted from Dam 2 (Figure 4-9) and pumped into the holding cell for fire fighting activities.

This report is based on one sampling event and may not be representative of the actual water quality of the reuse water. The water analysed from Dam 2, which is used for training purposes was found to be outside the Reuse Guidelines for several parameters and the organics were outside the ANZECC Guidelines of 200 ug/L (Table 1-1).

Large holding tanks, sufficiently sized for the required daily training program may need to be considered to ensure the Dam 2 water can be adequately disinfected for reuse purposes.

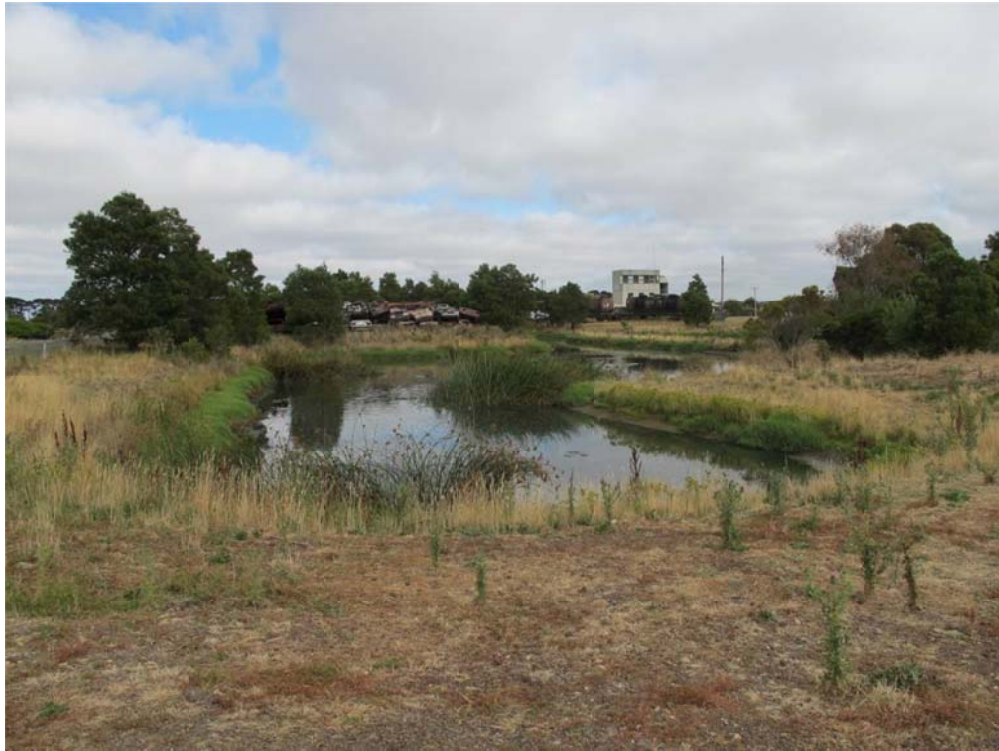
Figure 4-10 Dam 3 entry point

The overflow from Dam 2 enters a small drain which runs into Dam 3 (see Figure 4-10).
