Site History Review
Fiskville Training College,
4549 Geelong-Ballan Rd, Fiskville, VIC

Ref no: 212163.1

Prepared for Ashurst

March 2014

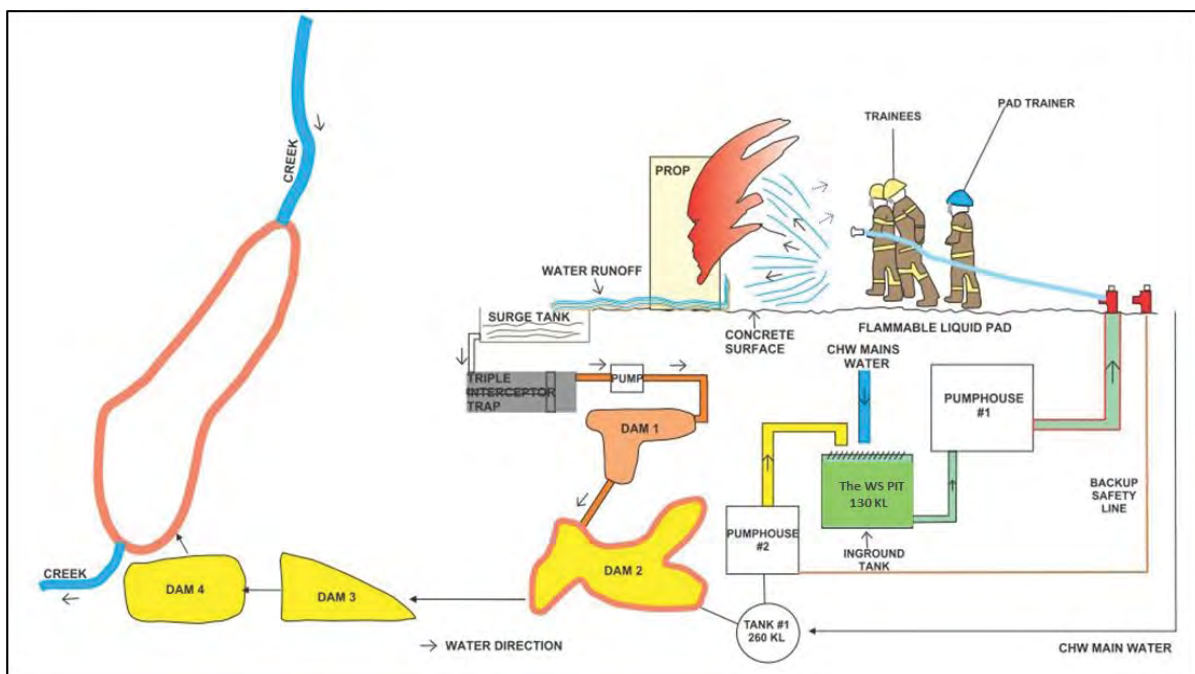
Figure 2-3: Schematic figure showing the dams and drainage system at FTC

- Airstrip (Feature 14) and associated hangar (Feature 13). CFA has advised that the hangar is not used for fuel or chemical storage.
- Drainage channels and pipes for PAD effluent located between Dams 1 to 4, including a crushed concrete pipe between Dams 1 and 2 which is likely to be leaking.

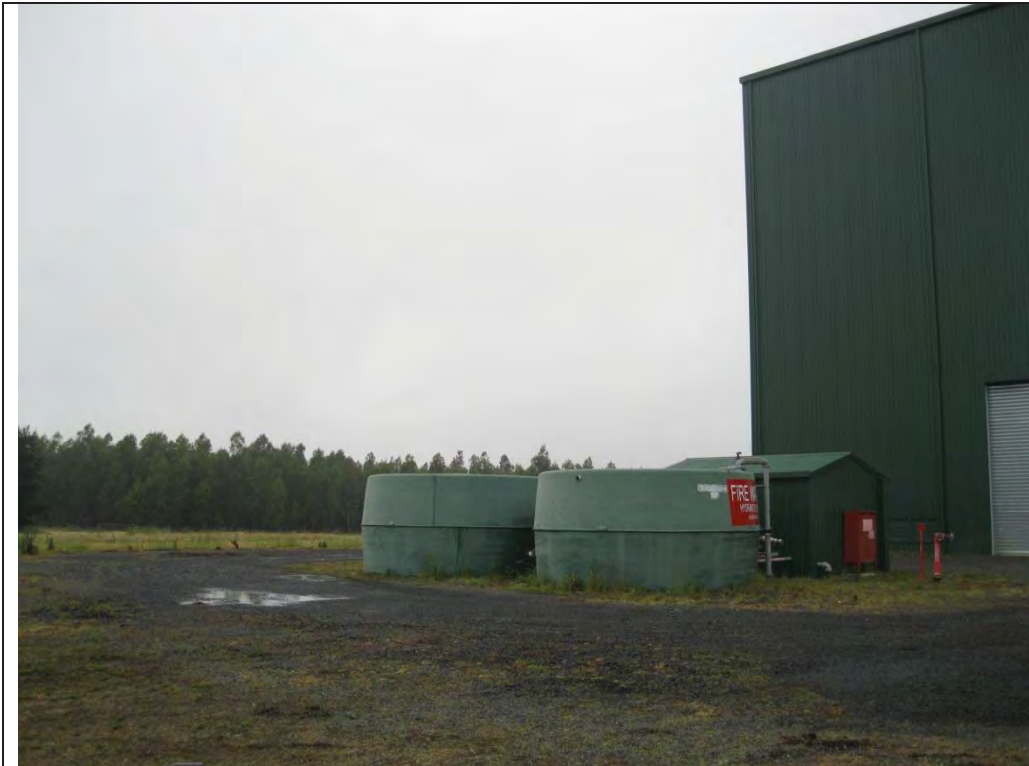
PLATE 5 Rain Water Tanks

Water Source and Storage	Water supply to the buildings is from the two rain water tanks situated on the western side of the building (See Plate 5, in Appendix B). The volume of these tanks is 25,000 L each.
