MFB Submission:

Senate Economics Reference Committee Inquiry into Non-Conforming Building Products

Post Incident Analysis Report

**Lacrosse Docklands
673-675 La Trobe Street, Docklands
25 November 2014**

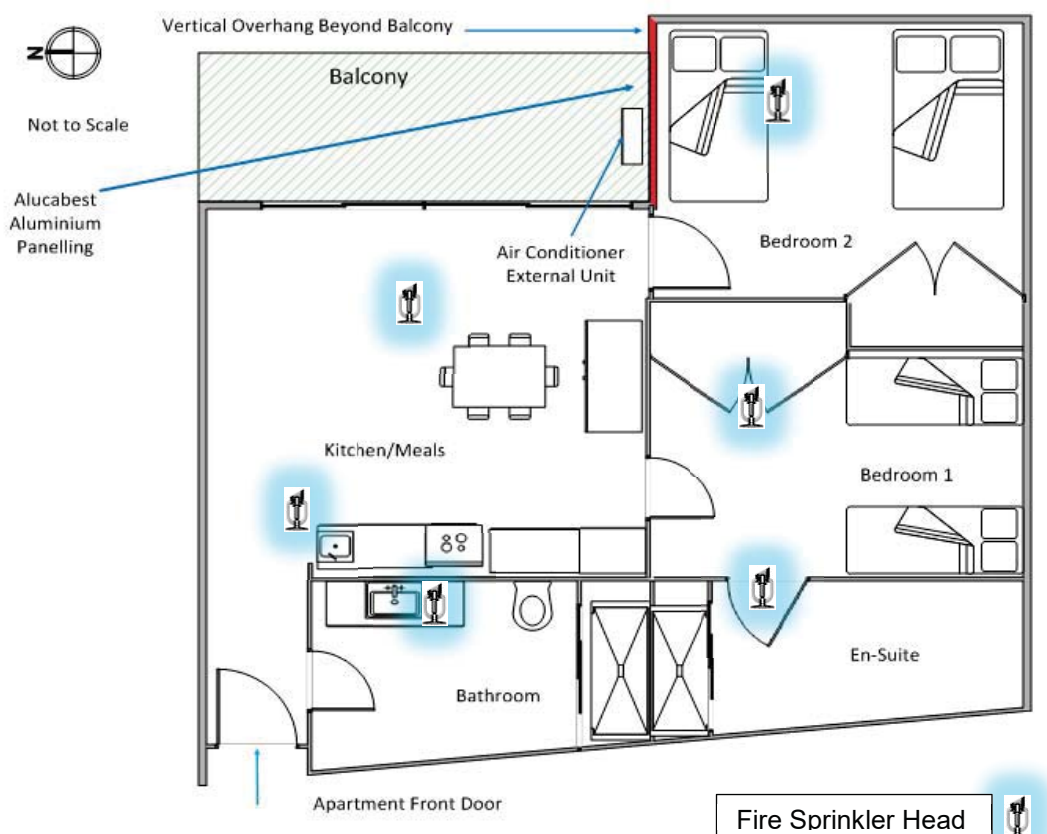
Figure 1 – General floor layout of apartment 805

At approximately 01:30 hours on the morning of Tuesday 25 November 2014, an occupant from Apartment 805 of the building, claims he investigated the smell of smoke. After checking the kitchen and making sure the gas stove was turned off, he returned to bed. Sometime later, the same occupant was woken by two other house mates who had discovered the fire burning on the balcony.

From inside the apartment, he could see a fire on the right hand side (south) of the balcony. The occupants of the apartment unsuccessfully attempted to extinguish the fire using a container of water.

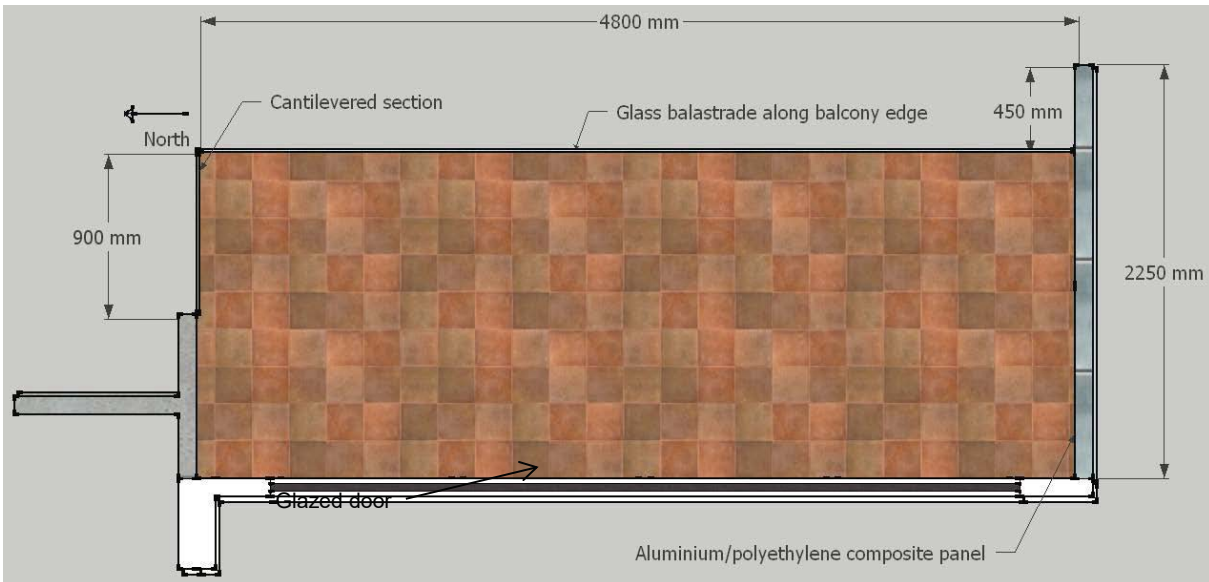
Figure 7 - Balcony Plan view

The apartments known as Apartments 605 to 2105 are located in vertical alignment from the 6th floor to the 21st floor on the east façade of the building. They include suspended concrete balconies of approximately 1.8 metres deep x 4.7 metres wide. A double-glazed sliding door assembly is fitted in the external wall of the building and provides access to the balcony.

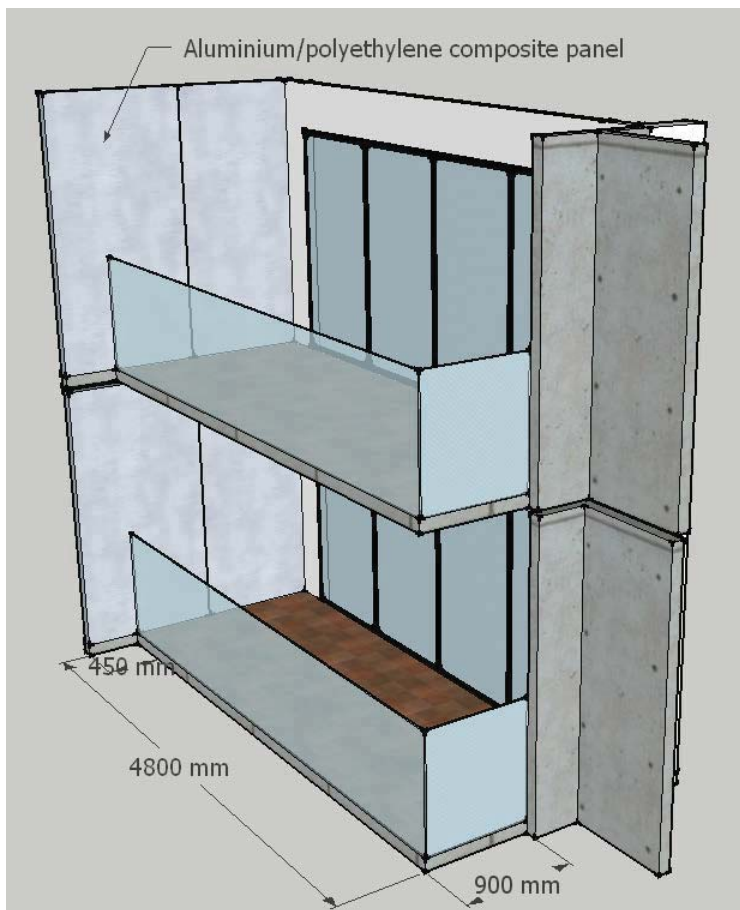
Figure 8 - Simplistic 3D interpretation of the balcony layout

The northern end of these balconies are bounded by 900mm concrete panels, which leaves the remaining 900mm balcony depth cantilevering out beyond the building face. A 1 metre high glazed balustrade is fitted to the remaining northern edge of the balconies and returns along the length of the eastern edge and butts into the southern wall.

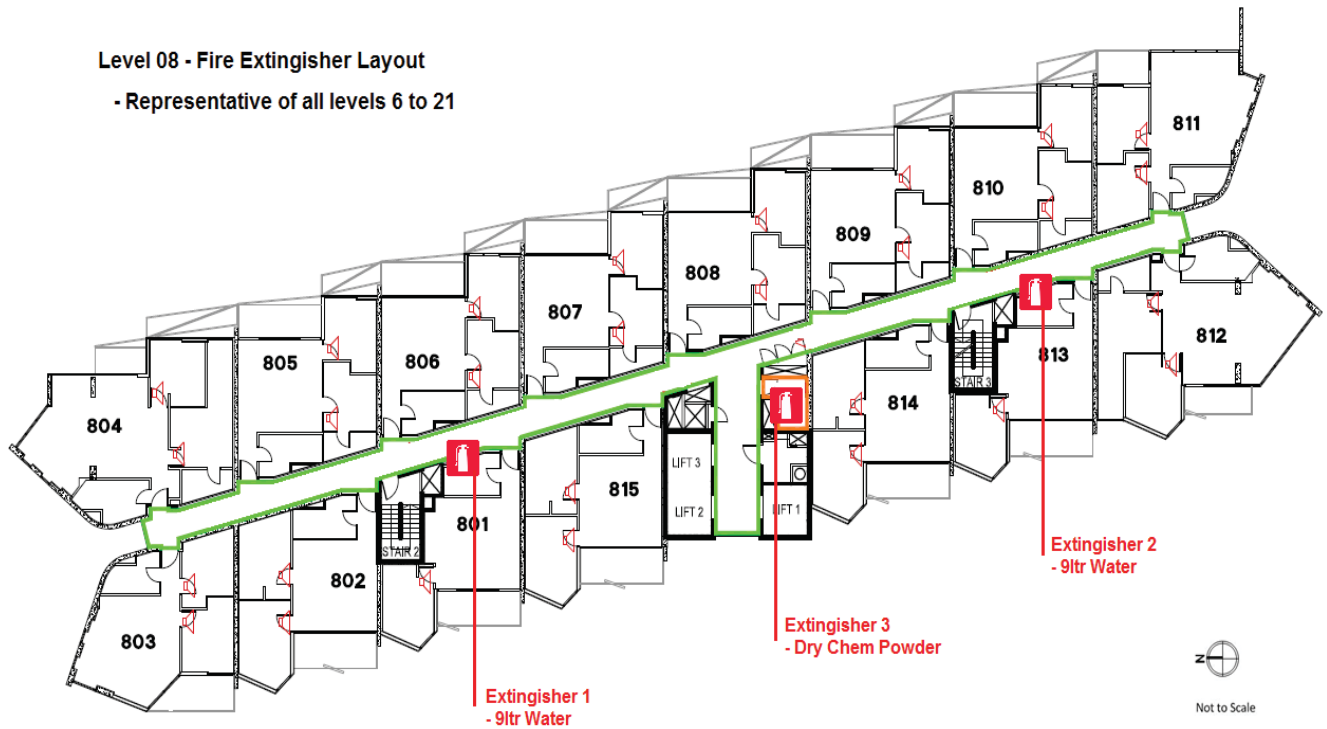
Figure 12 - Fire extinguisher layout

In this instance, a number of the purposely designed extinguisher enclosure housing Extinguishers 1 and 2 shown in [Figure 12 \(refer previous page\)](#), were being used by occupants as storage areas thus blocking access to the extinguishers.

It was noted during investigations that extinguisher three (as shown in [Figure 12](#)) on all residential levels was locked within a service room where they were inaccessible to occupants and fire-fighters.

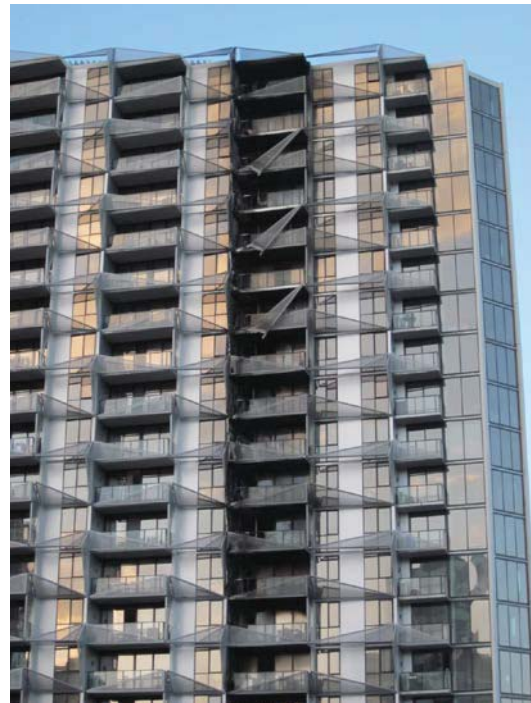
Photo Post Fire

Fire damage was essentially restricted to the façade and external balcony area adjacent to Apartment 605 and Apartments 805 to 2105. Please refer to the [Fire Cause and Origin section](#) of this report for further information on fire damage.

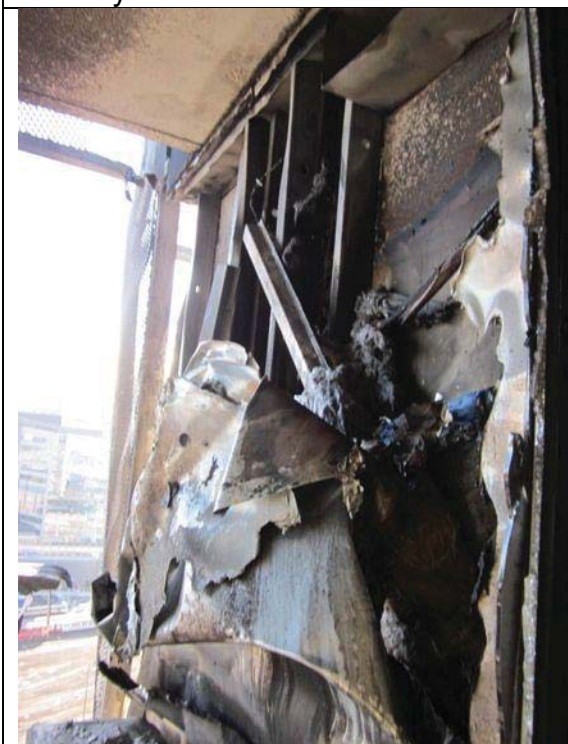
External wall at upper height

Wall between bedroom and balcony. Construction lightweight wall with steel studs, aluminium type external cladding plasterboard to internal. Material stored on balcony.

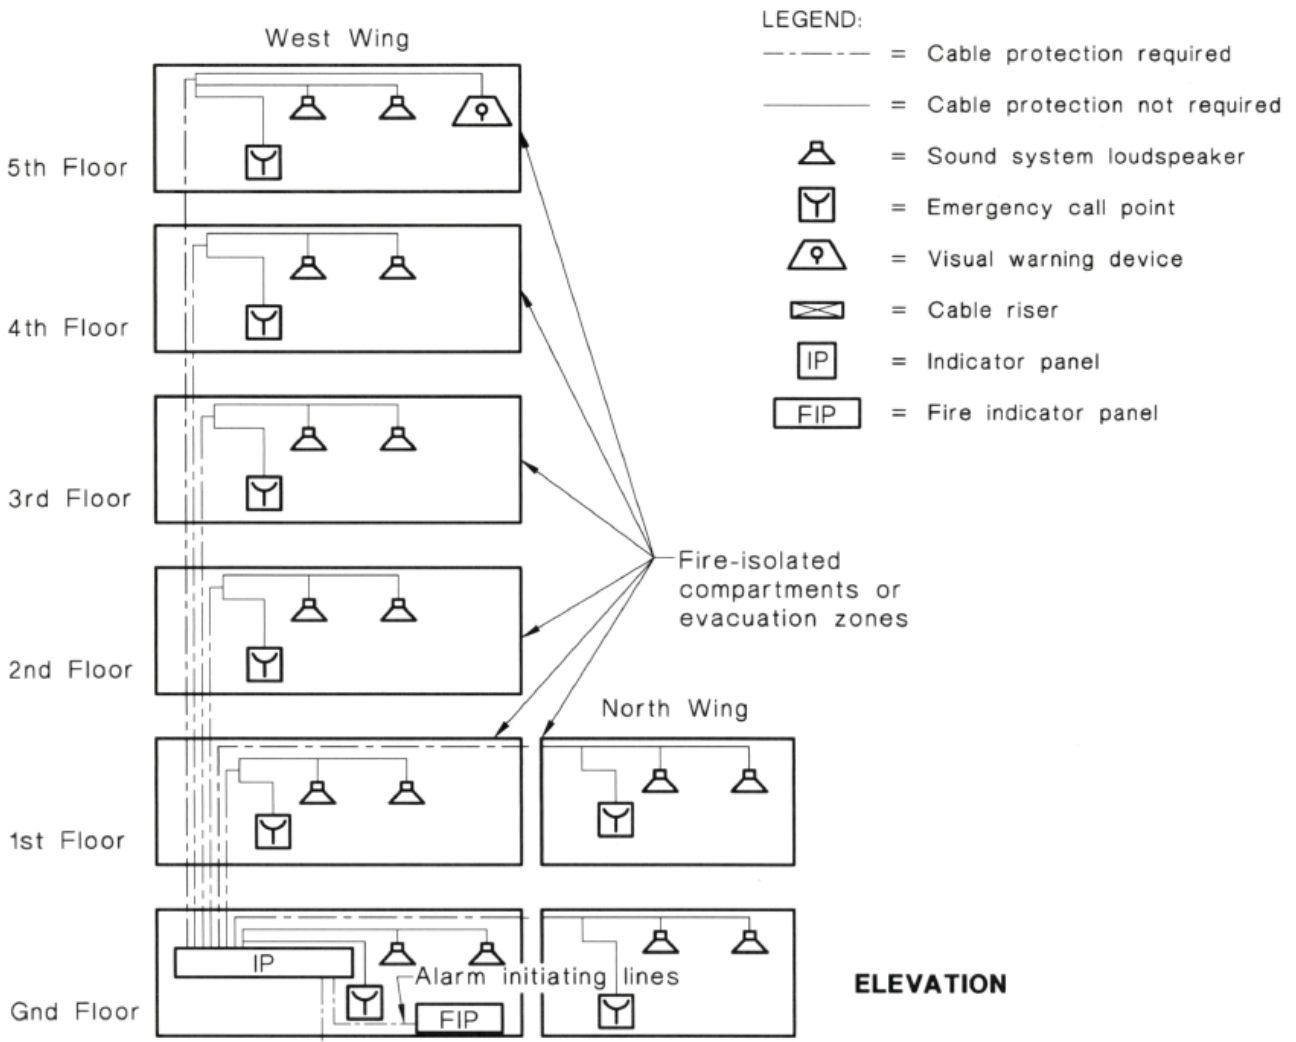
Figure 17 - Wiring diagram for EWIS

The EWIS system is designed and installed as per Australian Standard AS1670.4. This Standard requires all wiring between the EWIS’s main panel and the evacuation zone to be fire rated. The zone wiring itself is not required to be fire rated, instead non-fire rated thermal plastic sheath (TPS) wire is used. Refer to [Appendix 6 figure 17](#).

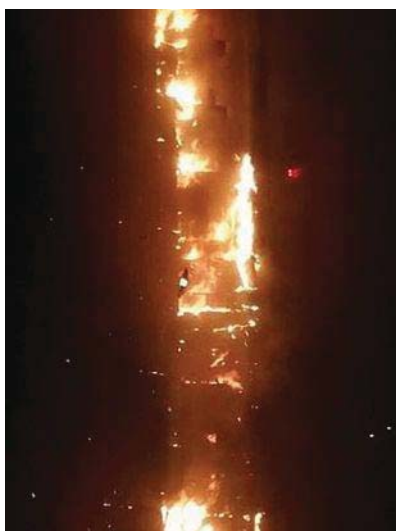
Torch Tower Dubai 21 February 2015

- 79 Storey residential;
- Reported as same façade material as the other Dubai fires shown - Aluminium/polyethylene composite panel facade;
- Fire Origin 52nd floor
- Rapid vertical spread up the façade of the building and significant flaming falling debris

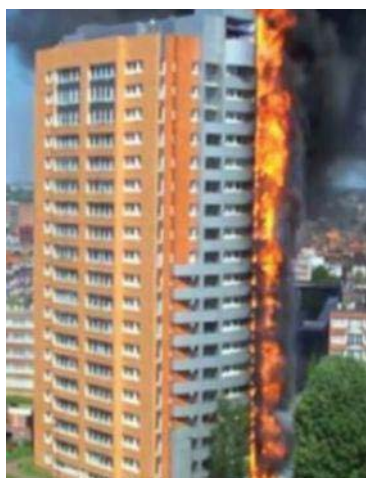
Mermoz Tower, Roubaix, France, 2012

- 18 storey residential building;
- Aluminium/polyethylene composite panel facade;
- Fire origin – 2nd storey balcony;
- Fire description - “rapid vertical flame spread to the top of the building within a few minutes”.

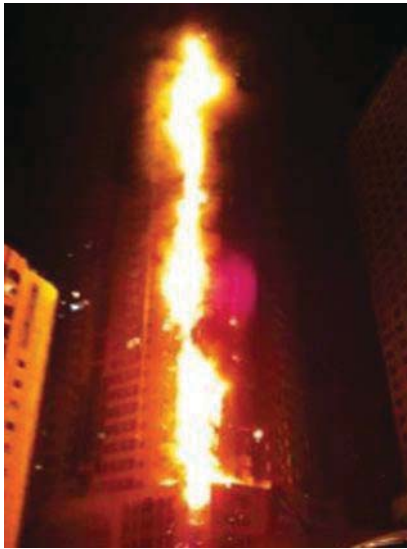
Al Tayer Tower, Sharjah, 2012

- *40 storey residential building containing 6 carpark levels;*
- *Aluminium/polyethylene composite panel façade;*
- *Fire origin – 1st storey balcony;*
- *Fire cause – “discarded cigarette landing on the balcony which contained cardboard boxes and plastics”;*
- *Fire description – “vertical fire spread on the metal composite cladding to the top of the building”;*

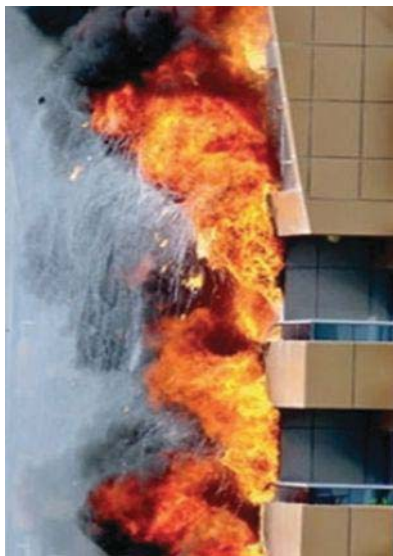
Saif Belhasa Building, Tecom, Dubai 2012

- *13 storey residential building;*
- *Aluminium/polyethylene composite panel façade;*
- *Fire origin – 4th floor;*
- *Fire description – “fire rapidly spread to reach the top of the building”*

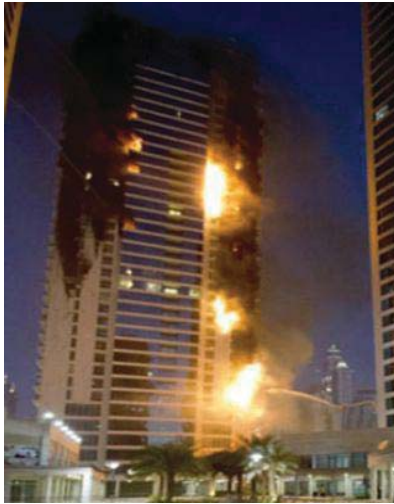
Tamweel Tower, Dubai, 2012

- 34 storey residential building (contains mixed use)
- Aluminium/polyethylene composite panel façade;
- Fire origin – roof level
- Fire description - “spread down the exterior of the building.”

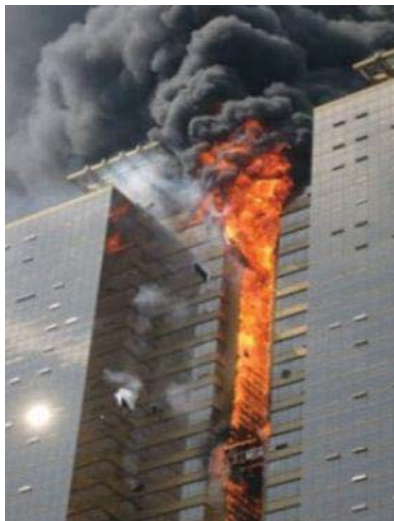
Wooshin Golden Suites, Busan South Korea

- 42 storey residential building (contains mixed use);
- Aluminium/polyethylene composite panel façade;
- Fire description - “spread vertically upward on the façade reaching the top of the building”
- Fire origin - fourth floor;

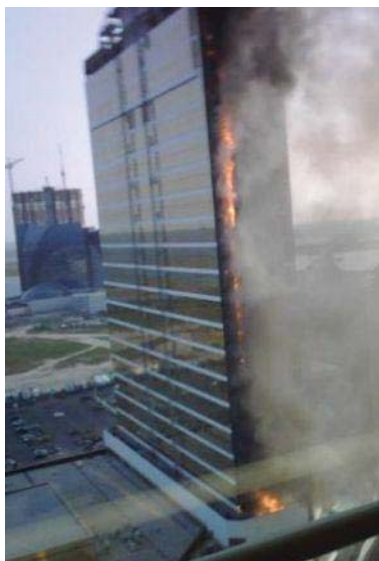
Water Club Tower, Atlantic City, USA

- *41 storey building under construction;*
- *Aluminium/polyethylene composite panel façade;*
- *Fire origin - internal fire on the 3rd floor;*
- *Fire description – “fire spread vertically and rapidly reached the top of the building”.*
