## 1.5 Waste Collection Information

## **2.0 SUMMARY OF PREVIOUS REPORTS**

### **2.1 A.S James – Geotechnical Investigation (July 1988)**

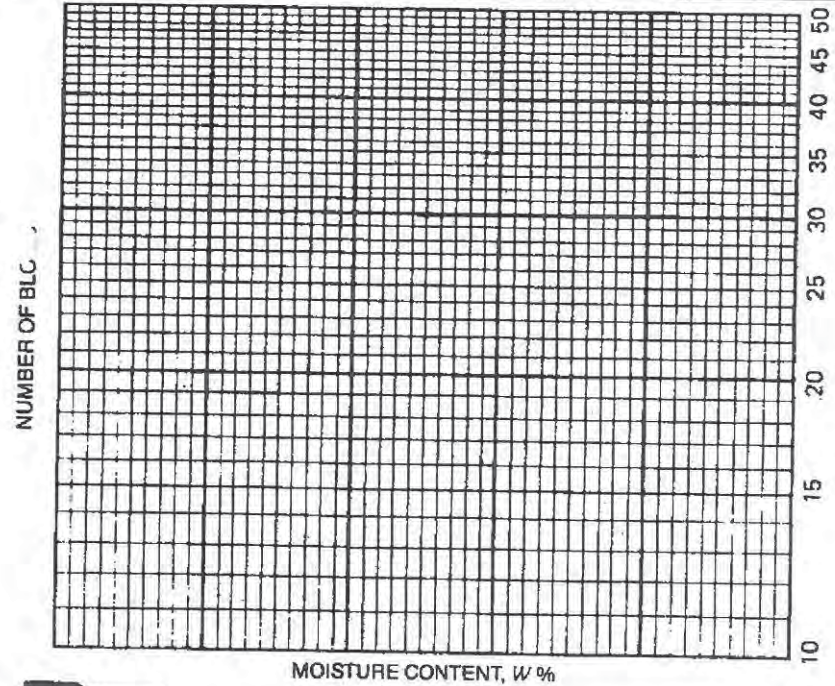
Tested  
Checked  
Figure 2

SAMPLE DESCRIPTION: GREY BROWN CLAY

LINEAR SHRINKAGE	
Mould No.	
Initial Length	mm
Final Length	mm
Longitudinal Shrinkage	mm
LS	% 21.1
Liquid Limit, $W_L$	% 94
Plastic Limit, $W_p$	% 30
Plasticity Index, $I_p$	% 64
Linear Shrinkage, LS	% 21.1

An Atterberg Limit geotechnical test was conducted on the soil sample collected from test pit and the soil was confirmed to be clay with low permeability.

- 2.03 In order to define the properties of the clay further Atterberg Limit testing has been carried out and the results are given on Figure 2.
- These tests define the clay as CH in accordance with the Unified Classification System and equally as a material of low permeability.

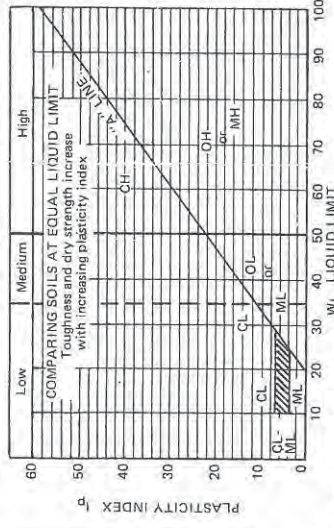
PLASTICITY CHART (For laboratory classification of fine grained soils)  
Adapted from A.S. 1726-1981 (App.D)
